## SEATTLE-TACOMA INTL AIRPORT

# **ALERT NOTICE**

#### ATTENTION ALL AIRCRAFT LANDING TO THE SOUTH:

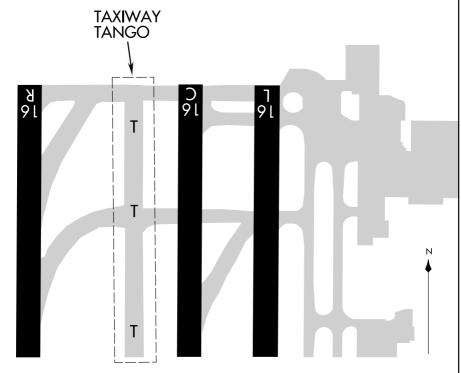
When transitioning from an instrument procedure to a visual approach to Runway 16C, verify you are aligned for the intended landing Runway, not Taxiway Tango. Taxiway Tango is west and parallel to Runway 16C.

Taxiway Tango has been mistaken for Runway 16C from the air during certain visibility conditions, i.e., wet runway, low sun angle reflections. Aircrews are advised to be aware of the proximity of the taxiway to Runway 16C and its runway-like appearance while on approach.

Aircrews should use visual cues, e.g., approach lighting systems, REILs, when available, to confirm alignment with Runway 16C not Taxiway Tango. Additionally, it is recommended when executing a segment of the ILS approach for a visual transition, track the localizer until the runway environment is visually verified.
