Vehicle Condition Report

2019 PEUGEOT BOXER

VIN # **VF3YFANF*2***8893**

INSPECTION DATE:
March 17, 2026 @ 08:58 UTC

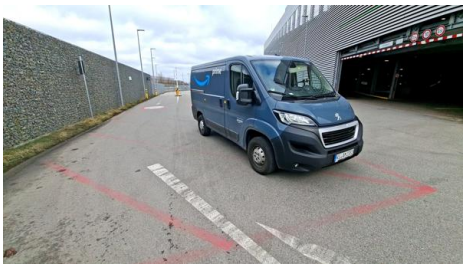
COMPONENT	CROPPED PHOTO	DAMAGE TYPE	SEVERITY	REPAIR METHOD	GRADE SCORE
1 Front Right Door Body Side Molding		Missing	Part is missing	Replace	3
2 Rear Right Quarter Side Molding		Missing	Part is missing	Replace	3
