RE: Claim CLM-2026-0912 - Policy PL-2026-44718 - Date of loss 2026-09-12

Damage Photographs and Leak Location

Adjuster Summary

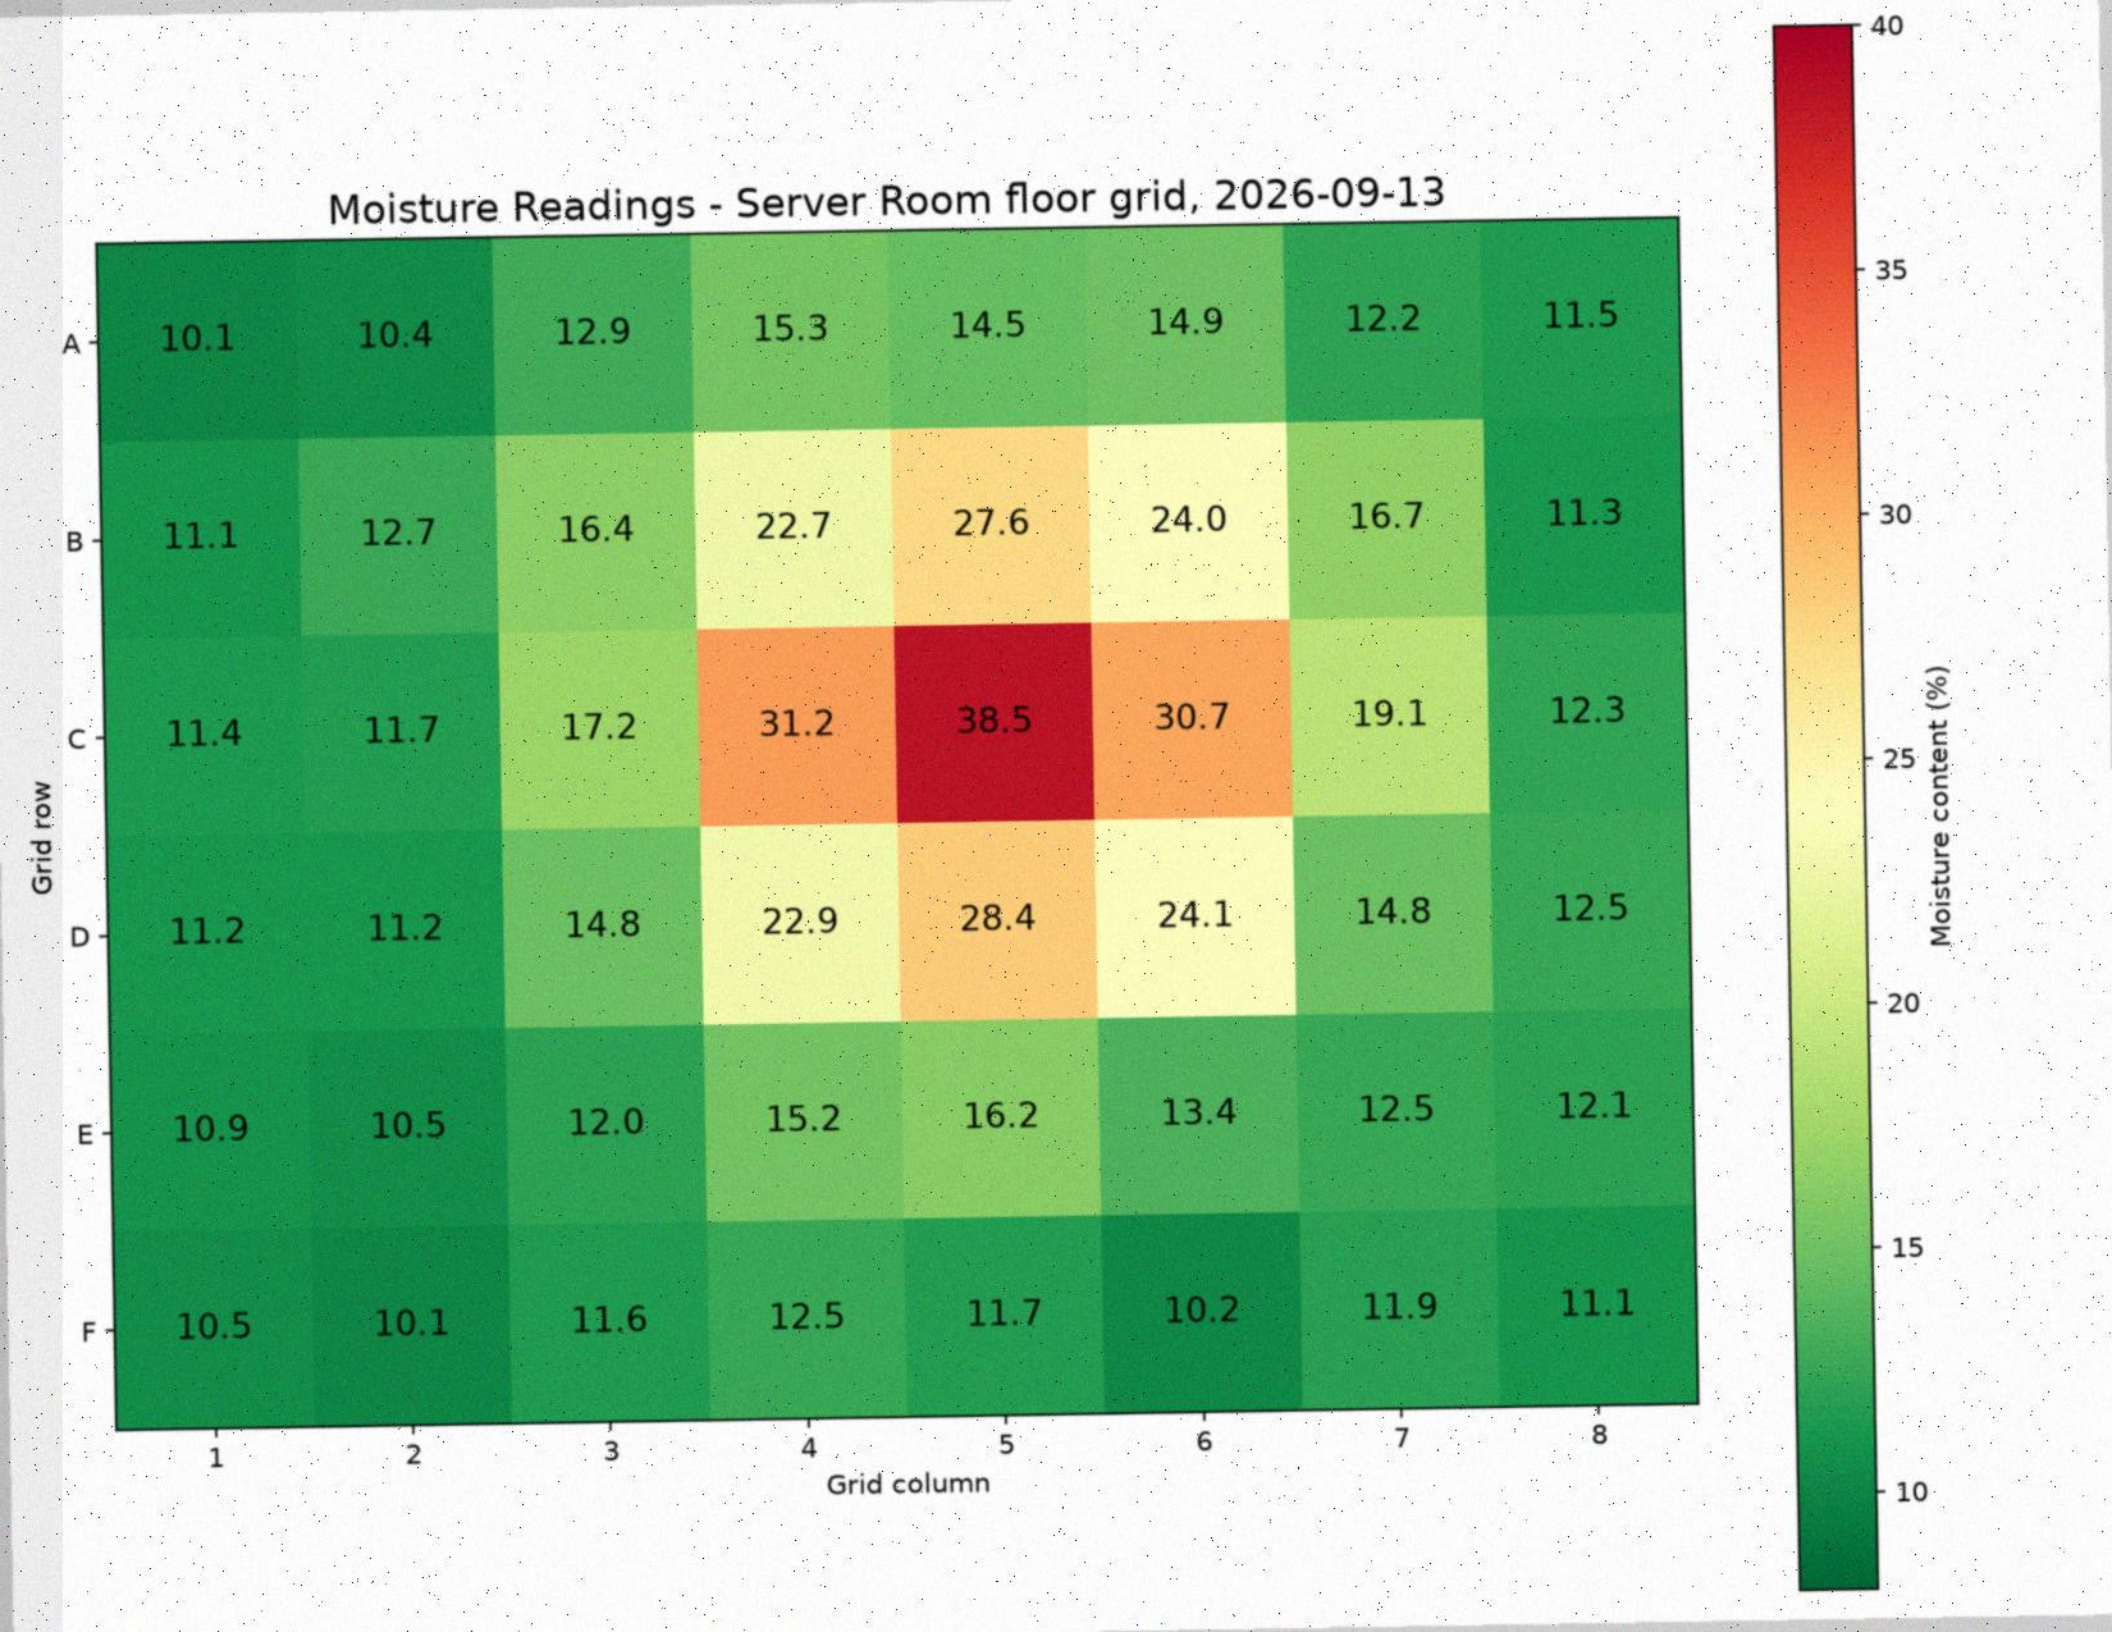
Moisture Readings - Server Room floor grid, 2026-09-13
A 10.1 10.4 12.9 15.3 14.5 14.9 12.2 11.5
B 11.1 12.7 16.4 22.7 27.6 24.0 16.7 11.3
C 11.4 11.7 17.2 31.2 38.5 30.7 19.1 12.3
D 11.2 11.2 14.8 22.9 28.4 24.1 14.8 12.5
E 10.9 10.5 12.0 15.2 16.2 13.4 12.5 12.1
F 10.5 10.1 11.6 12.5 11.7 10.2 11.9 11.1
Grid row
1 2 3 4 5 6 7 8
Grid column
Moisture content (%)
40 35 30 25 20 15 10

Inspection. The site was inspected on 2026-09-19. Moisture mapping confirms a localized plume centred on the Server Room.
