Equipment Inspection Form

Northwind Analytics, Inc.

Asset: Cooling loop flange FL-204
Site: Plant 3, Bay C
Inspection date: 2026-09-18
Inspector: R. Okafor

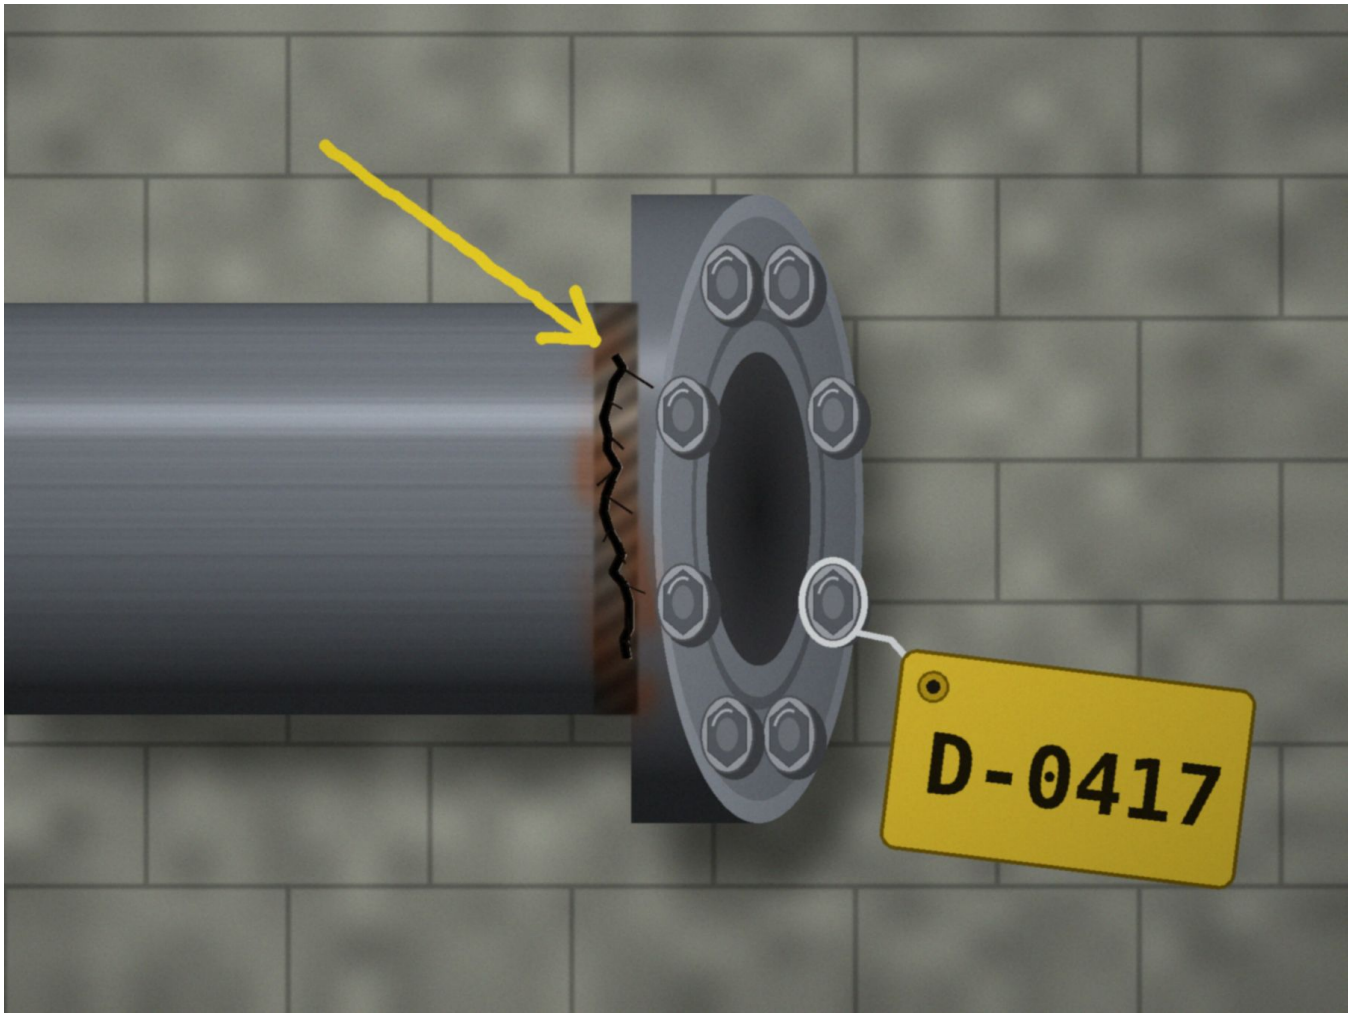
Defect photo

Hairline crack at weld, east flange.
Recommend replace gasket before Q4.
Re-inspect in 30 days - R. Okafor

2. A crack was found at the weld seam at the pipe-to-flange joint; see the defect photo on page 2.

Photo ref D-0417: crack at the weld seam at the pipe-to-flange joint, east flange FL-204. The yellow arrow marks the crack; light rust staining is visible below it.

Disposition: Open - replace gasket, repair weld and re-inspect in 30 days.
