Lot Summary and Final MRB State

LOT	PRODUCT	FLOW	LOTSIZE	MRB
Q8R7-22	AMX-4100	LVT gate	12 wafers	2026-06-11

Disposition

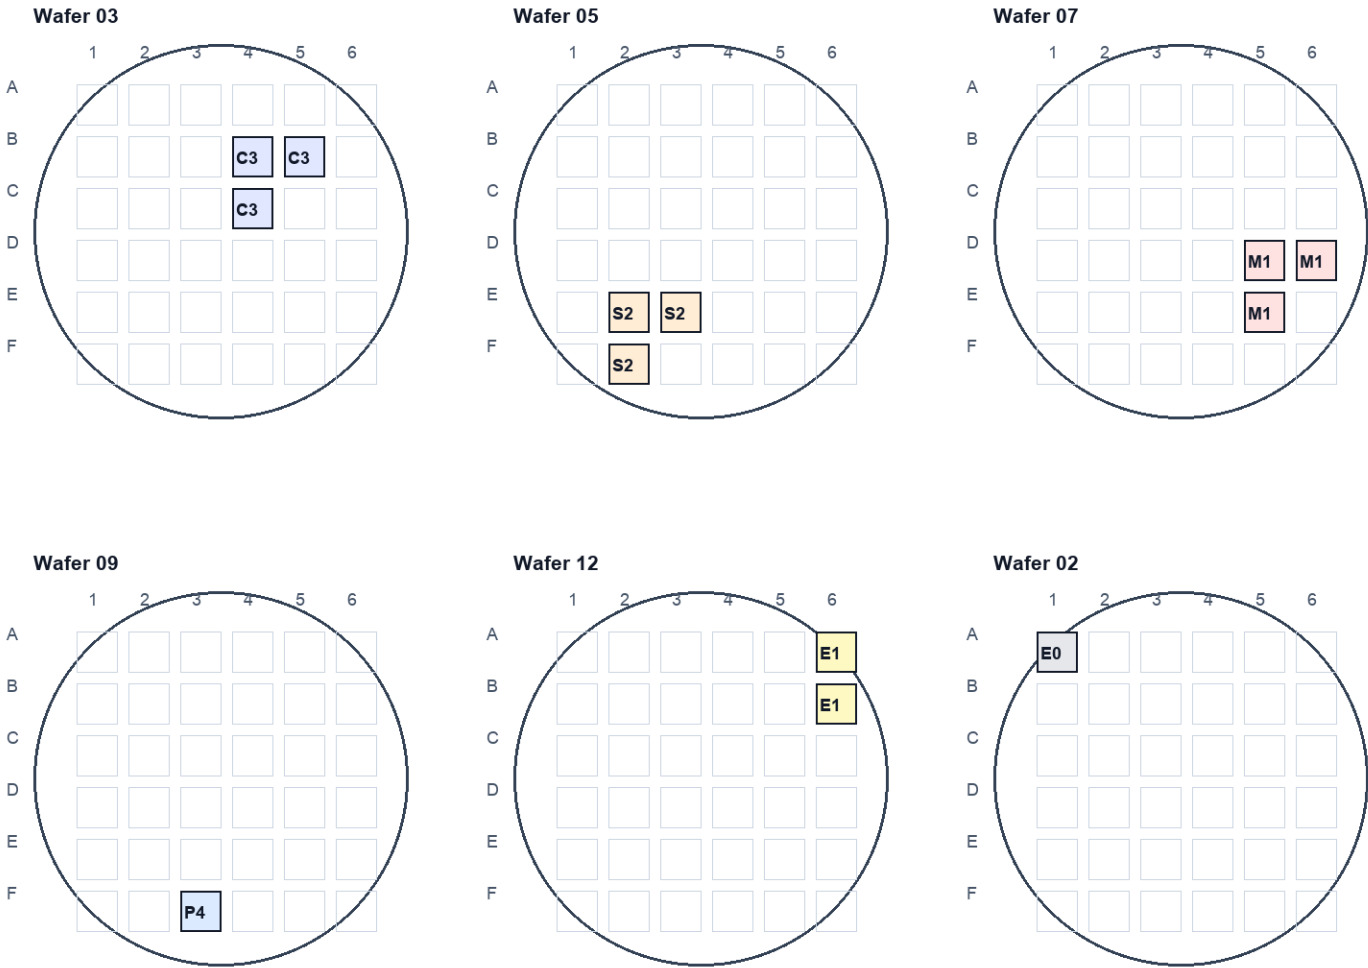
Route note

PVD-03 alarm at 09:18 triggered containment. The lot continued to RTP-08 only after engineering released the tool to complete the already-loaded chamber sequence.

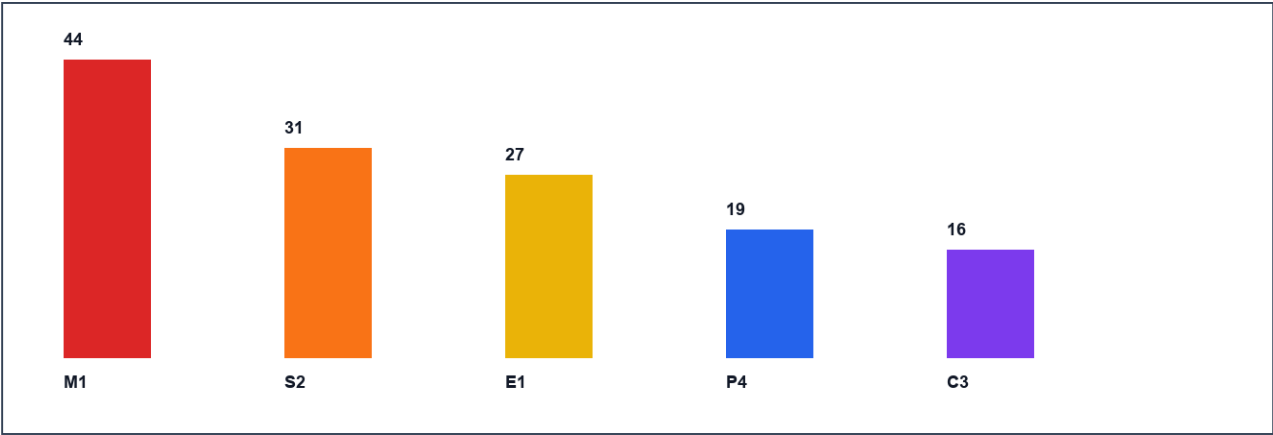
Code	Class	Count	Affected wafer	Disposition
M1	metal flake	44	07	scrap wafer 07
S2	scratch	31	05	hold for review
E1	edge bead	27	12	hold
P4	parametric drift	19	09	conditional release
C3	center cluster	16	03	hold

Classification rule
M1 metal flake is a scrap class when clustered on adjacent D-row sites. S2, E1, and C3 require engineering hold. P4 is allowed only as conditional release with reliability sample.
