ROUTINE MECHANICAL INSPECTION

Rotating equipment condition report

EQUIPMENT
Cooling Water Pump P-204A

WORK ORDER
WO-26-0917

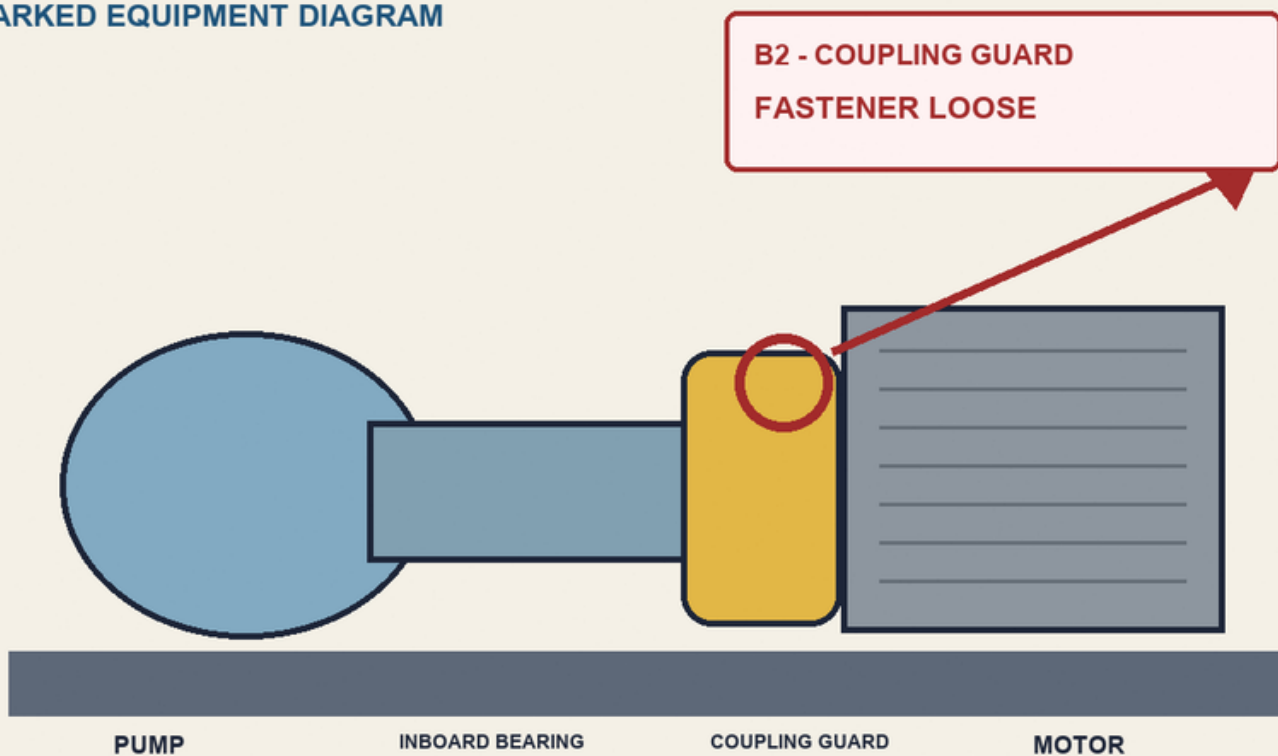
MARKED EQUIPMENT DIAGRAM

Oil seep at inboard bearing.

Recheck after 48 h.

ACTION Tighten fastener B2 before the next restart. Record completion in WO-26-0917.
