Factual Information

History of Flight

Landing	Sys/Comp malf/fail (non-power) (Defining event)
Landing	Landing gear collapse

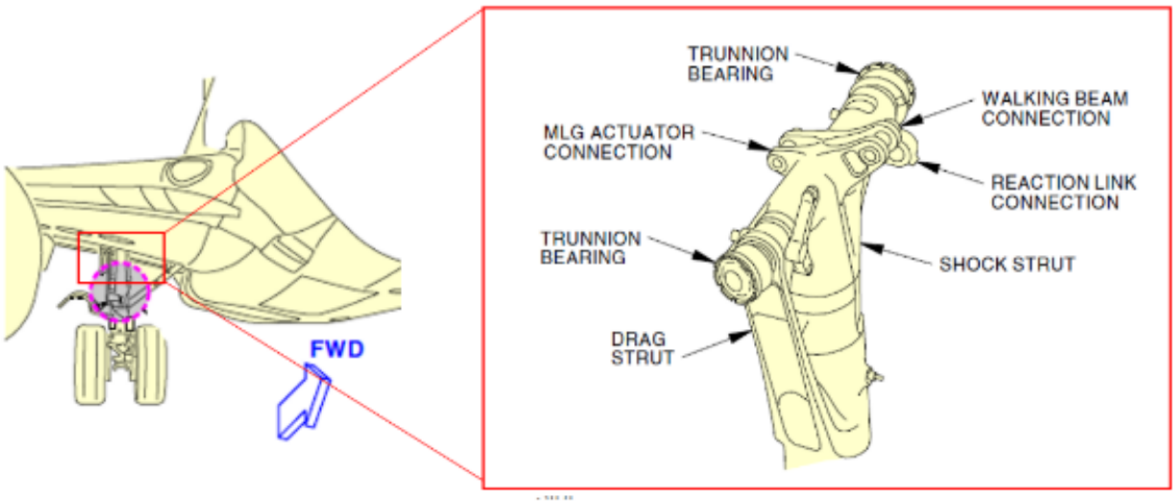
A main gear shock strut provides the primary support for each MLG (see figure 2). The shock strut consists of an integral drag strut, an outer cylinder, and an inner cylinder. When the MLG extends or retracts, the shock strut rotates about two trunnion bearings and two pins (forward and aft) at the top of the outer shock strut. The forward and aft trunnion pins extend through a trunnion bearing and support assembly in the wing and landing gear beam. Trunnion bolts keep the trunnion pins from backing out during landing gear operation.

Figure 2. Illustration of the MLG components. (Source: Boeing. Image Copyright Boeing. Reproduced with permission.)

Post accident inspection found that the left MLG forward trunnion pin and its spherical bearing were in place with no visible damage to the wing spar. The inspection also found that the left MLG aft trunnion pin had fractured in half vertically across its diameter. One-half of the aft trunnion pin remained within the spherical bearing of the rear landing gear beam, and the other

half remained in the outer cylinder of the MLG trunnion. The trunnion pin half that remained in the landing gear beam spherical bearing had moved aft and was found protruding from the aft side of the bearing.

The left MLG aft trunnion pin had fractured approximately perpendicular to the length of the pin at its midspan. The trunnion pin was extracted from the airplane for further examination. The aft section of the pin was between 4.5 and 5.0 inches long, and the forward section of pin was between 5.25 and 6.0 inches long. The aft section of the trunnion pin was examined at Boeing's Equipment Quality Analysis (EQA) laboratory in Seattle, Washington with NTSB personnel present. The forward section of the trunnion pin was removed from the aircraft over a month later, and was sent to the NTSB Material Laboratory, where it was examined before bringing it to the Boeing EQA lab for additional Barkhausen and temper etch inspections. The results of the examinations at the NTSB Materials Lab and Boeing EQA lab are discussed below.
