**Acuren Group Inc.**

REPORT #: UT-BALJIN-2026-28

PROJECT: Corrosion 2026

ITEM(S) EXAMINED: **CML 1.04, 1.13**

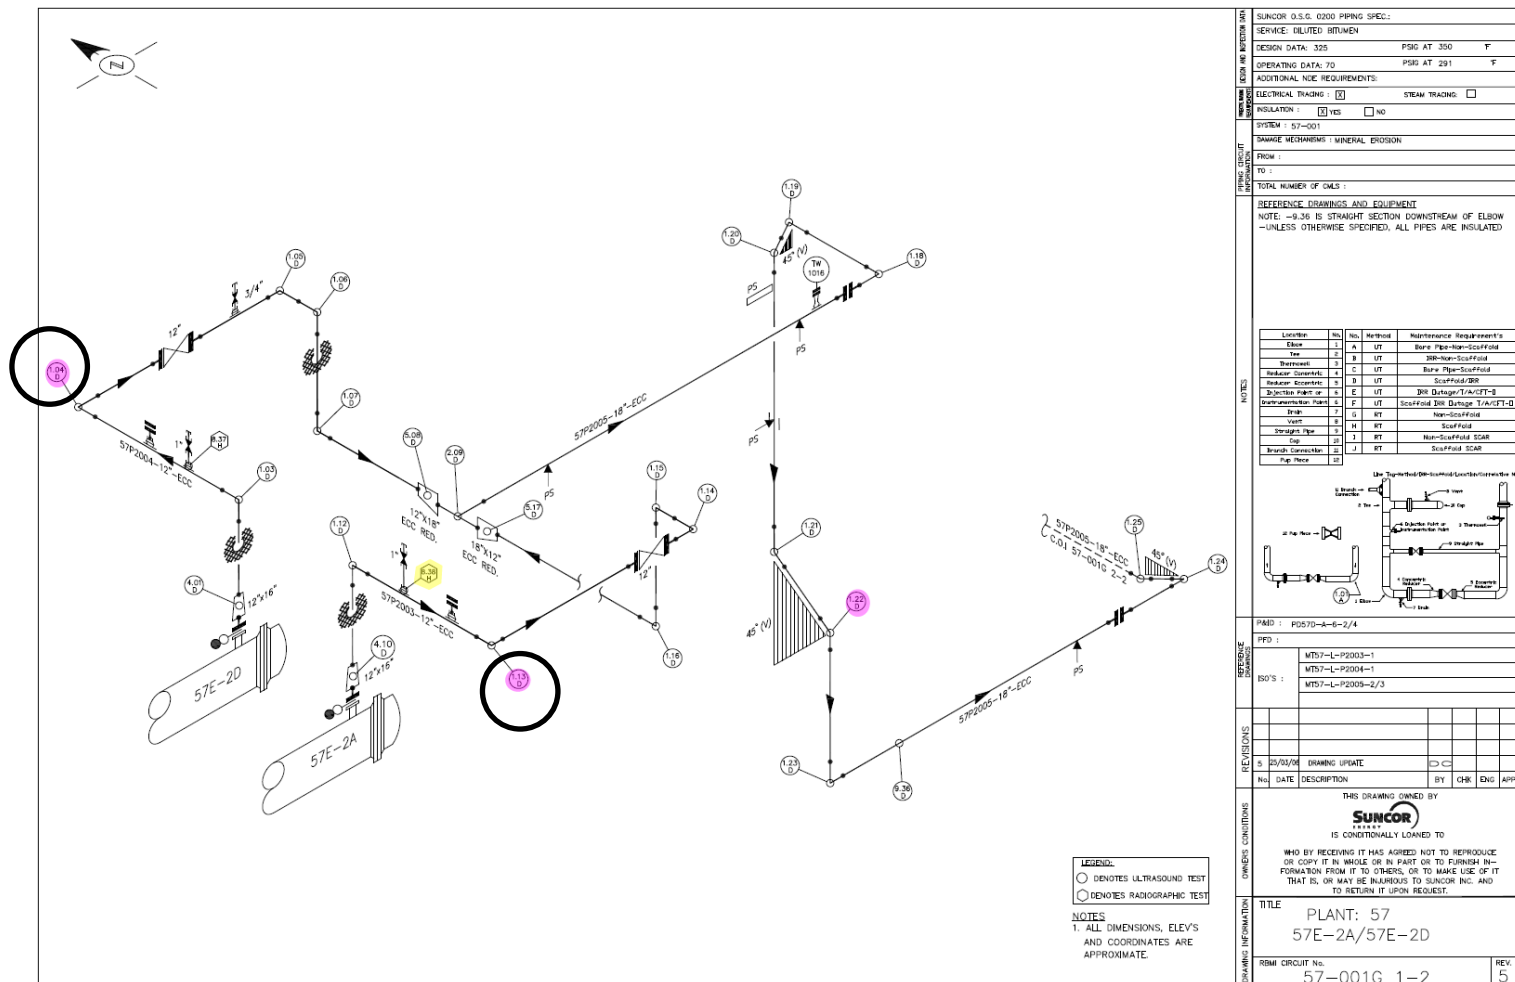
Circuit:
57-001G 1-2
CML
1.04, 1.13
