Instructions to get ERP Trigger and Logging Up and Running - Bench Unit

Testing Pre-deployment - Field Unit

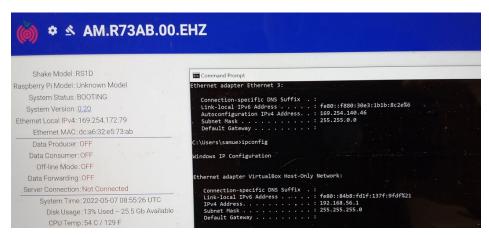
1) Plug in GPS receiver (USB) – female connector (USB extender cable) – mount high above ground and once powered, use "cgps" to test GPS connection status. Keyboard, HDMI monitor and mouse connection show, but not necessary to boot and run. Field unit has only Ethernet, USB extender, and USB power.

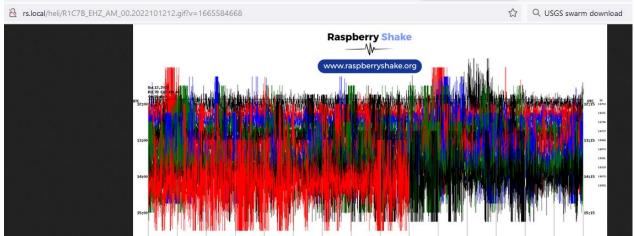
- 10) cat /opt/settings/sys/STN.txt
- 11) Put the STN into "station" field in main.py e.g., for this test R1C7B
- 12) Run main.py
- 13) Use Helicorder to see recent activity bottom of rs.local (dates with collection will be shown)
