GIF++ test of BIL2 pack

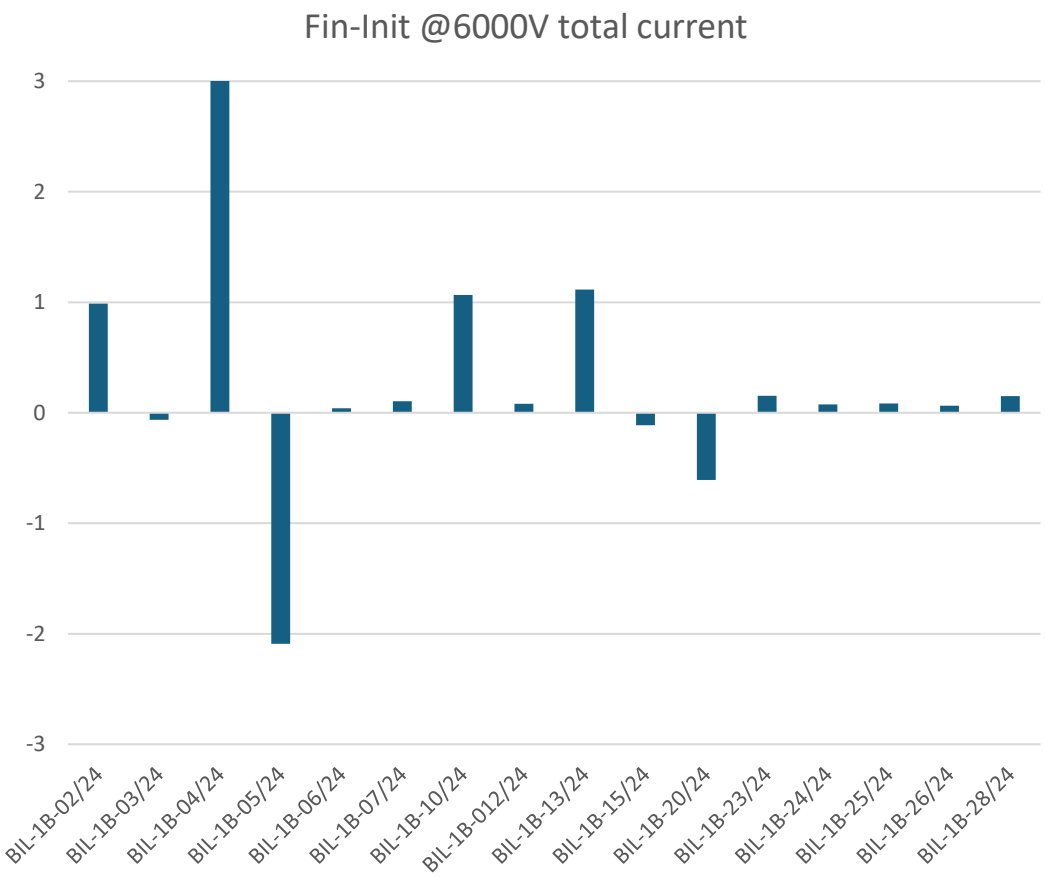
Comparison source off @6kV

- The higher tagged initial currents lowered
- A few increased, to be investigated in BB5
- The initial worst (21) was not properly monitored. To be retested in BB5
- We are still in the learning curve → we need to improve the standardization of the test performed by different people

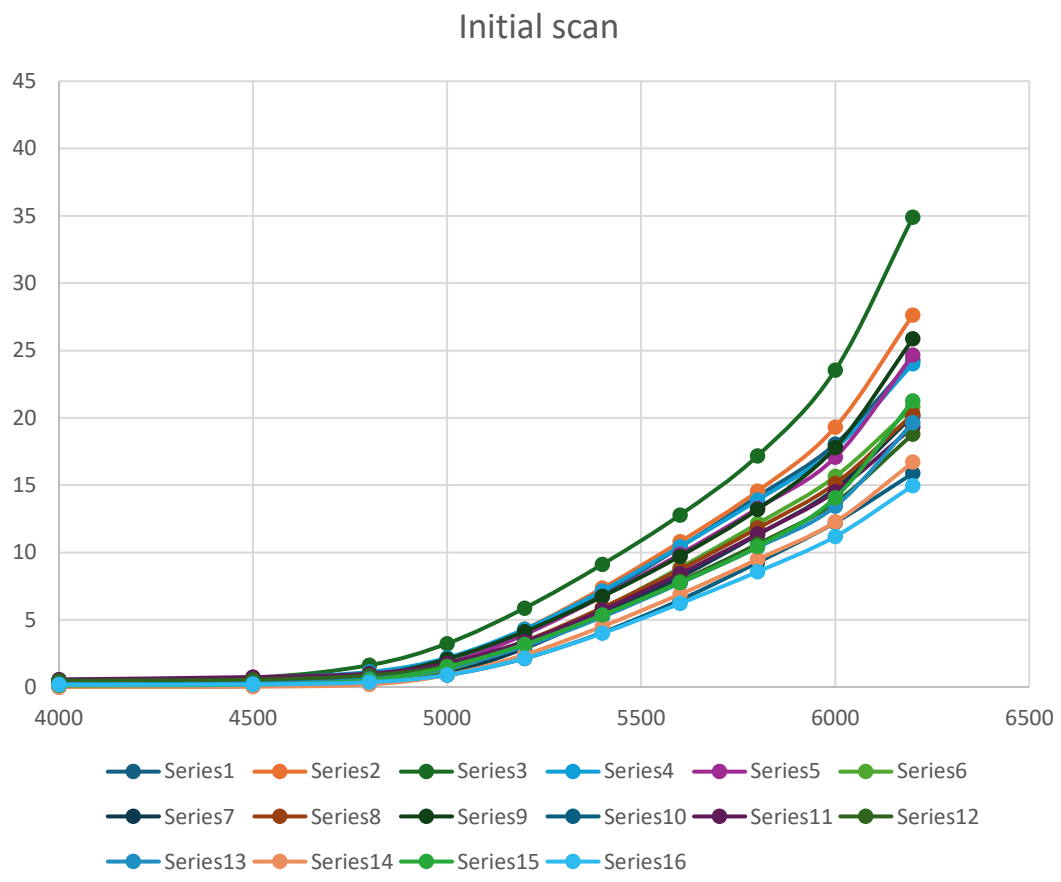
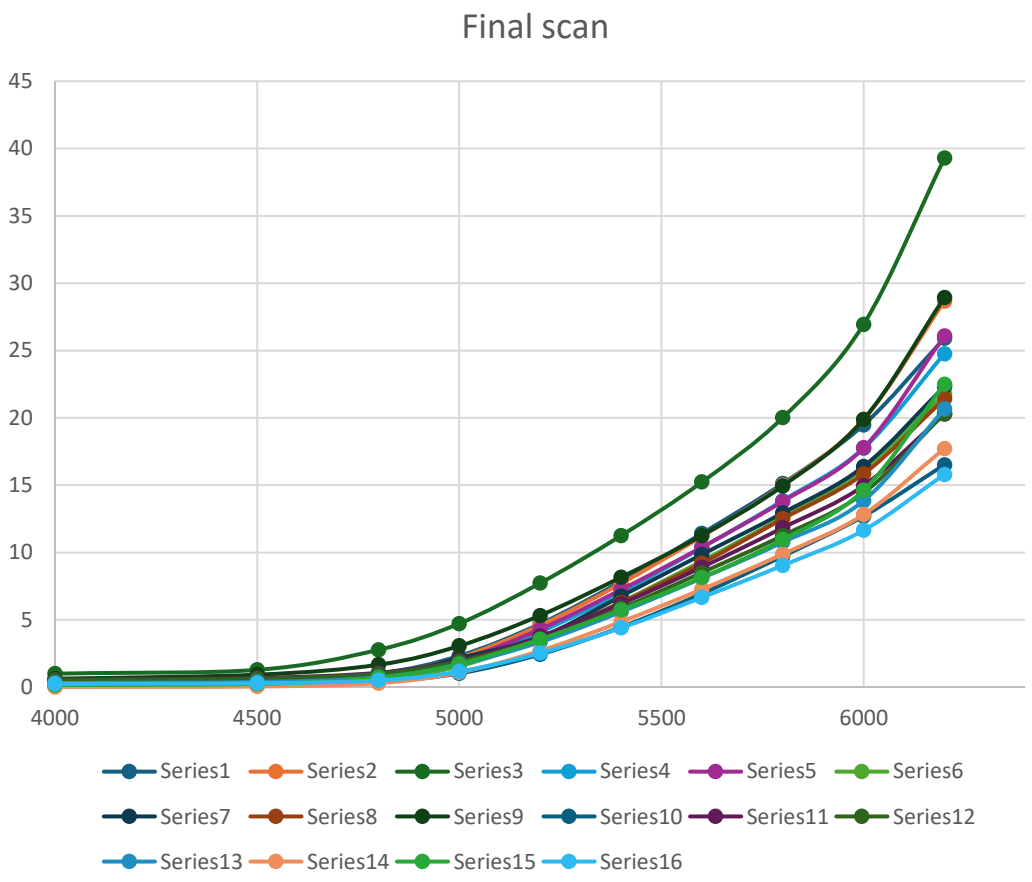
Initial vs. final source filter 100 (first 16 gaps)

ADC problem for the gaps 17-21→ CAEN

- Trends monitored on CAEN currents
- Channel 11 is the last gas gap alone
- Was set
- Final scan to be repeated in BB5
