GIF++ test of BIL2 pack

Overall information

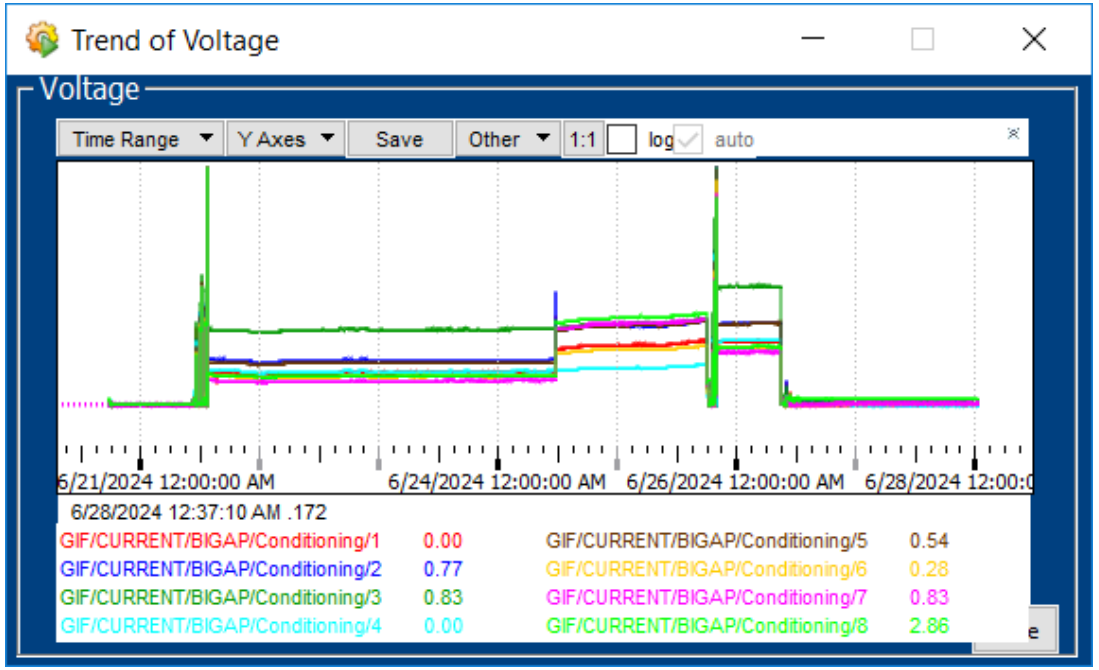
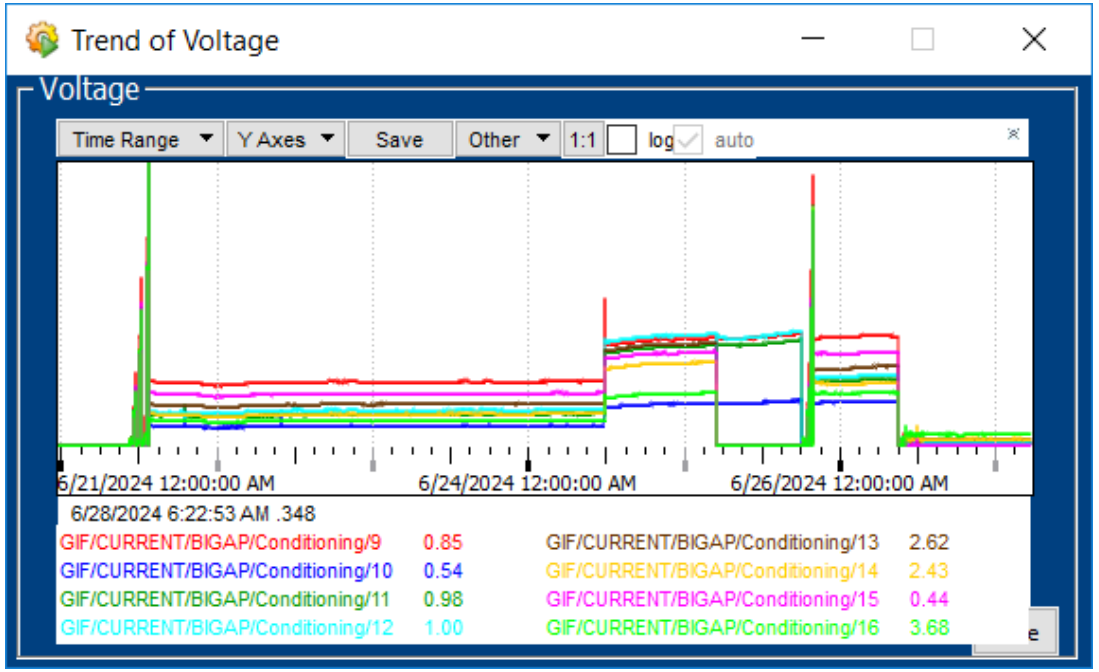
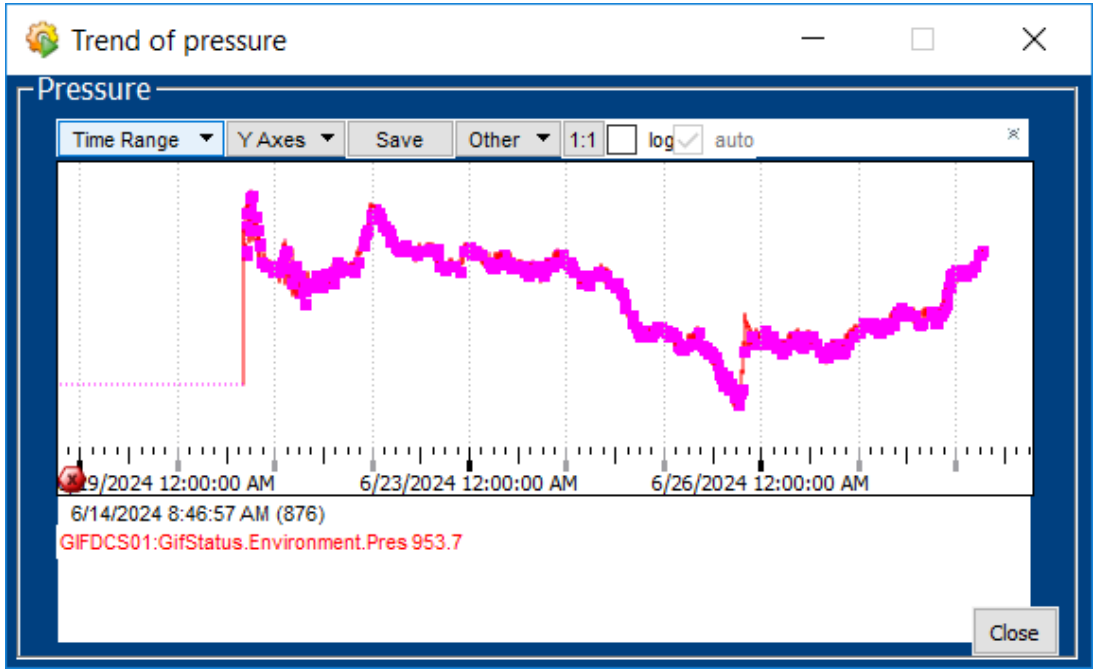
Conditioning trends

- Small effect of the pressure between initial (959 mbar) and final (953 mbar)
- Equivalent to about 0.6 % of the full voltage (36V)

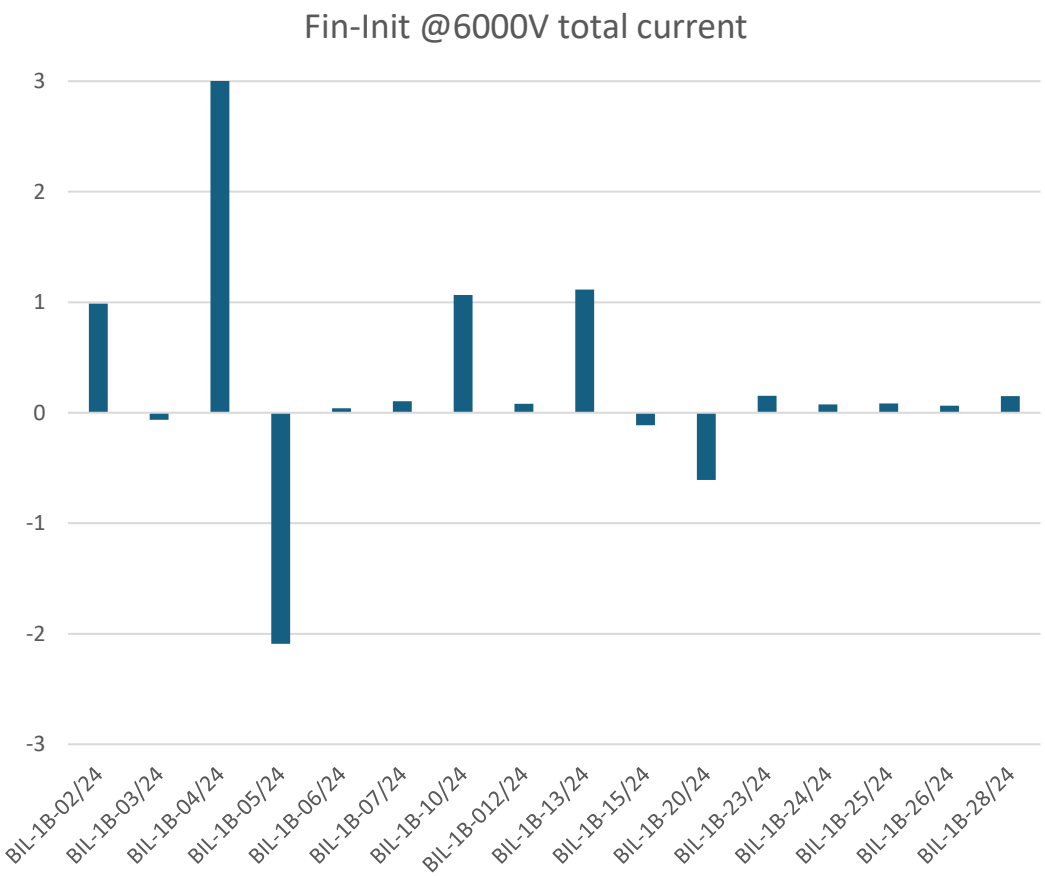
Comparison source off @6kV

- The higher tagged initial currents lowered
- A few increased, to be investigated in BB5
- The initial worst (21) was not properly monitored. To be retested in BB5
- We are still in the learning curve → we need to improve the standardization of the test performed by different people

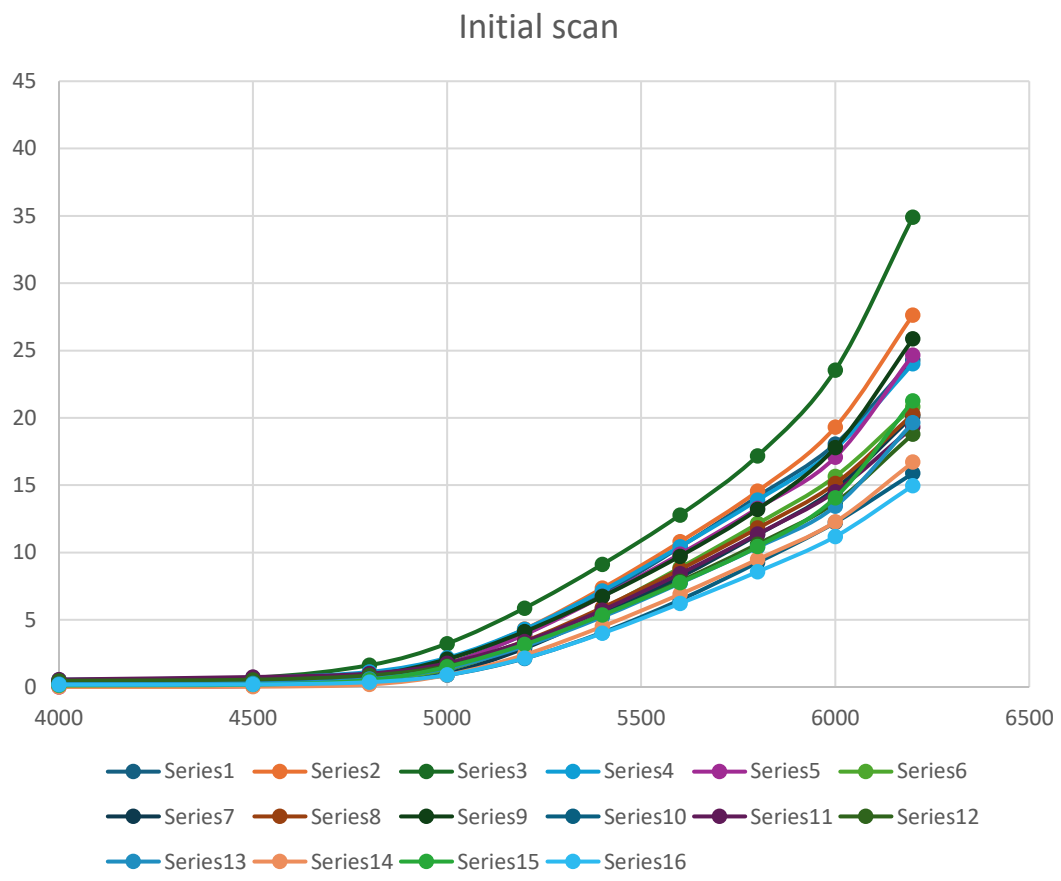
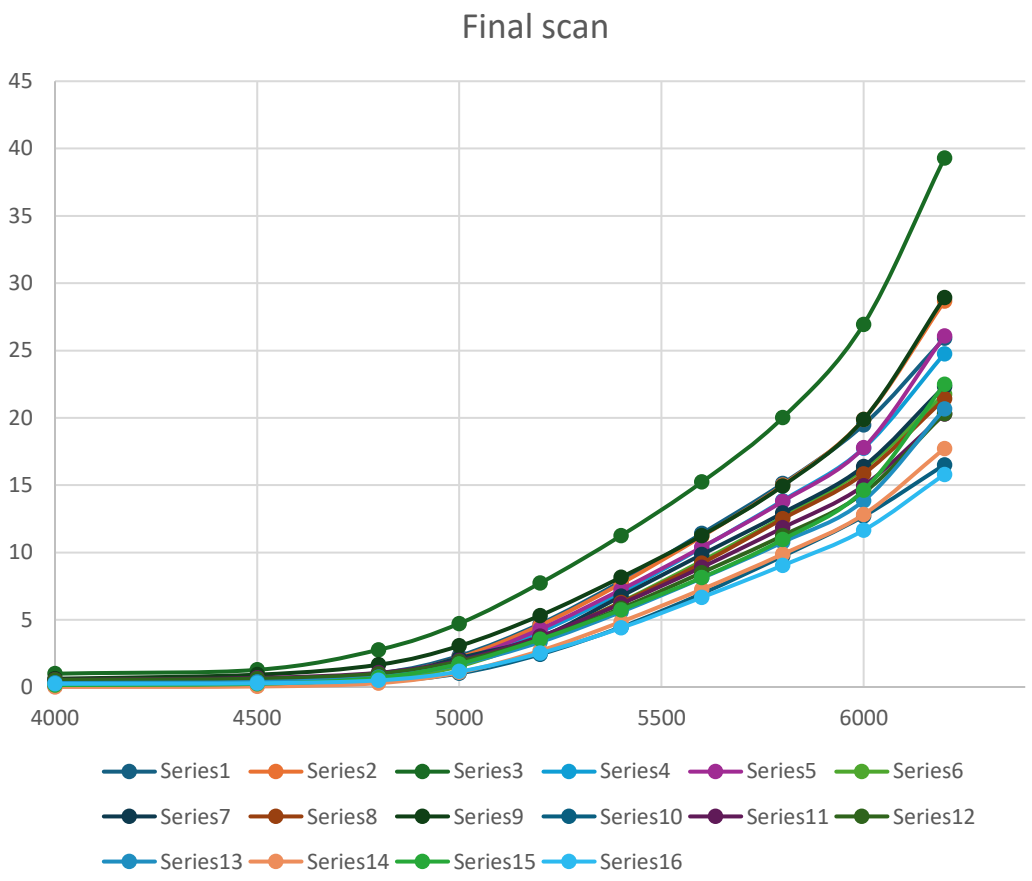
Initial vs. final source filter 100 (first 16 gaps)

ADC problem for the gaps 17-21→ CAEN

- Trends monitored on CAEN currents
- Channel 11 is the last gas gap alone
- Was set
- Final scan to be repeated in BB5
