zavzaSeal
Waterproofing & Insulation
Done Right

Addendum to Estimate #27

PROPERTY ADDRESS: 2317 Lincoln St, North Bellmore, NY 11710

Subject Area: Central Wood Beam in Crawl Space

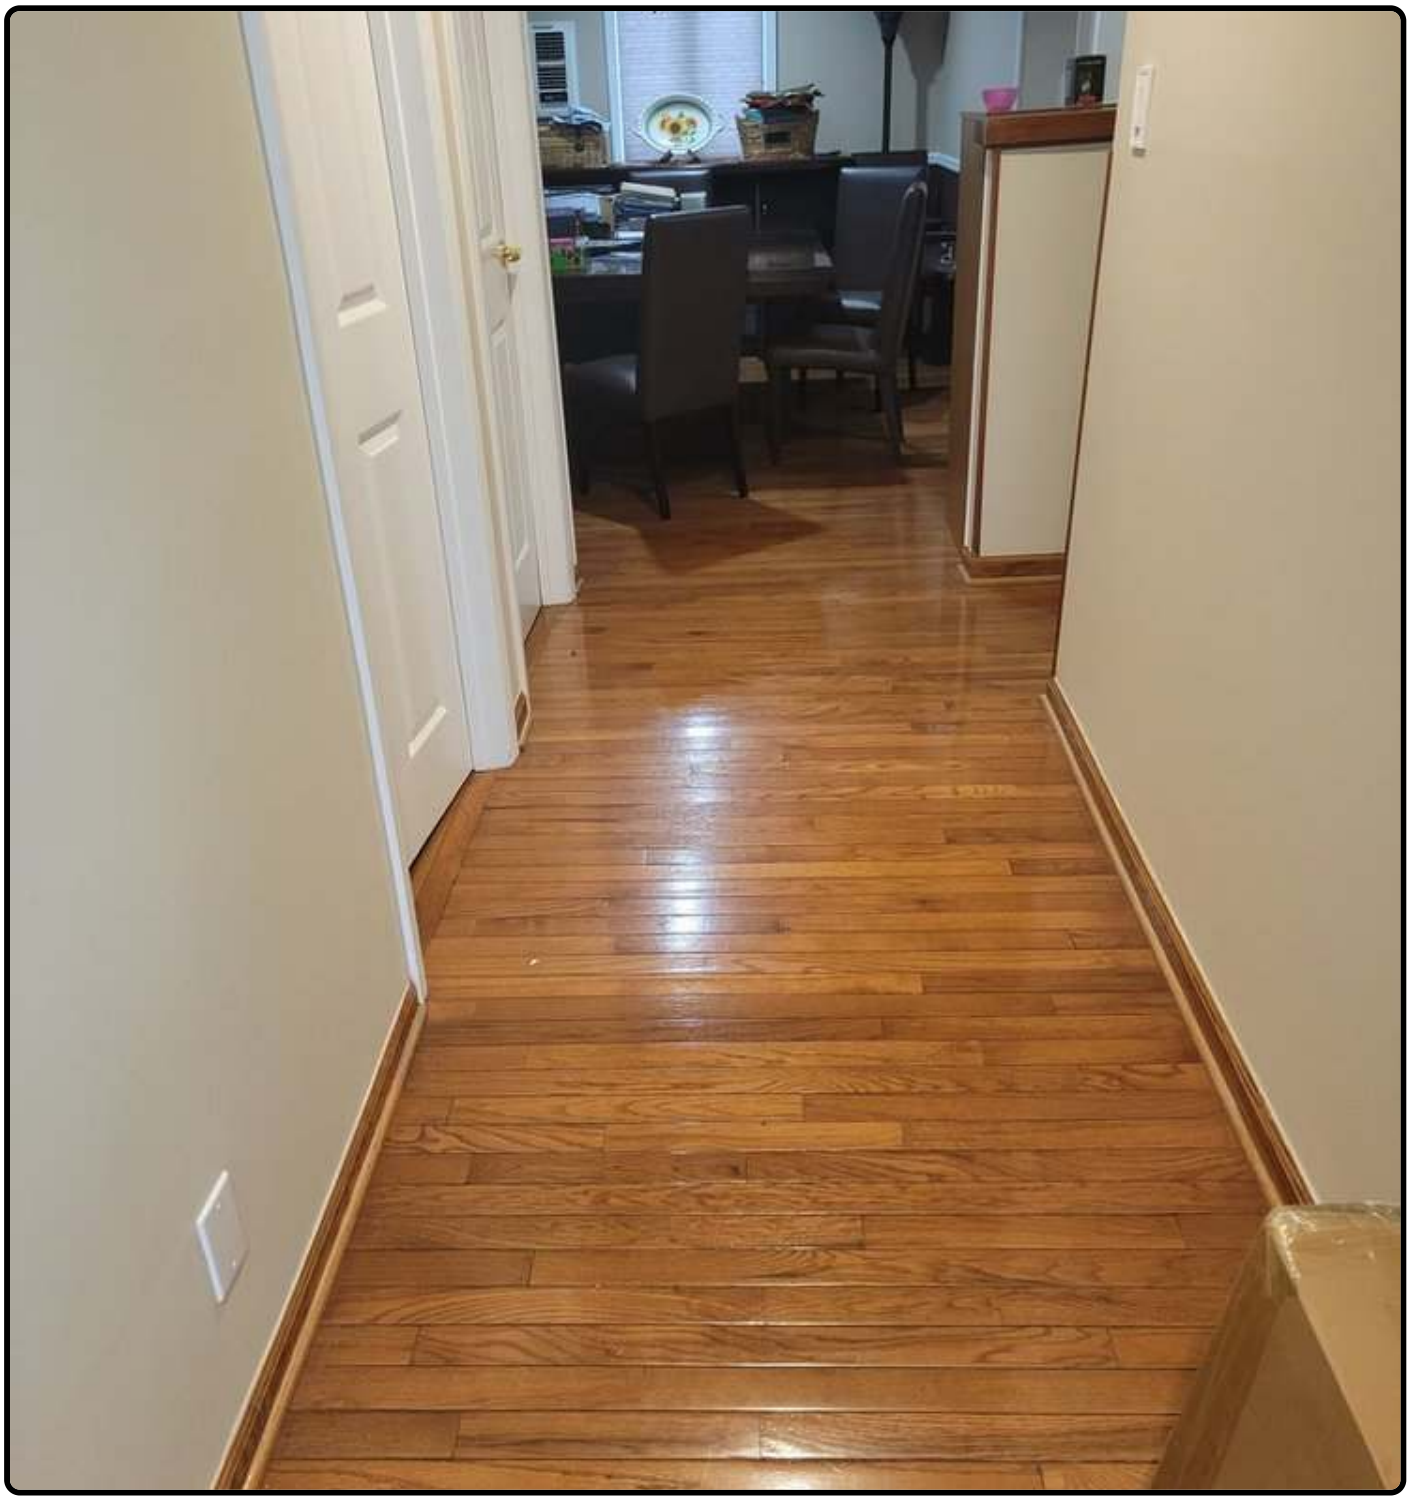
Exhibit A

Analysis: The floor is bulging upwards (please see Exhibit A). The bulge is actually a shift and misalignment caused by a deflection point of the wood beam. The measurements of the beam are not sufficient in size for a central beam, and to make the situation worse, in the past someone made adjustments to the beam by installing 2 wood shims that are very small and misaligned on top of 2 bricks with no lateral support (please see Exhibit B). The central beam is composed of 3 wood planks that add up to 7” in height and 5” in width (please see Exhibits C&D), spanning over approx. 15 feet – this caused the beam to bend and will continue to cause the beam to bend over the years until it will crack. Measuring the height from the concrete slab to the bottom of the wood beam, our senior estimators found a difference of almost 1” (please see Exhibits E&F).

Solution: Install 2 concrete filled steel columns in the middle of the span of each side of the crawl space.
