zavzaSeal
Waterproofing & Insulation
Done Right

Addendum to Estimate #27

PROPERTY ADDRESS: 2317 Lincoln St, North Bellmore, NY 11710

Subject Area: Central Wood Beam in Crawl Space

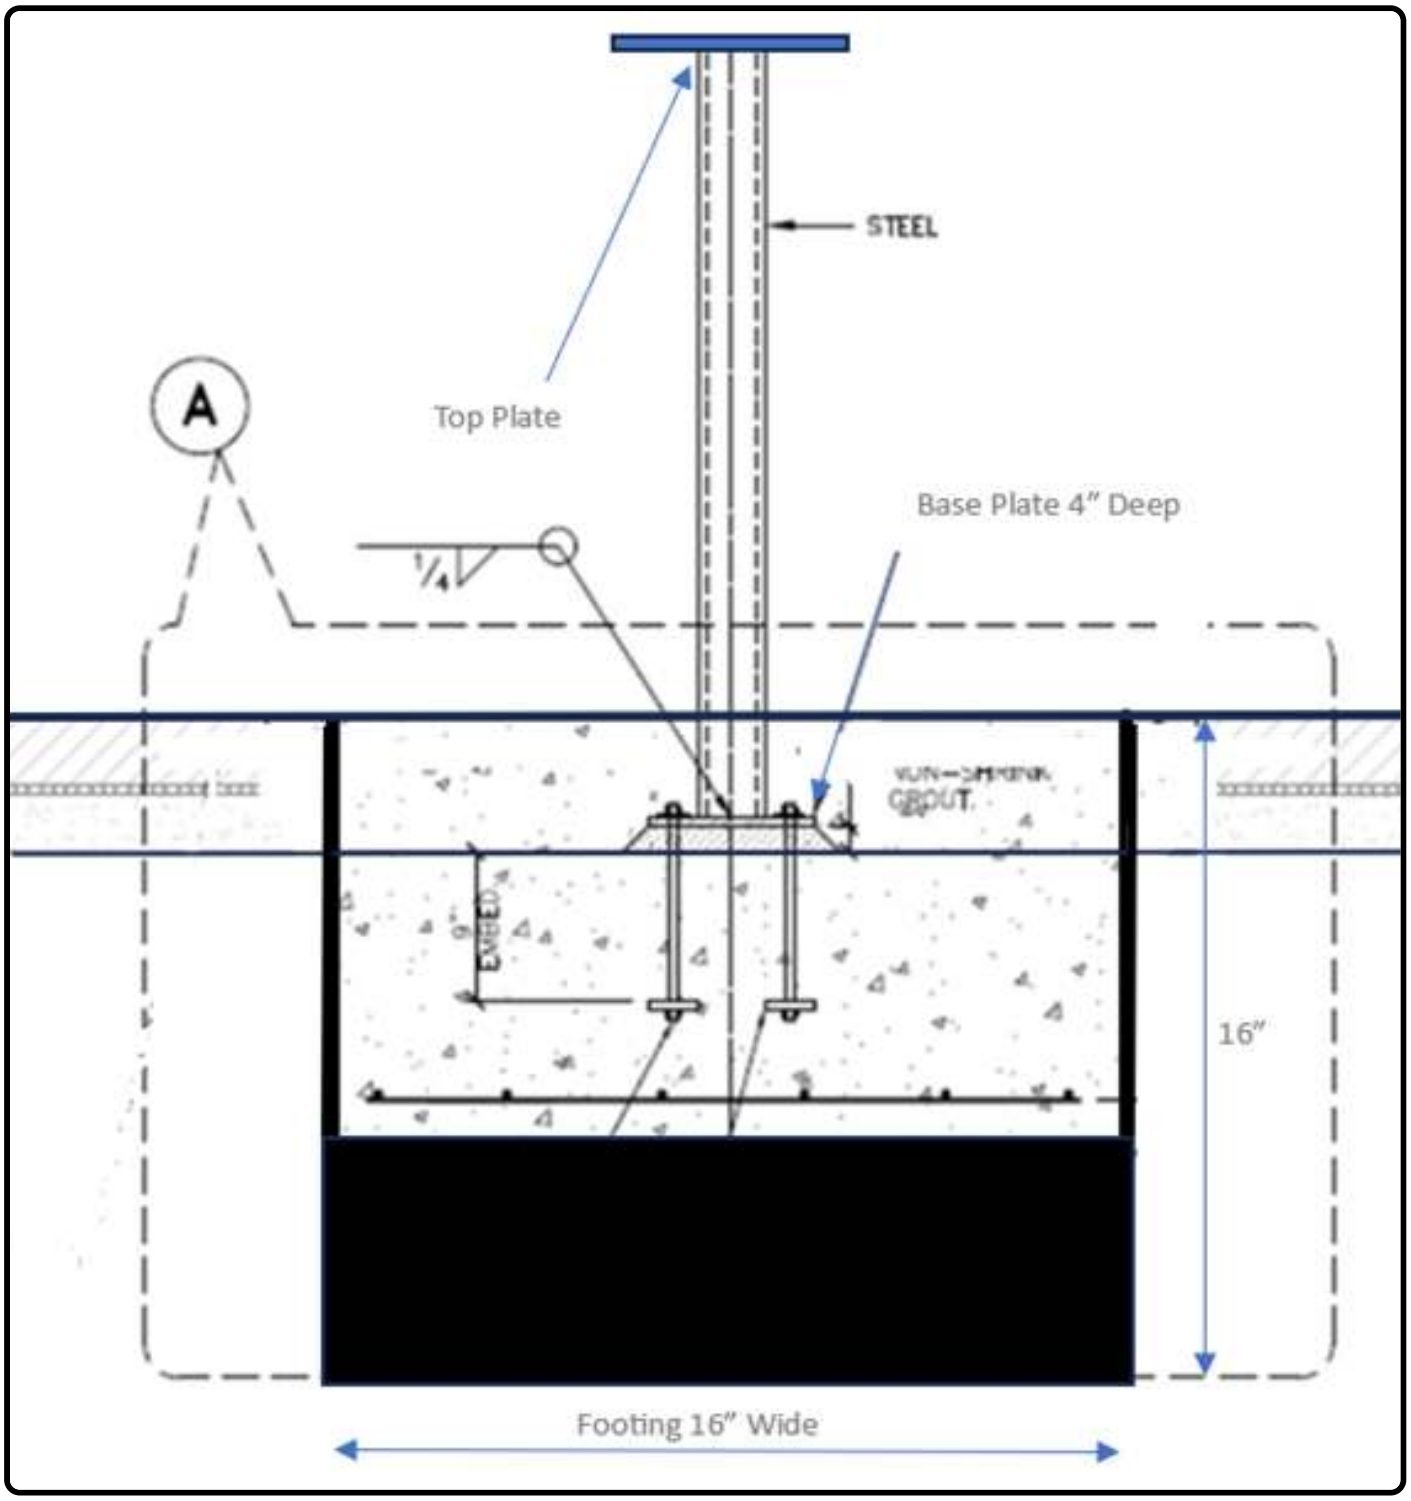
Exhibit SK-1

STEEL
Top Plate
A
Base Plate 4" Deep
1/4
NON-SHRINK GROUT
EXPOSED
16"
Footing 16" Wide

- For each column, we shall:
  - Sawcut the concrete slab.
  - Utilize diamond blades to cut the concrete slab.
  - Excavate and establish a new rebar-reinforced 12"W x 12"L x 12"D footing (please see Exhibit SK-1) on a well-compacted soil.
  - Add a #4 rebar cage to enhance structural integrity of the footing.
  - Pour concrete mixed with fiber to increase the PSI of the concrete.
  - Level the concrete with the existing concrete slab.
  - Allow the concrete to cure for at least 24 hours and come back to install the new steel column.

- We shall install a new 4" diameter concrete filled steel column with top and base plates secured to the newly installed footing and the central wood beam on top. The new column will be factory primed with rust inhibitive paint.
- We shall remove and dispose of all the debris and leave the work area broom cleaned to complete.
