Sample Gardens

123 Sample Street Mid City, OH 23445

GENERIC ENERGY CONSULTING

I. EXECUTIVE SUMMARY

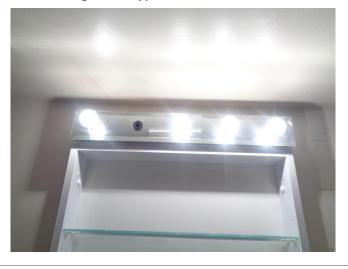
Figure 40: Typical Kitchen Fixture

Owner installed and maintained fixtures in the apartments include fixtures with incandescent bulbs in the kitchen, apartment entrance, and bathroom. The facility maintenance staff has been replacing burnt out bulbs with CFL lamps in the kitchen and living room fixtures.

Improvement Summary:	 Implement a lighting retrofit in building common areas and exterior, including the following major items: Retrofit existing incandescent, compact, and linear-fluorescent technology fixtures with LED technology lamps. Retrofit the exterior lighting fixtures with LED technology fixtures. Halogen lamps shall be replaced with LED lamps with similar or higher wattage output.
	Property staff shall be trained on the operation and maintenance of the new high-efficiency lighting systems.
Benefits Attained:	Installing high-efficiency lighting will significantly reduce the property's electrical consumption while maintaining equivalent or better light levels. In addition, many of the recommended bulbs and fixtures have longer lifespans, which will reduce the number of bulbs replaced at the property.
Assumptions:	GEC modeled this improvement using spreadsheet-based calculations. Light runtime hours were based on observations made on site and discussions with property staff.
