ArmorGalv® Evaluation

Document #D01

Evaluation of ArmorGalv® under Salt Fog Exposure and Partial Immersion in Saltwater

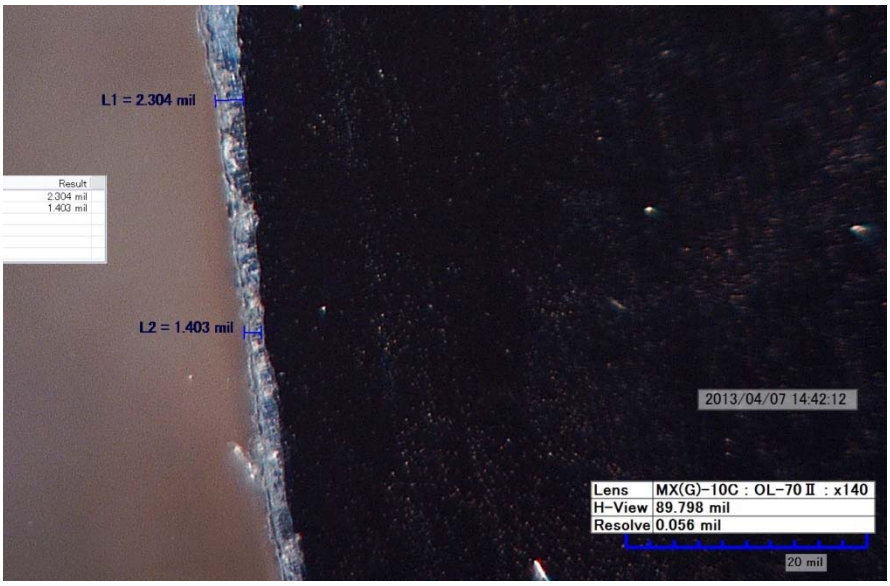
In addition to the visual observations, a specimen that was exposed to the salt fog environment was cross sectioned and mounted in epoxy and polished to a 1 micron finish for metallographic examination. This exposed specimen of the ArmorGalv® process was compared to an unexposed specimen prepared in like manner. From this comparison, consumption of the coating was not identifiable, primarily due to variations in the measured coating thickness. (Figures 5 and 6.) Although measurements indicated a slight difference in coating thickness of the two specimens, the thicknesses were similar and in fact a thinner coating layer was measured on the unexposed specimen. Since the coating thicknesses measured were similar, there was no measureable coating loss.

Figure 5 Unexposed specimen of ArmorGalv®

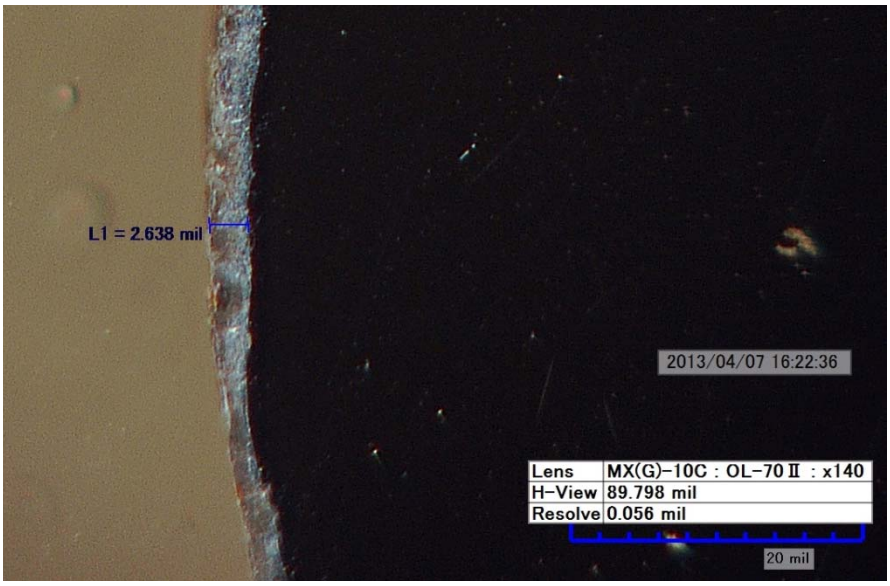
Figure 6 ArmorGalv® after 3000 hours in salt fog environment
