INTERIOR GLAZING

INTERIOR GLAZING FASTENER INDEX

PROJECT
KIRKLAND & ELLIS

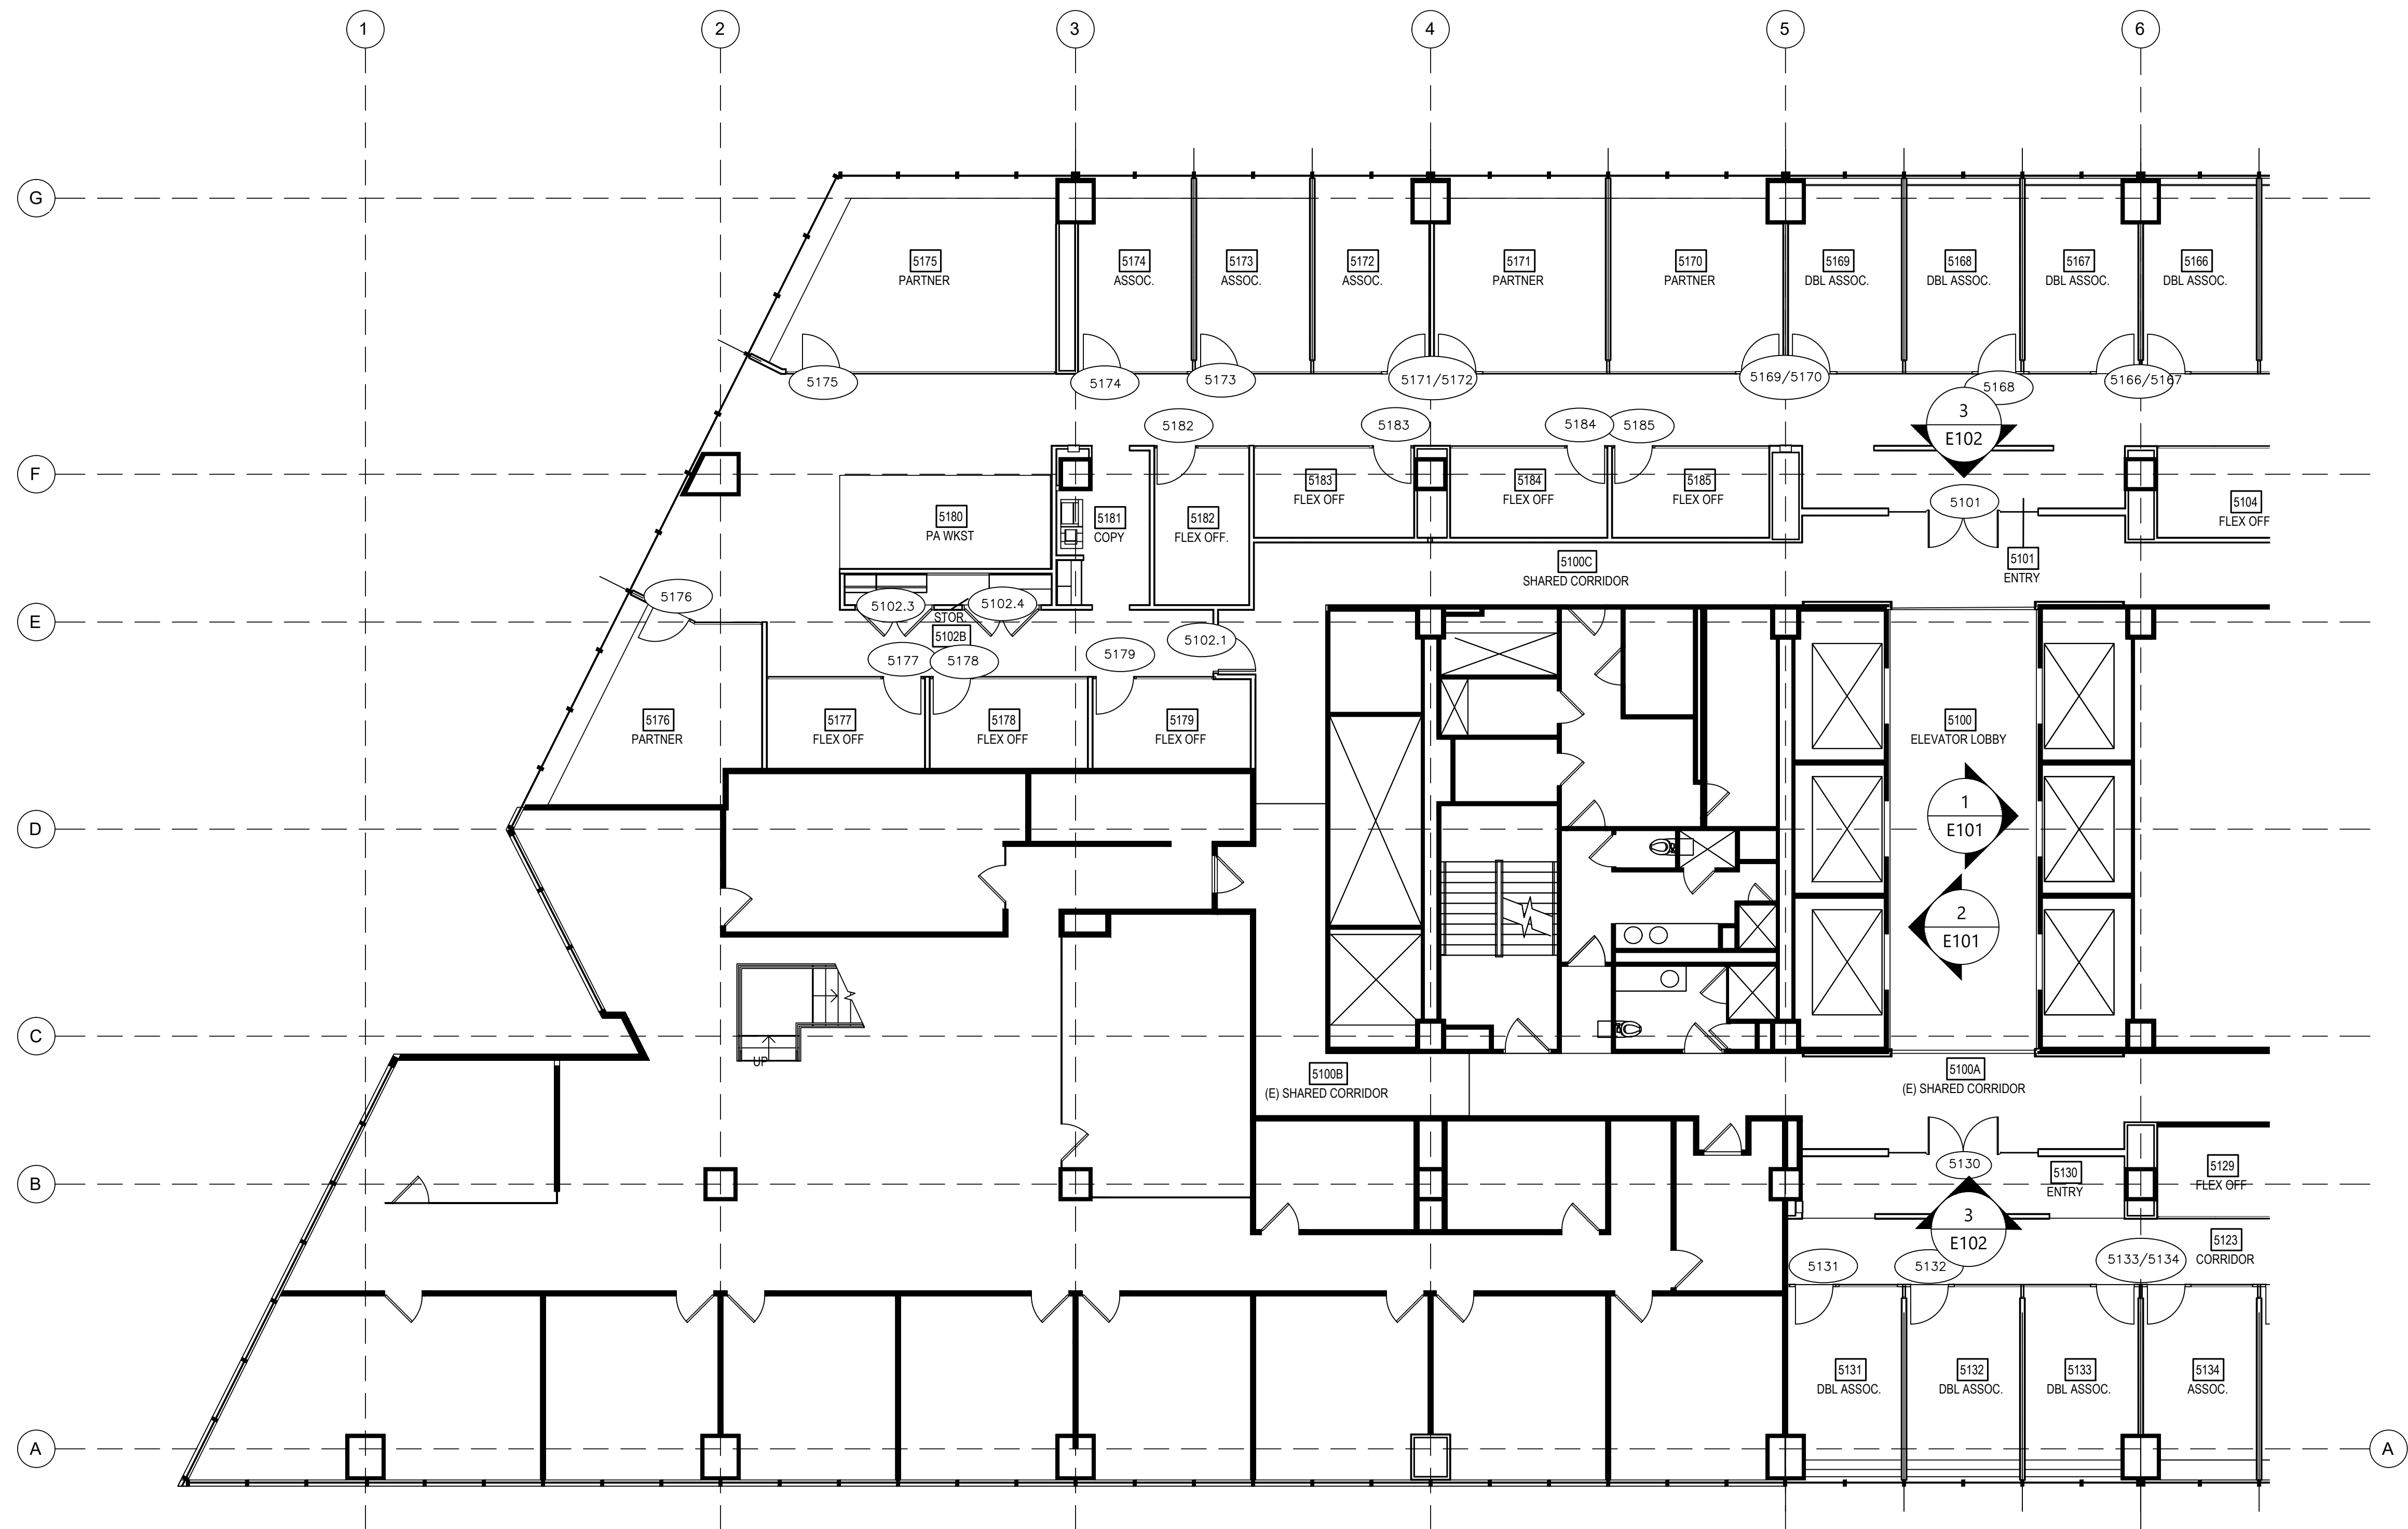
A LEVEL 51— FINISH PLAN— PART A
ARCH REF: 1/A401A

WE DO NOT NEED THESE
STRINGS OF DIMS. THERE ARE
NO DLOS.
KEEP IF YOU WANT.

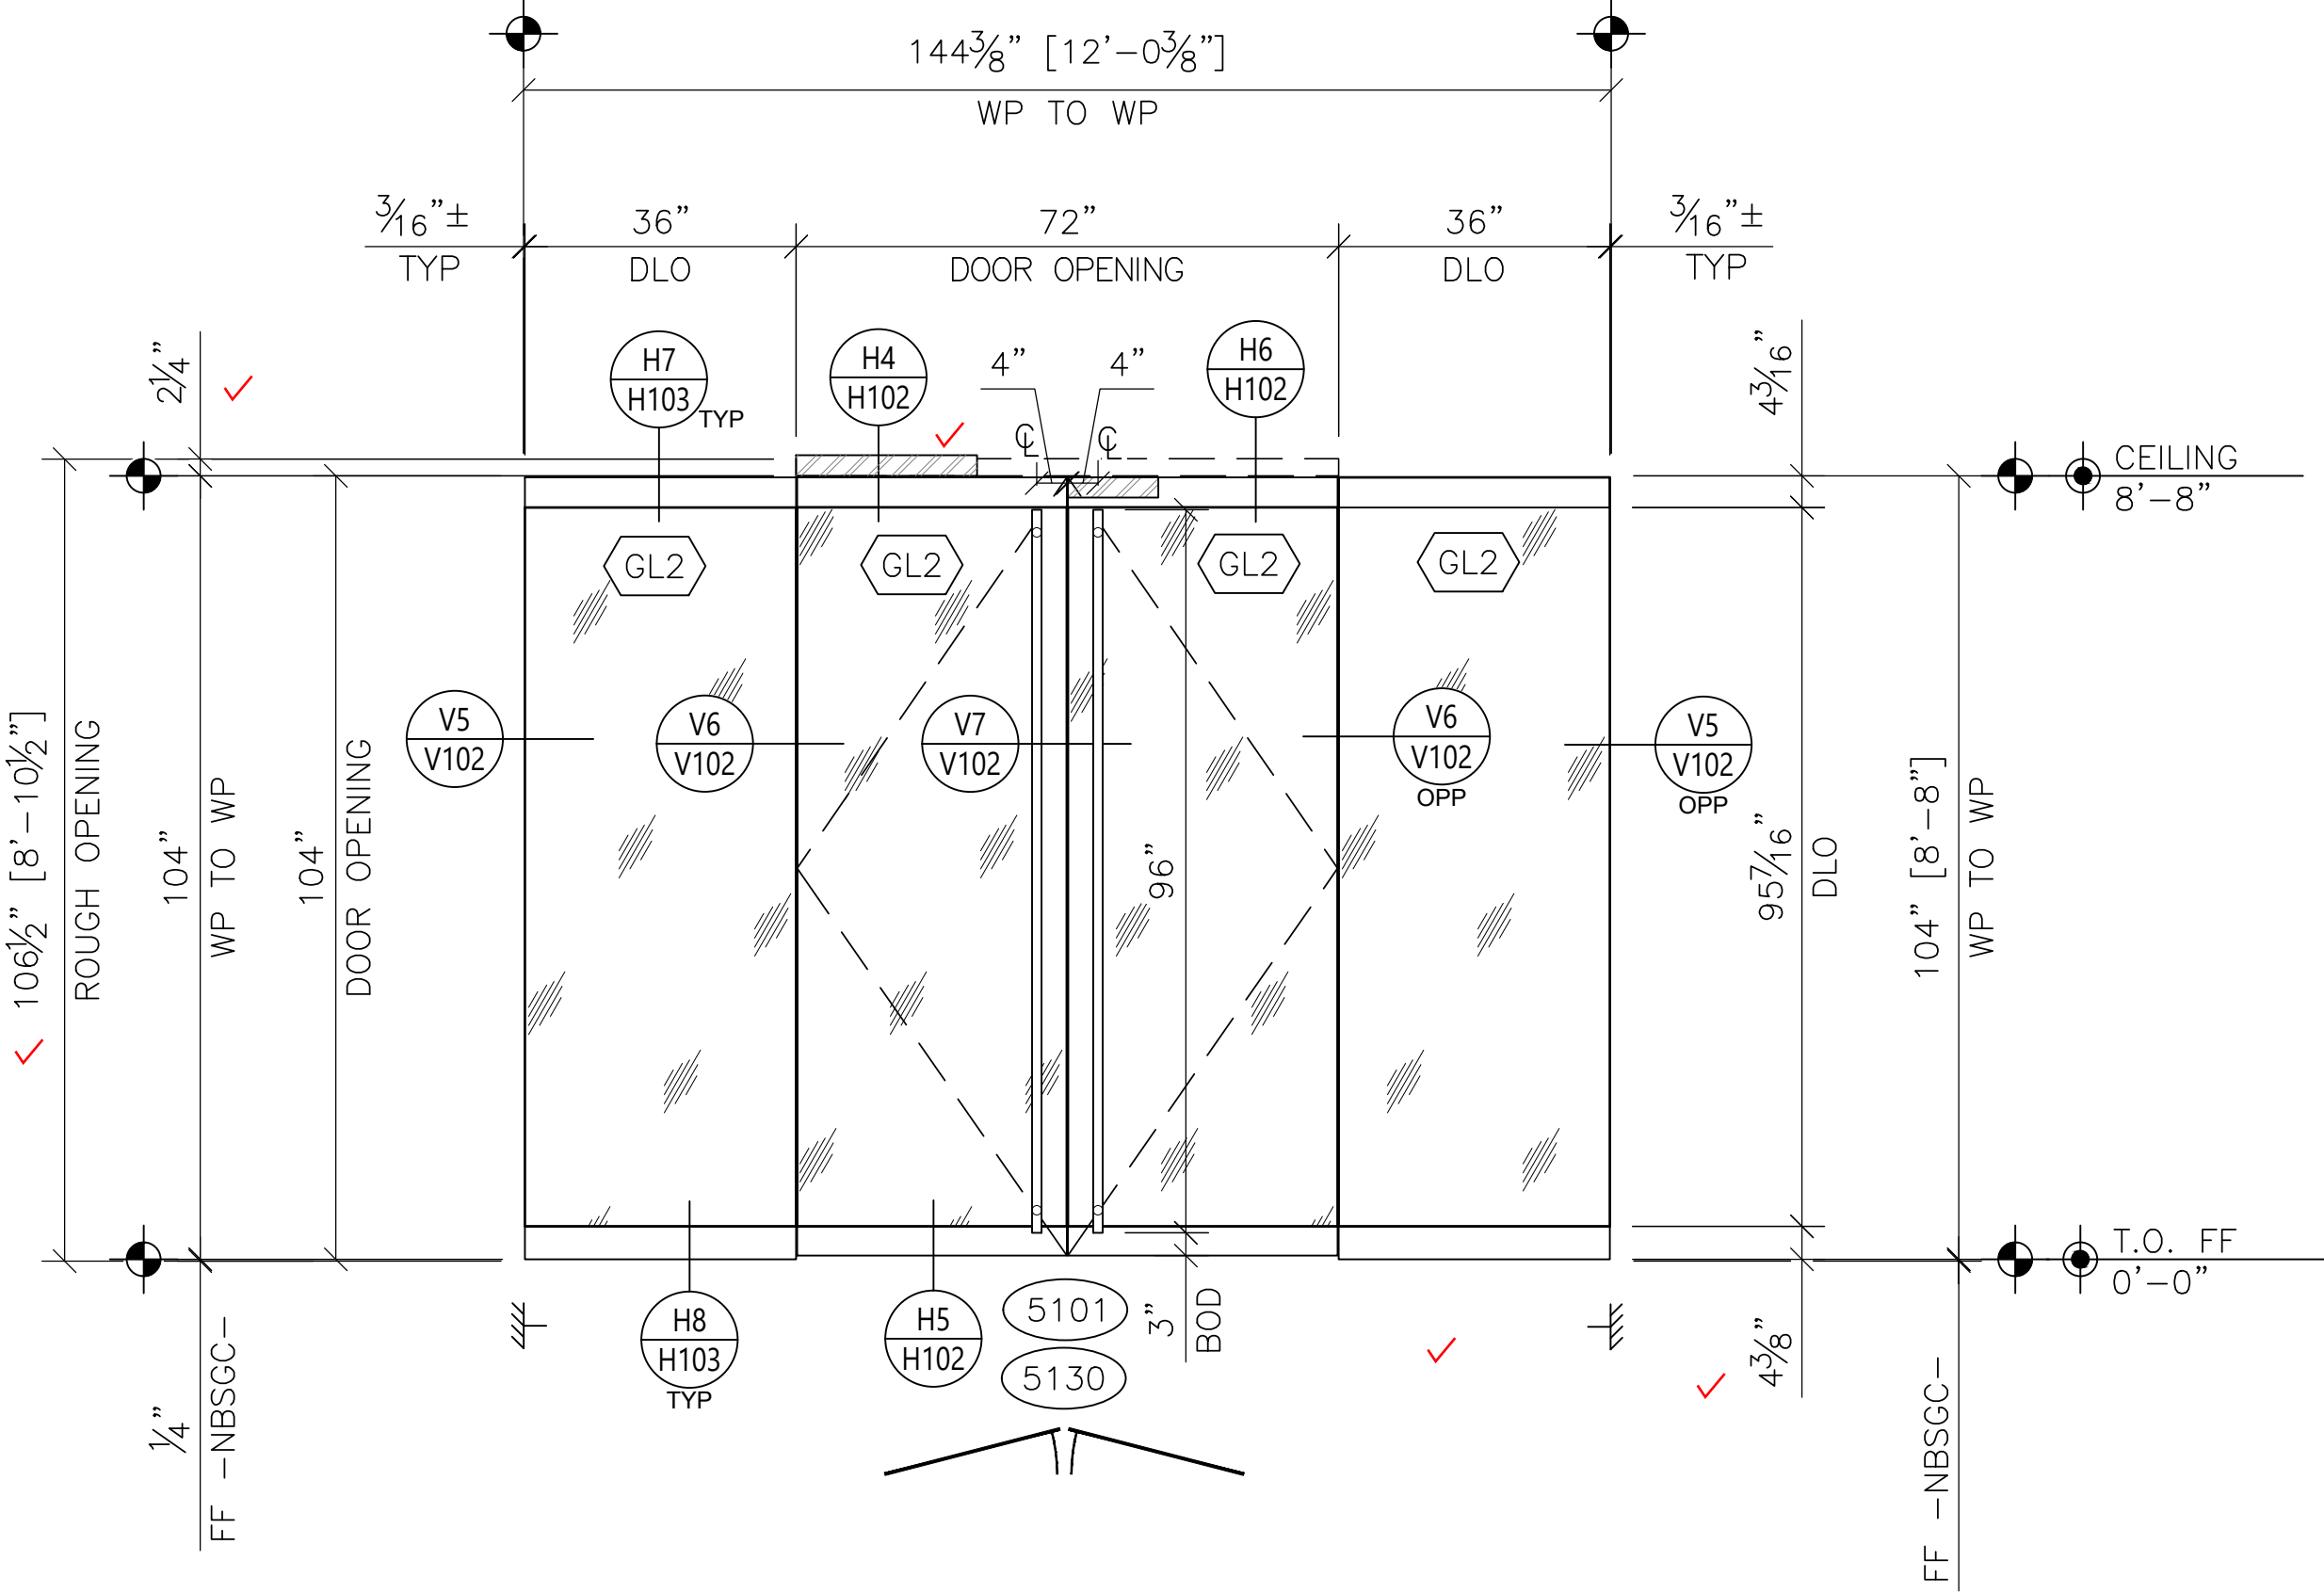
2 ELEVATION—WEST
QUANTITY: 1
ARCH REF: 2/A803
@ ELEVATOR LOBBY 5100

CHECK PICK POINT

SAME HERE

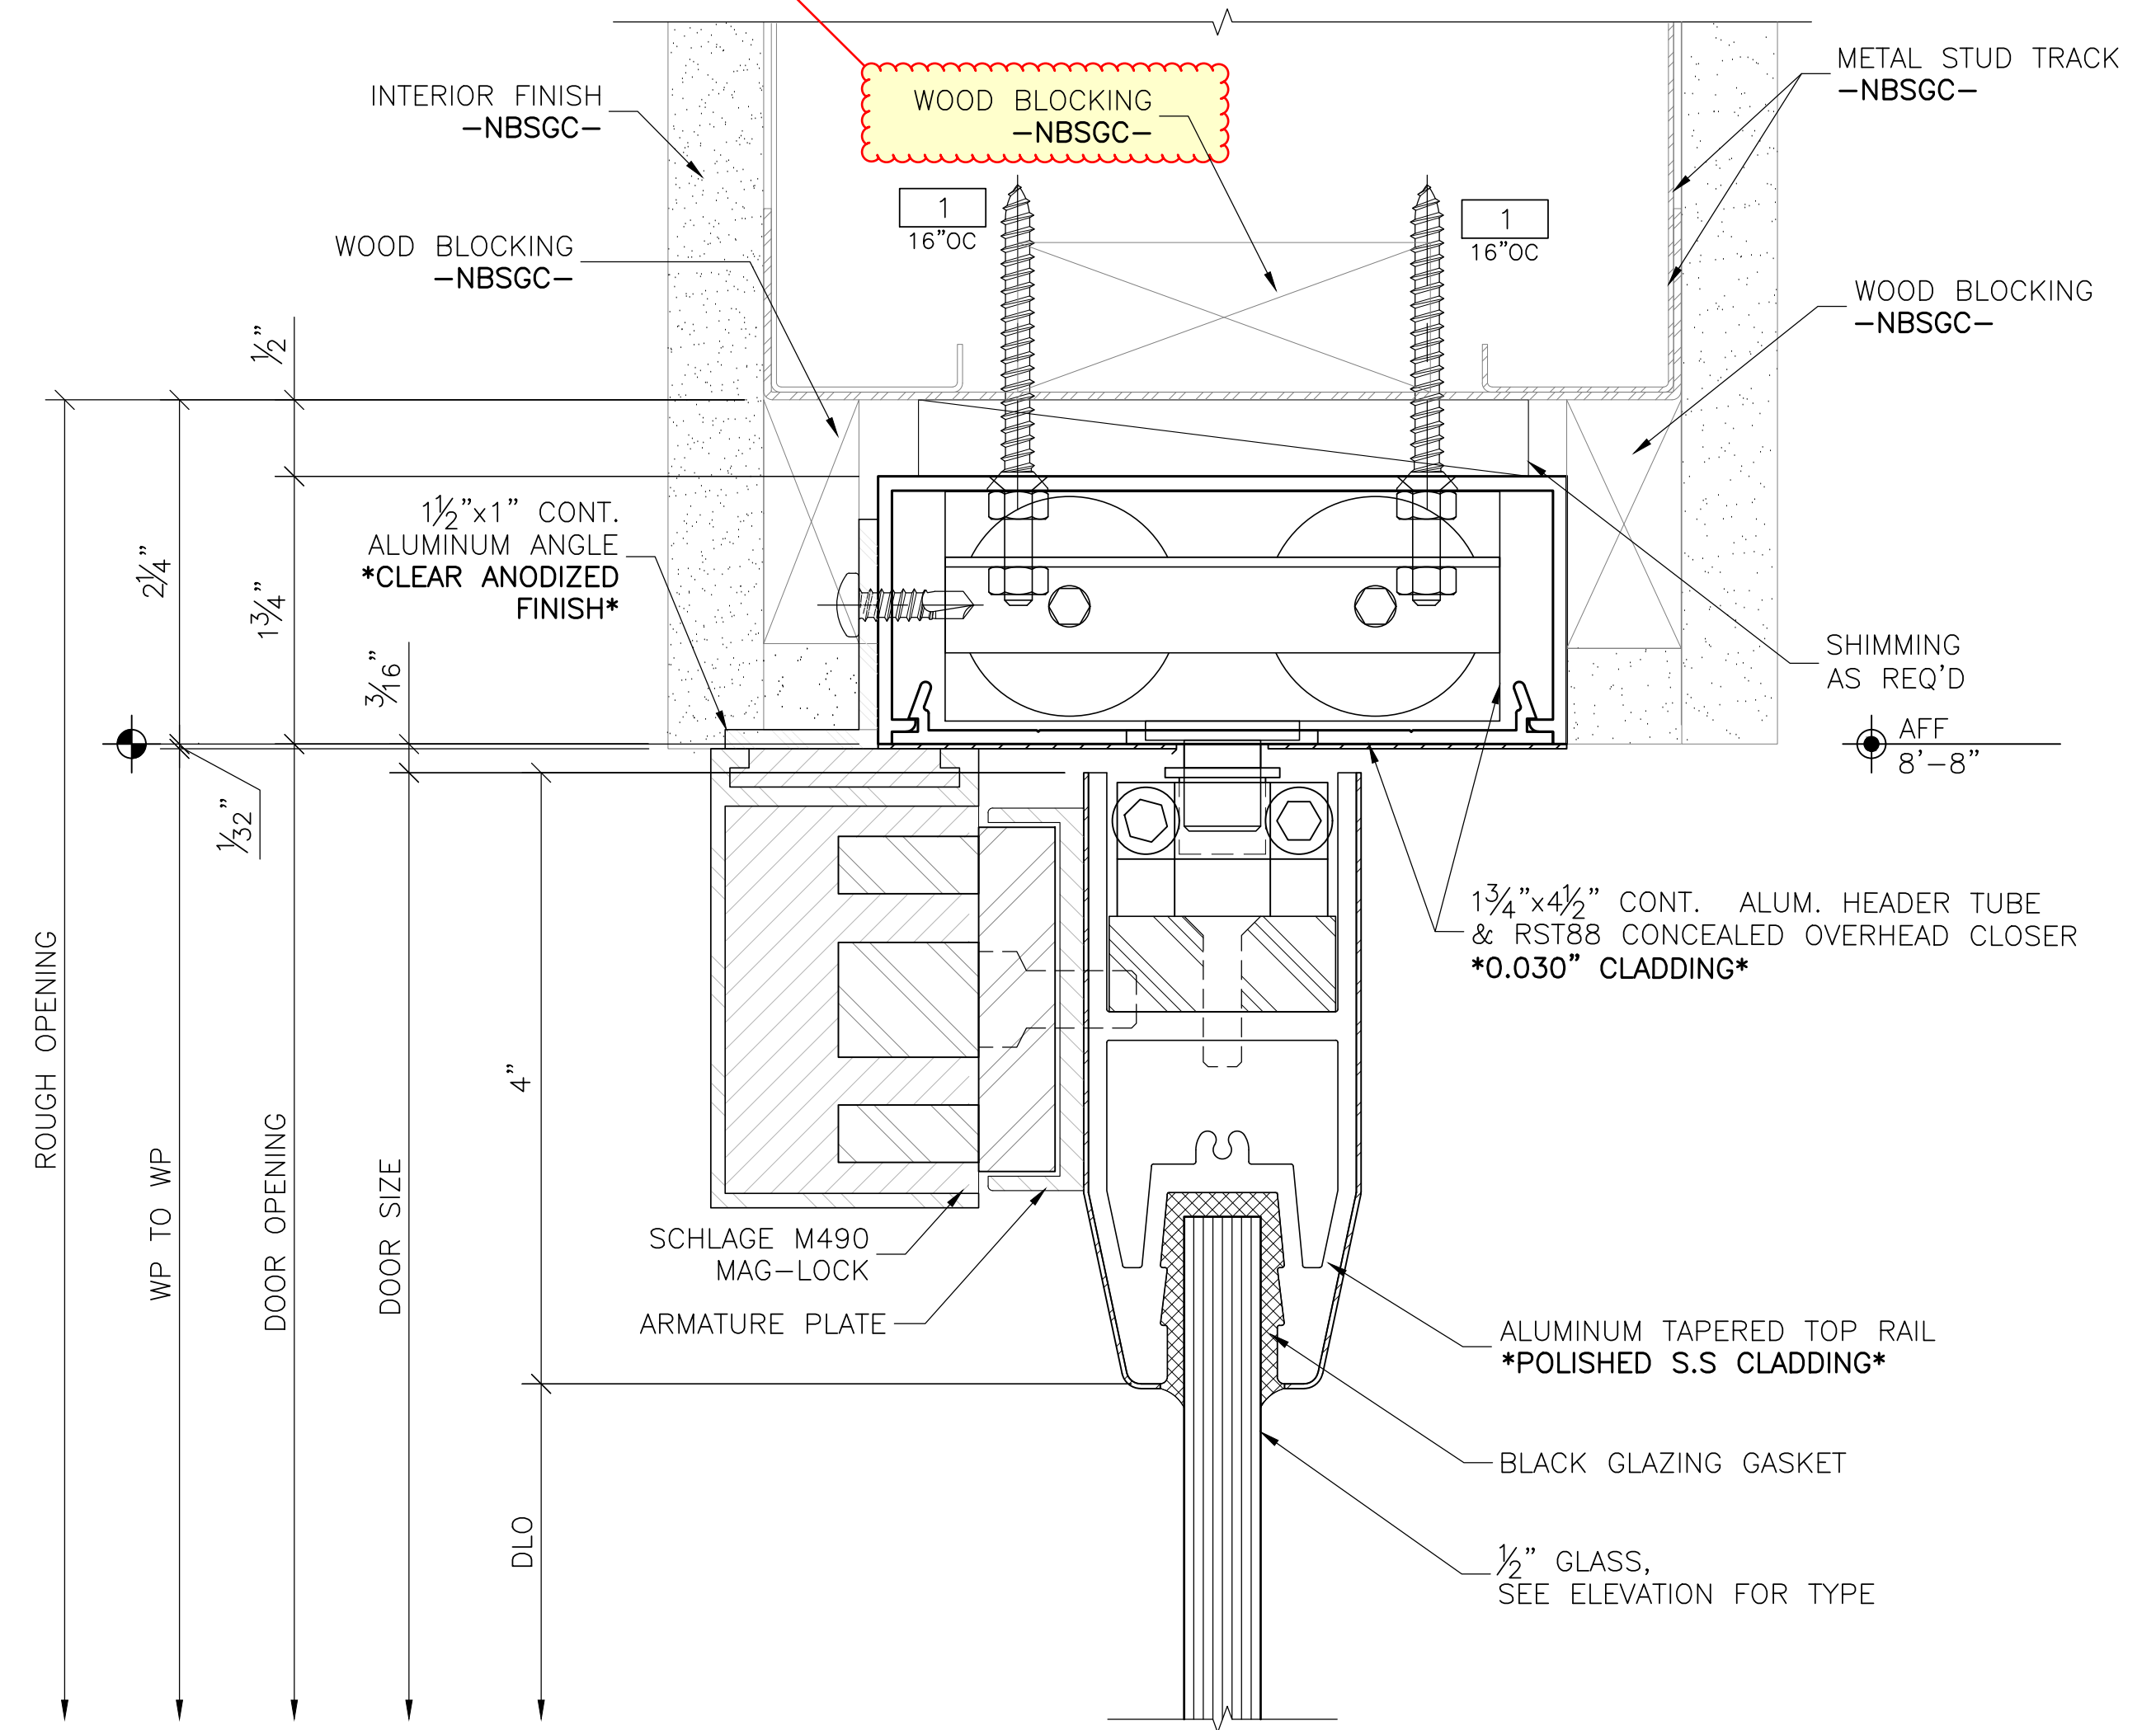
H6
DOOR HEAD DETAIL
W/ CLAD TOP RAIL & HEADER TUBE COC & MAG-LOCK
ARCH REF: 7/A621

I THINK WE NEED TO FIX THE
BLOCKING SO IT AT LEAST LOOKS
LIKE THE FASTENERS ARE GOING
INTO IT...
