Sheet: /
File: exterm.kicad_sch

Title: EXTERMINATION

Sheet: /main/
File: main.kicad_sch

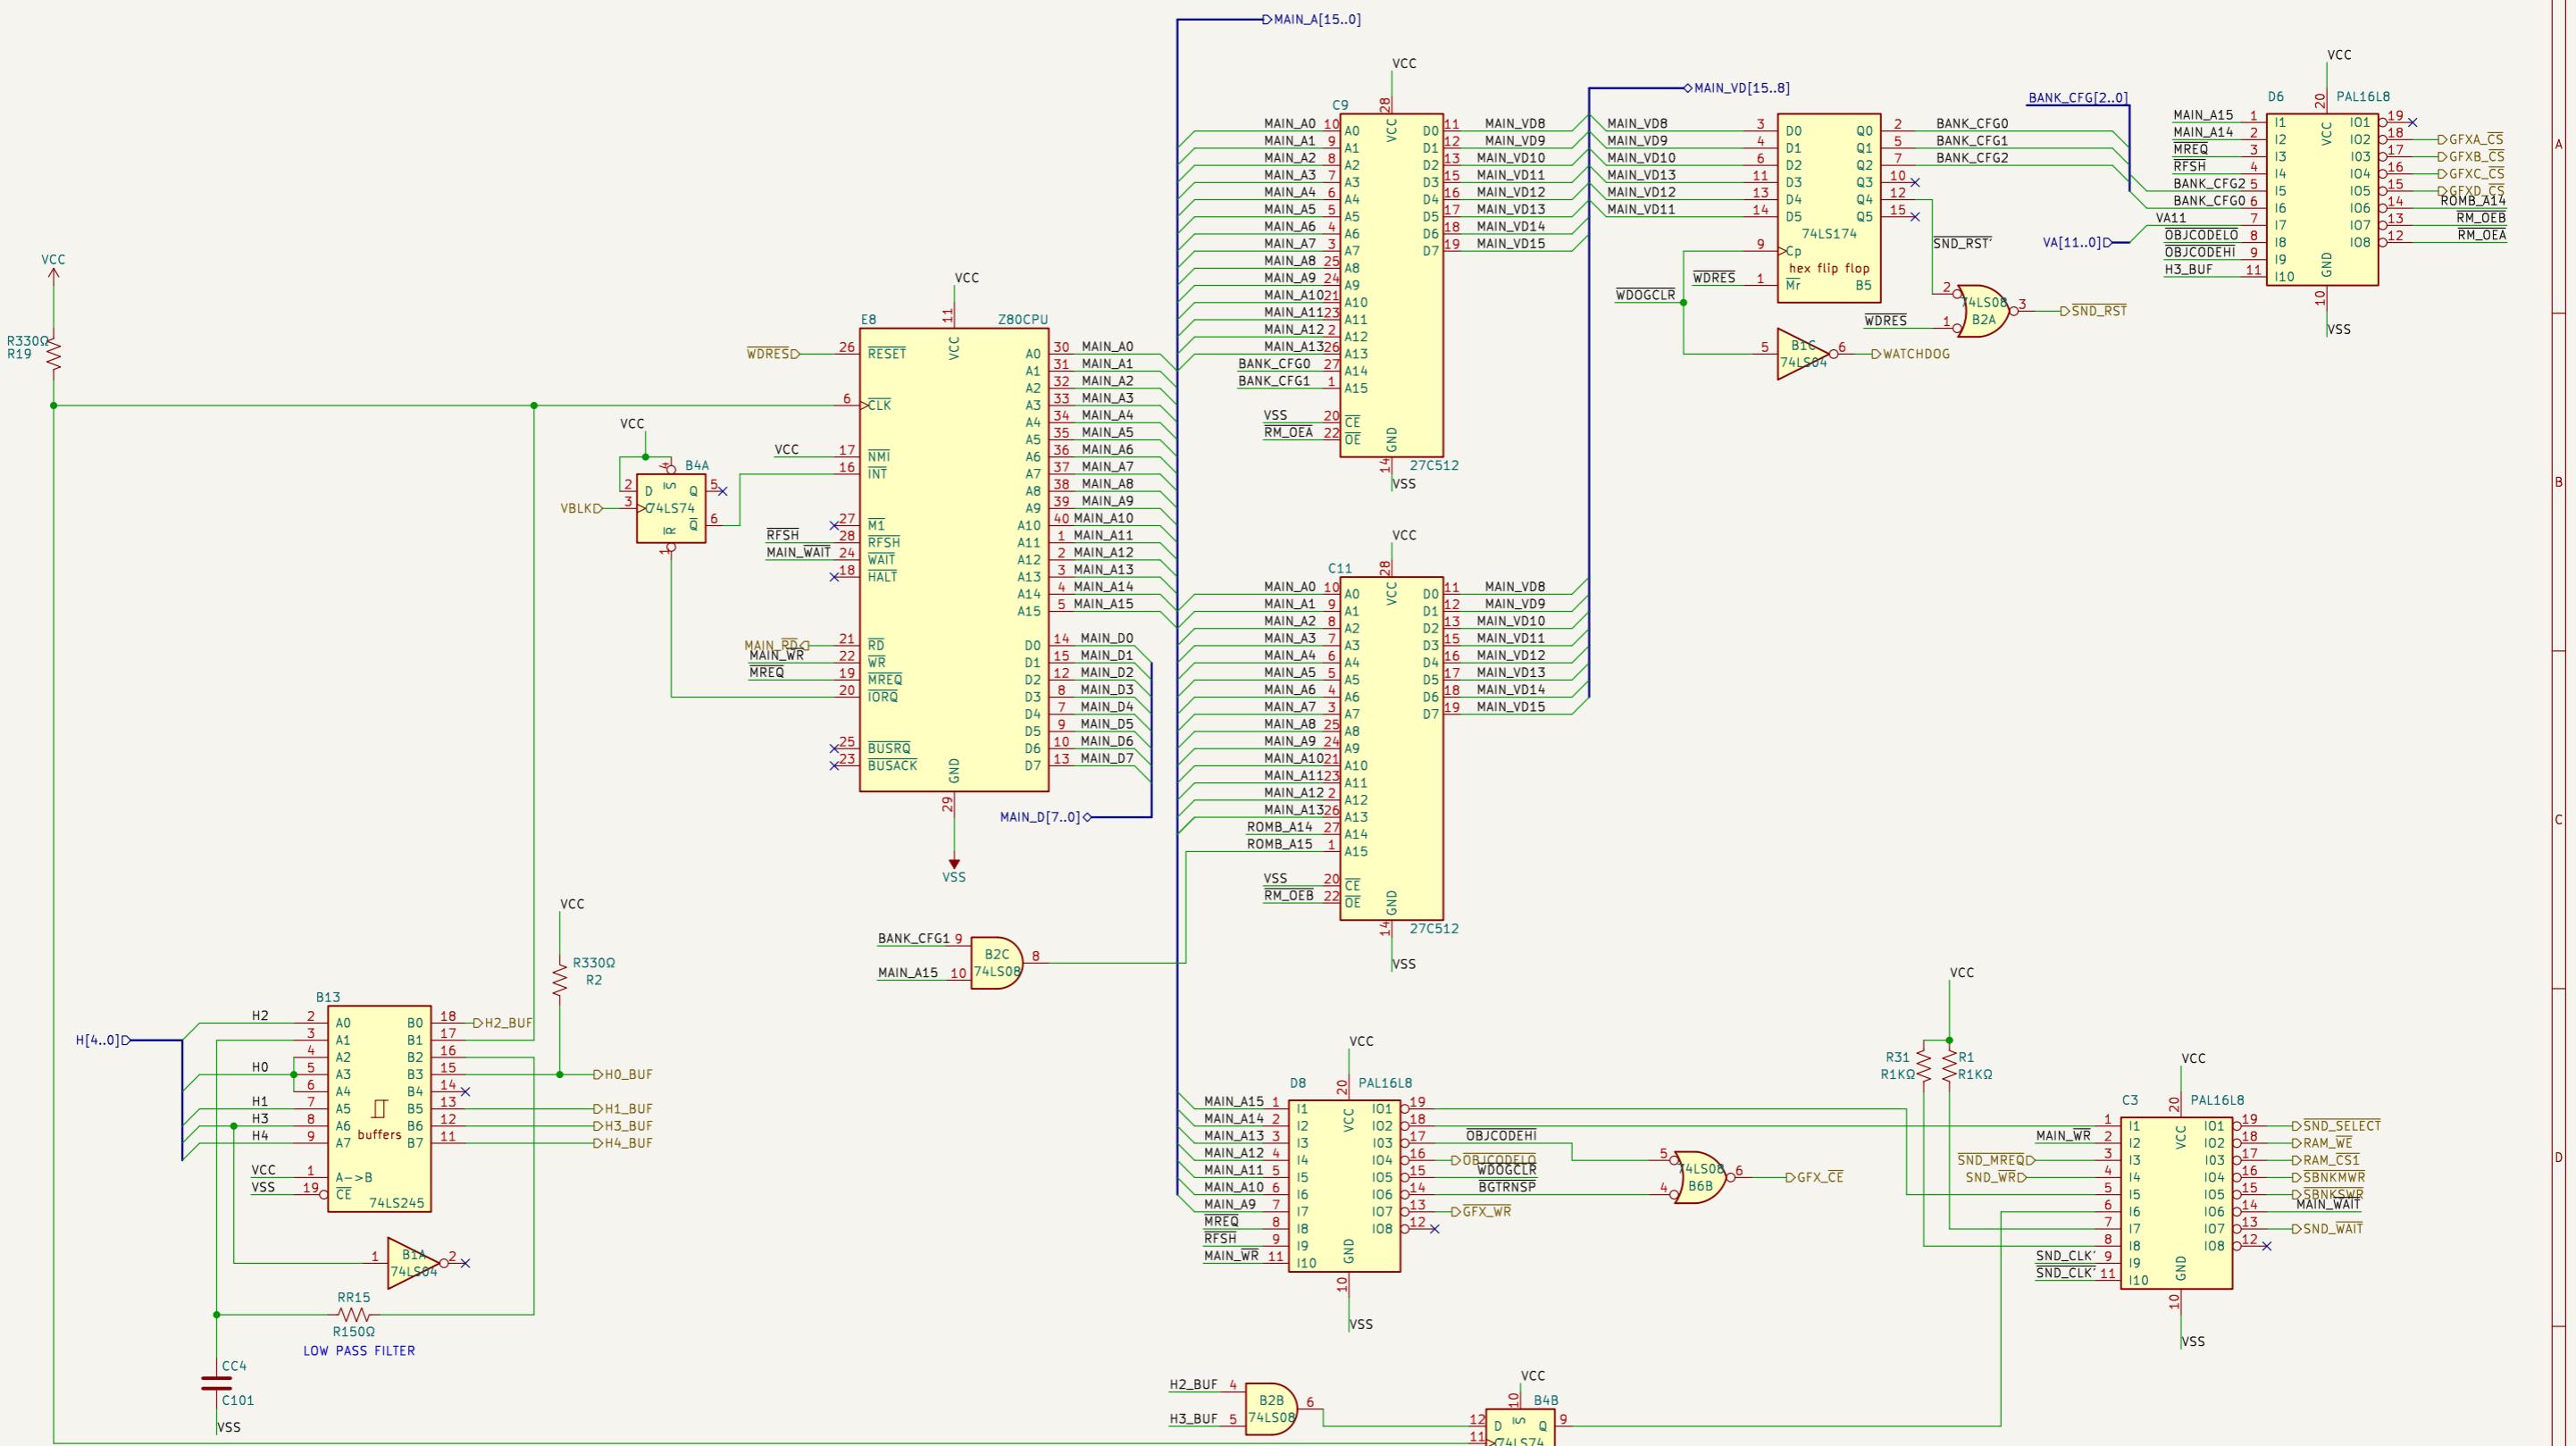
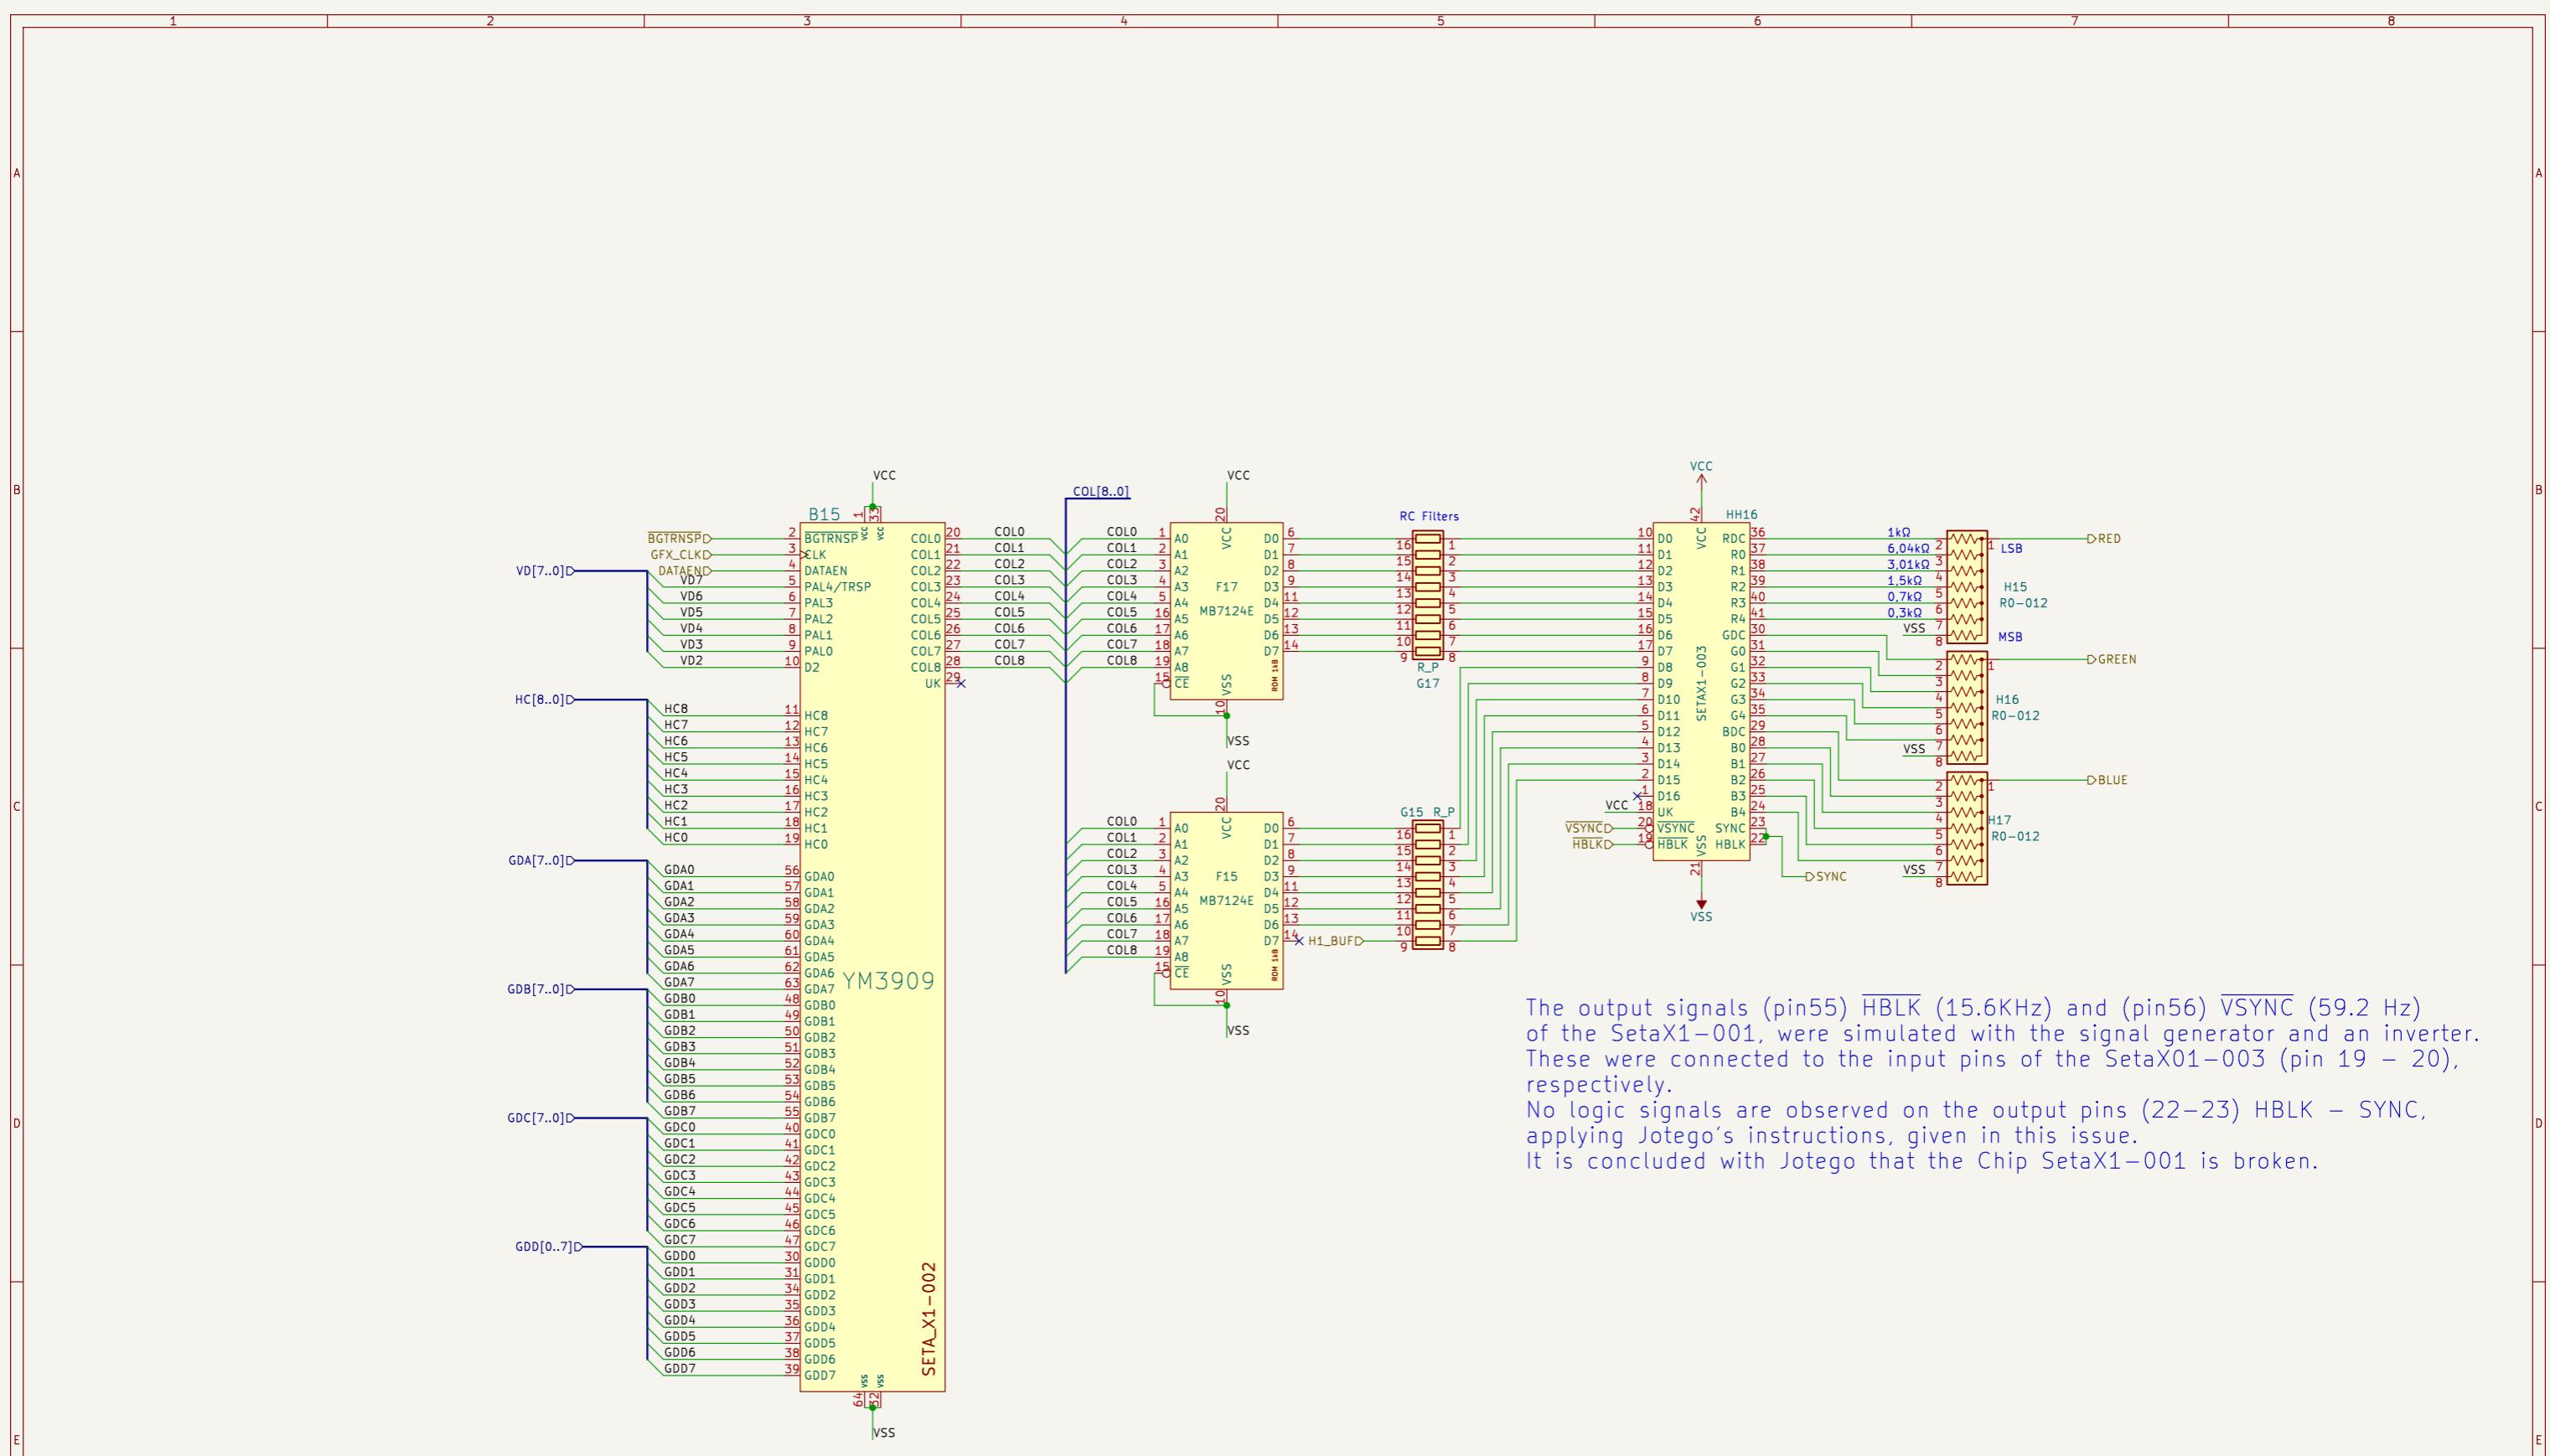
The output signals (pin 55) **HBLK** (15.6KHz) and (pin 56) **VSYNC** (59.2 Hz) of the SetaX1-001, were simulated with the signal generator and an inverter. These were connected to the input pins of the Setax01-003 (pin 19 – 20), respectively. No logic signals are observed on the output pins (22–23) **HBLK** – **SYNC**, applying Jotego's instructions, given in this issue. It is concluded with Jotego that the Chip SetaX1-001 is broken.

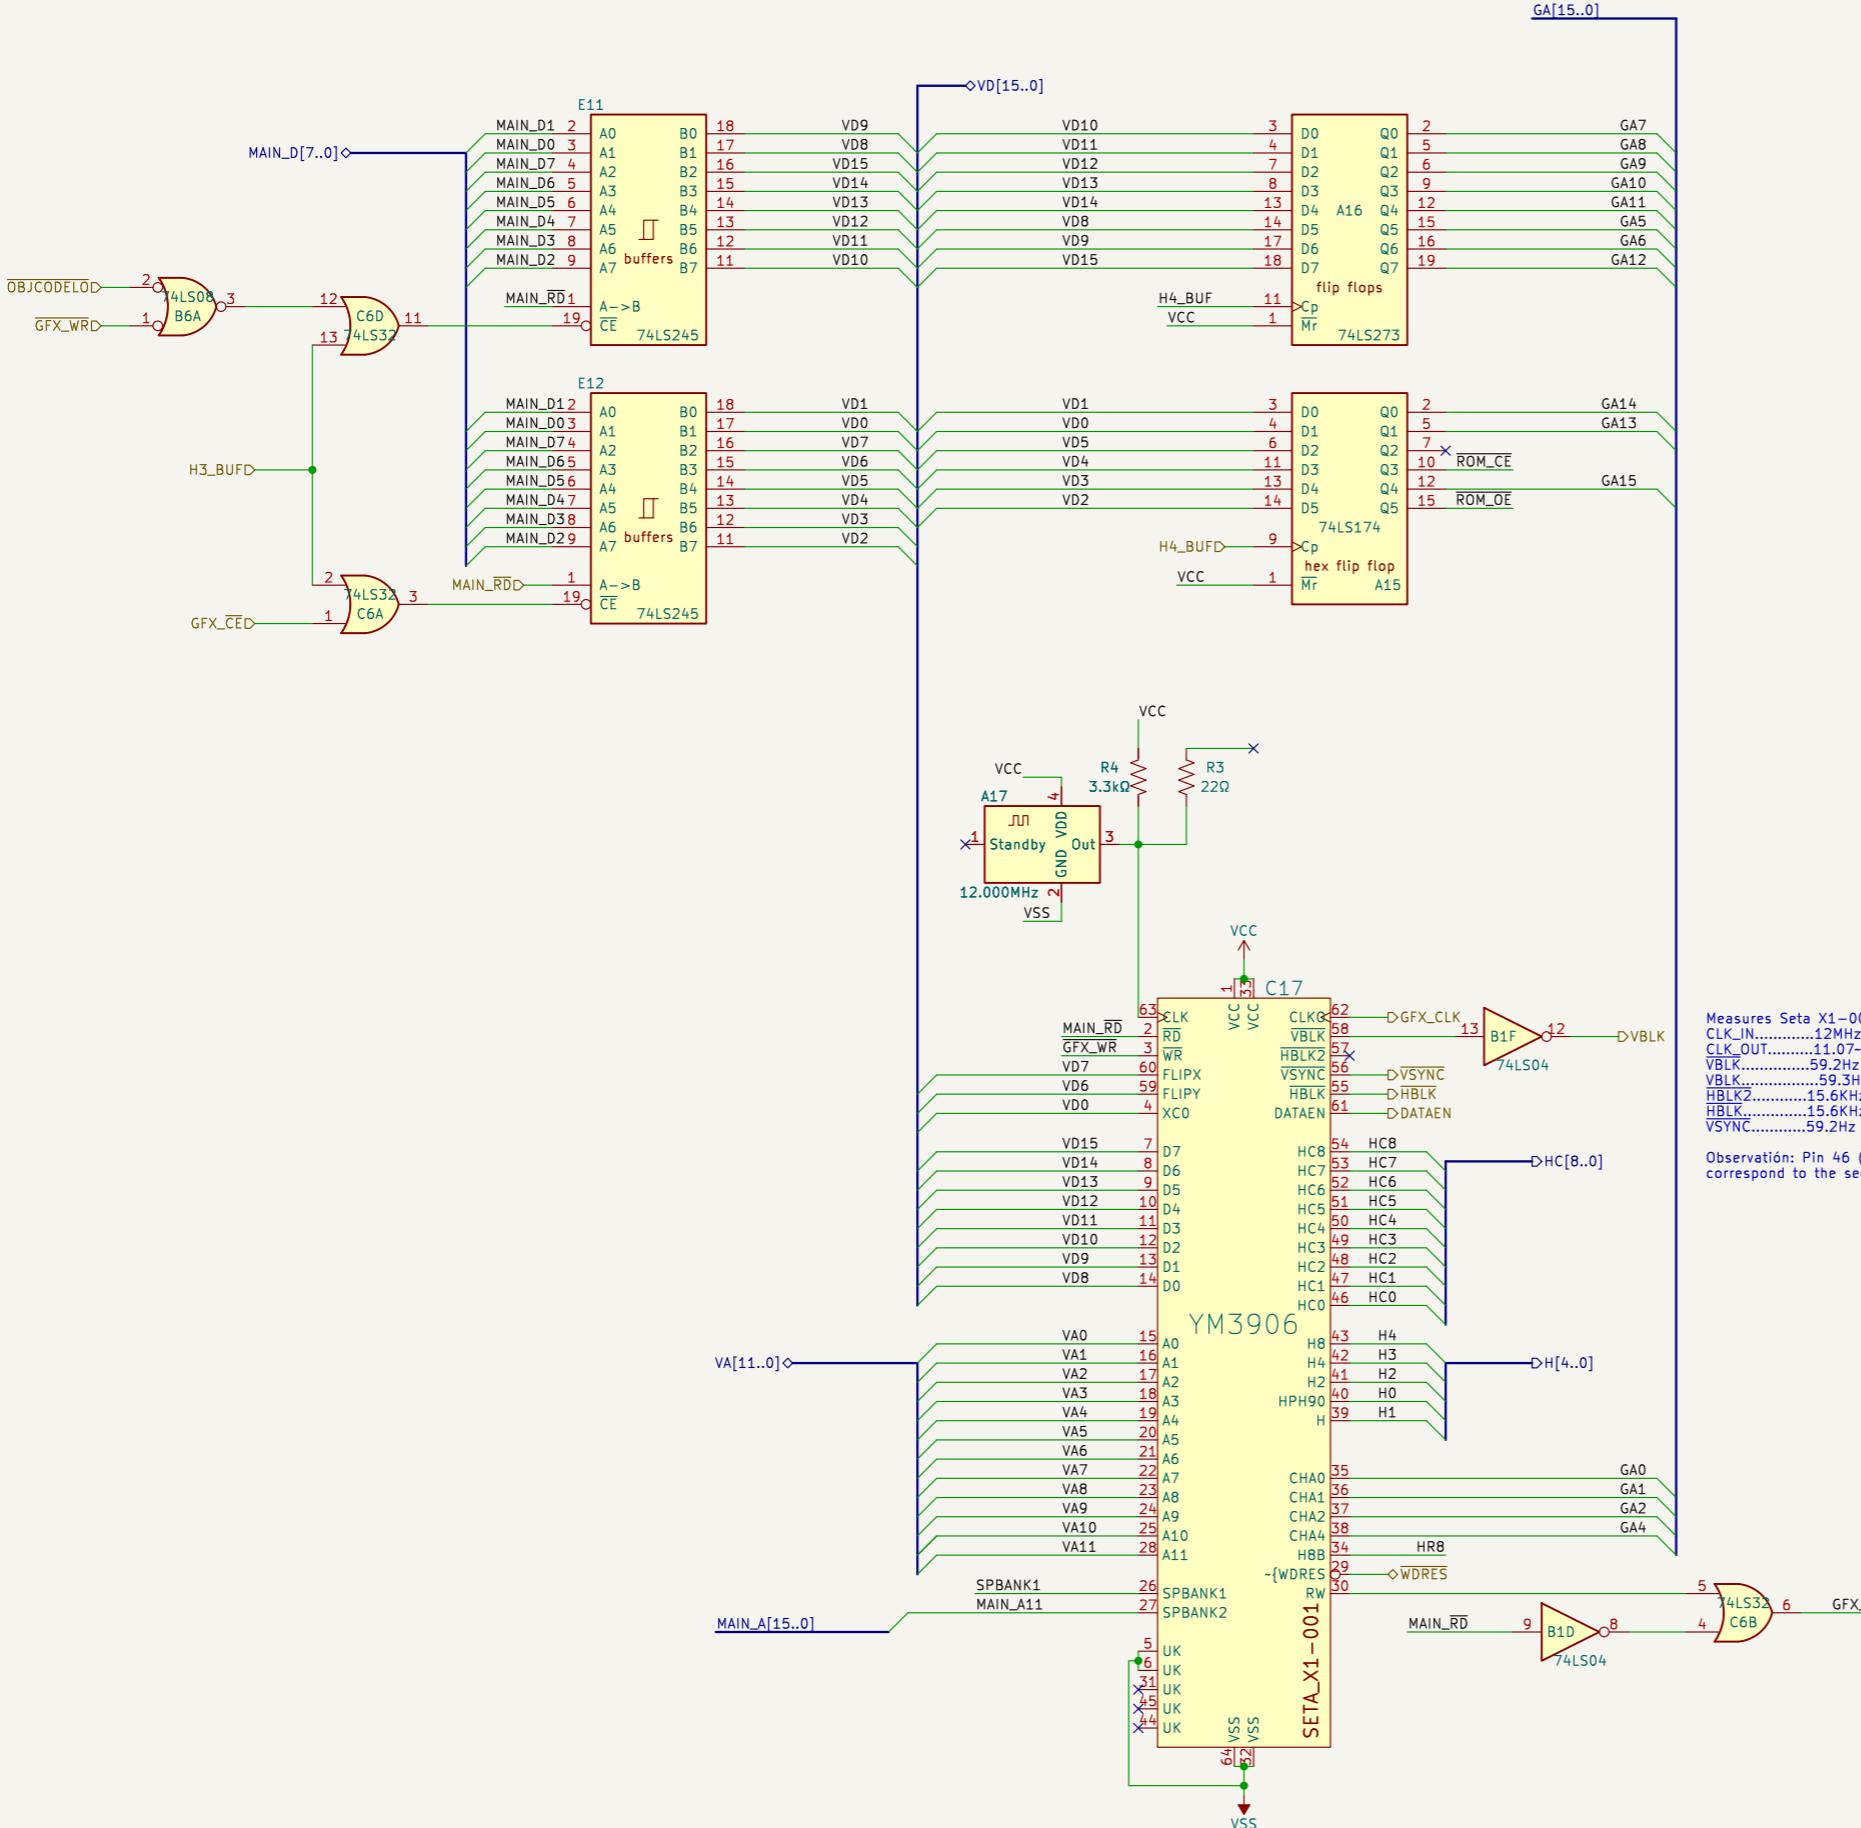
Measures Seta X1-001:
 CLK_IN.....12MHz
 CLK_OUT.....11.07-12.01MHz
 VBLK.....59.2Hz
 VBLK.....59.3Hz
 HBLK2.....15.6kHz
 HBLK.....15.6kHz
 HBLK.....15.6kHz
 VSYNC.....59.2Hz
