PART NUMBERS 15741-05K, F-15741-TL5

K2 Clutch Control Valve Kit

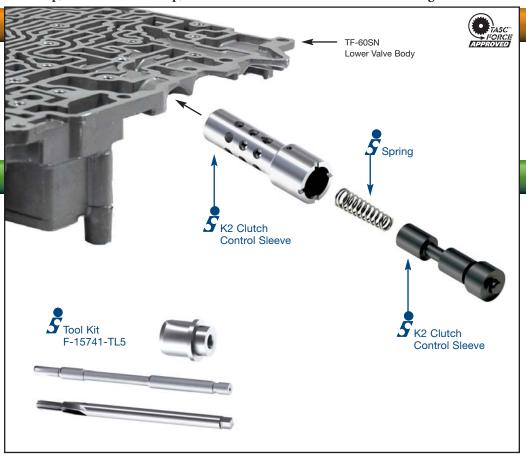
The K2 Clutch control valve provides source pressure for control of clutch (band) apply and release. Responding to TCU and the linear solenoid the K2 control valve will establish control timing of apply & release relative to engine torque. Bore wear will cause an overlap or premature exhaust of clutch pressure.

Flare upshifts or downshifts

• Bind up, excess clutch overlap, clutch distress • Pressure control out of range codes

Either a Wet Air Test or a Vacuum Test in the two locations shown, result in leakage. A vacuum test must hold a minimum of 18".

Ream the valve bore and install the Sonnax improved valve and sleeve assembly and calibrated spring.
