42-47RH/RE, 48RE, A727, A904

PART NUMBERS 22912, 22912A, 22912B, 22912C

Servo Pistons

Sonnax Part Summary

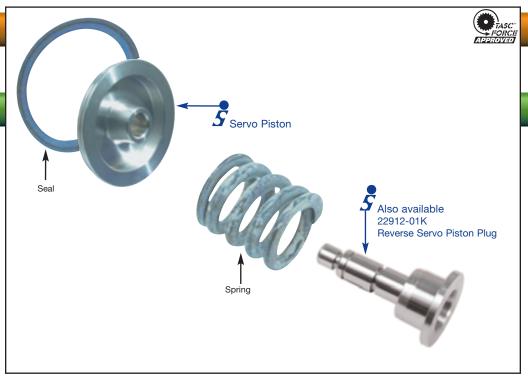
Burned bands, rear servo piston sticking/breakage

• Pin bore wear

Piston cocking in bore and pin bore wear inhibits band apply.

Many Chrysler A727, 42-46-47RH/RE, 48RE and A904 transmissions experience rear servo piston sticking/breakage, pin bore wear and reverse band slippage. The servo piston has a tendency to get cocked in the bore, inhibiting band apply. The high reverse line pressure continues to apply against a cocked piston, causing piston breakage. The bore of the piston also wears from side loading, resulting in insufficient band apply pressure. Sonnax has developed billet aluminum pistons **22912**, **22912A**, **22912B** and **22912C** to address these problems.

This billet aluminum piston resists breakage and rounded seal ridges prevent the piston from sticking in the case bore.

- Sonnax billet pistons resist breakage better than the original cast pistons.
- Seal ridges on the pistons have been rounded to prevent the piston from sticking in the case bore.
- The lower piston seal ridge has been made slightly smaller to prevent sticking.
