46RH/RE A727 & 47RH/RE

Part Numbers 22900-10, 22900-15

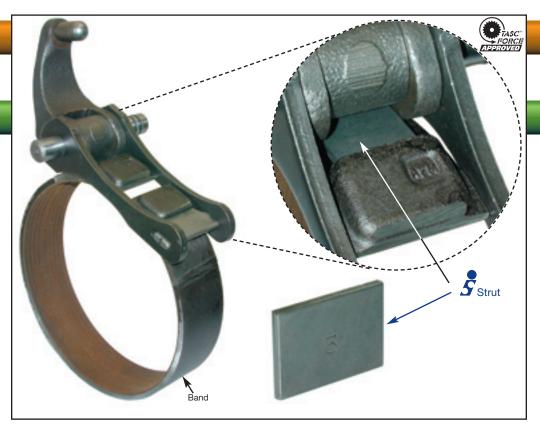
Oversized Band Strut

No reverse or slip after low/reverse drum resurfacing

OEM strut of insufficient length to adequately hold drum after resurfacing

These extended length struts compensate for material removed by machining when used drums are salvaged by machining the outer diameter.
