41TE (604) '94

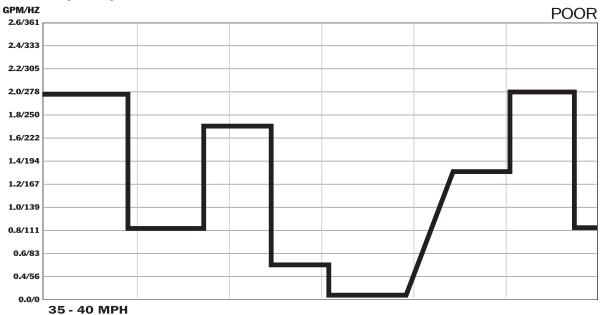
Condition: TCC switch valve cycling.

Notes: Known good bypass valve under pump (3-second screen time).

Correction: Converter friction, controller update and correct fluid required.
