## 4L60-E ('94)

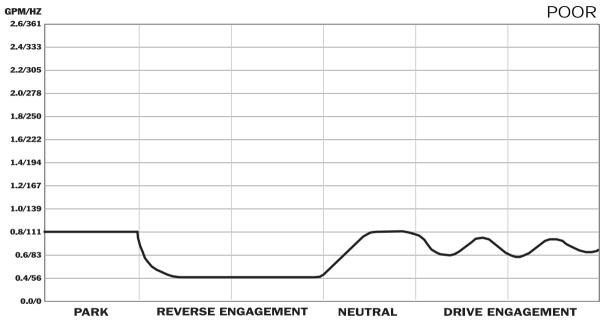
**Condition:** Repeated 3-4 clutch failure, 2nd gear starts when hot due to low AFL psi. Rebuilt bad pump surface to rotor tolerance.

**Correction:** Needs good pump.
