# **Stator Support Bushing**

#### 22005A-01K

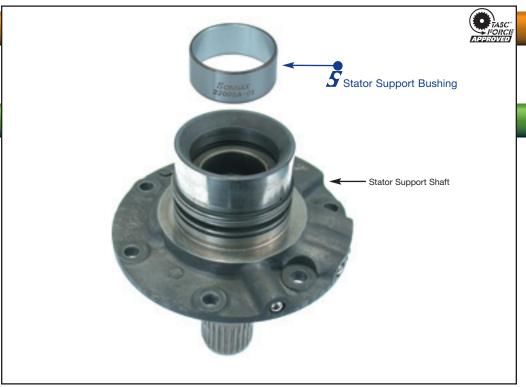
A worn stator support bushing allows forward clutch oil to cross leak into TCC release oil circuits.

### TCC slip, forward clutch failure

• Damage to sealing rings and stator tube • TCC lining failure • Forward clutch drags on in neutral and reverse

The stator support bushing in 47RH/RE transmissions can wear out, allowing forward clutch oil to cross leak into TCC release oil circuits. This can lead to TCC slip, forward clutch failure and damage to the sealing rings and stator tube. Sonnax replacement bushing **22005A-01K** will help you avoid these problems.

Replace the worn bushing in the stator support shaft with this replacement bushing.
