TF-60SN

PART NUMBERS 15741-11K, 15741-TL11

Secondary Regulator Valve Kit

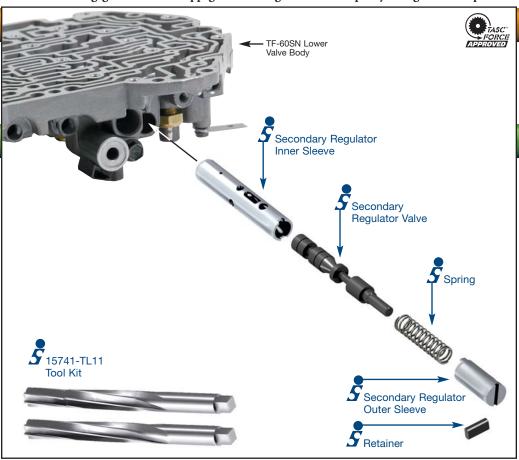
Bore wear at the spring end of the valve allows the SLT circuit and regulated converter pressure to cross leak. Bore wear at the balance end of the valve reduces converter and lube flow.

Either a Wet Air Test or a Vacuum Test in the location shown, result in leakage. Vacuum test must hold a minimum of 18".

The Sonnax replacement sleeve and valve kit allows the hydraulic integrity of the bore to be restored after reaming. With the improved materials and valve support, the service life can be extended beyond the OE casting.
