Part Summary **Data Sheet**

JATCO/NISSAN

PART NUMBER 113741-17K, F-113741-TL17

Chain slippage and pulley fracture

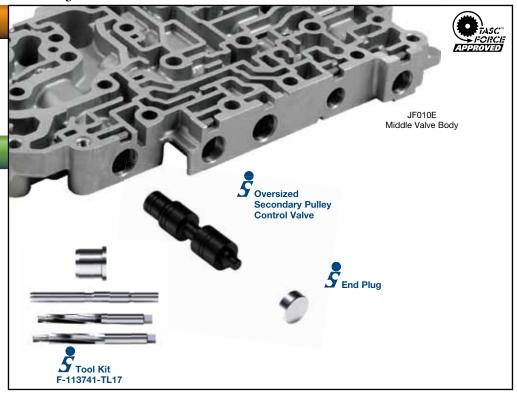
F-113741-TL17

2 Reamers 1 Reamer Jig 1 Guide Pin

Tool Kit for 113741-17K, can also be used for 113741-19K
