AXODE

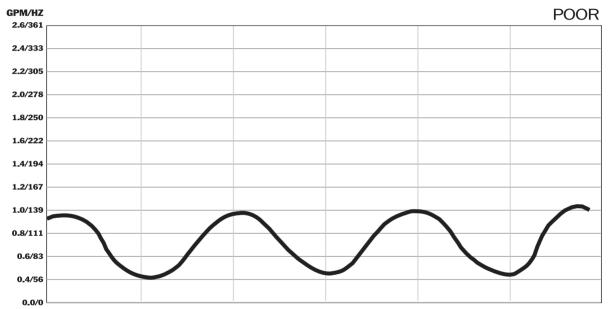
Event: After 1-2 shift and between 35-55 mph. **Condition:** Misdiagnosed as engine surge.

Correction: Install Sonnax Boost Valve 96201-01K, Bypass Clutch Control Sleeve Kit **96206-01K**, and new valve body relief tees.
