PART NUMBER 56200-02K

# Pump Flow Control Valve Kit

#### 56200-02K

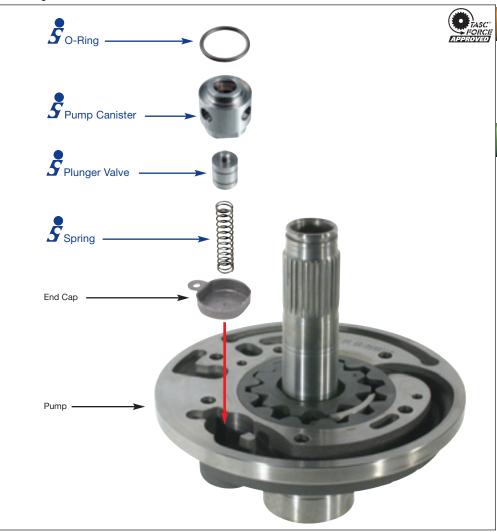
The pump flow control canister and plunger valve wear, allowing the plunger valve to stick open and/or leakage to occur. The canister o-ring relaxes and pressure bleeds past it.

The OEM flow control valve is designed to increase pump efficiency by rerouting excess line pressure back to the suction side of the pump. It is common for the plunger valve to become stuck open, or for the canister to wear. This decreases line pressures and results in delayed engagements. The Sonnax pump flow control valve kit eliminates the sticking and wear problems with redesigned and precisely machined parts.

This kit includes a harder canister with more support for the plunger valve, which prevents sticking, A case-hardened plunger valve with self-centering annular grooves, a replacement spring, and larger o-ring for improved sealing are also included.

- 1 Pump Canister
- 1 Plunger Valve
- 1 Spring
- 1 O-Ring
