## 41TE, 42LE

**PART NUMBER 92003-01**

# Input Clutch Hub Bushing & Tool

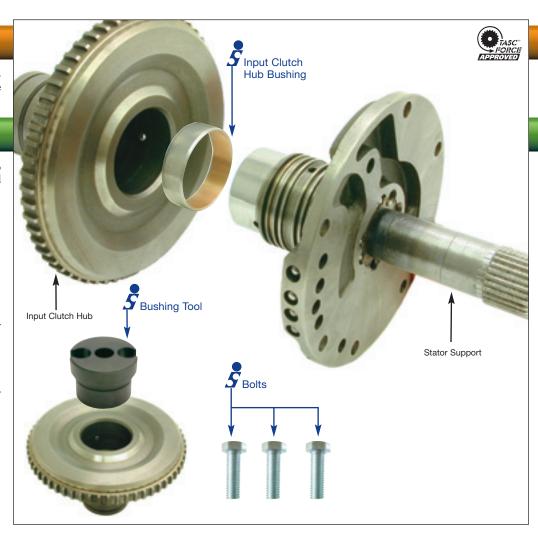
### 92003-01K

### Premature underdrive clutch failure

Excessive input clutch hub bushing-tosupport clearance causes leaks in the underdrive circuit.

The input clutch hub bushing is an oil control surface for the underdrive clutch. Excessive clearance between this bushing and the stator support will cause low underdrive clutch pressure, resulting in premature clutch failure. The Sonnax input hub bushing will restore the clearance necessary for proper operation.

The tighter-fitting Sonnax clutch hub bushing restores proper clearances and eliminates leaks.
