AW 55-50SN / AF 23-33

Diagnosis and Valve Body Information

Presented by
Bob Warnke
ATRA Powertrain Expo 2008

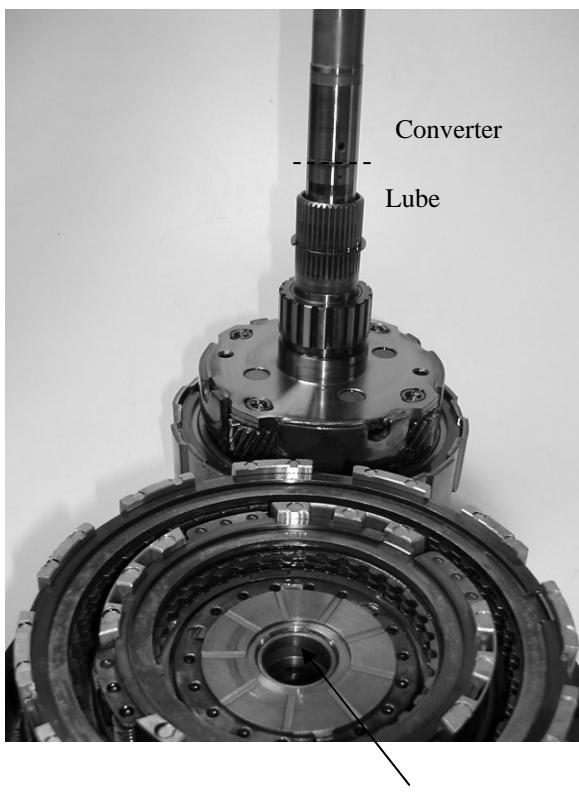
Lube pressure and flow on the 55 50SN, is low in comparison to other units. This converter requires multiple valves, along with the rear pump bushing, to control modulated TCC apply (see Figure 3). The converter clutch may remain fully applied at very low speed and high load, which taxes the fluid and lining, creating a break-away slip or RPM fluctuation.

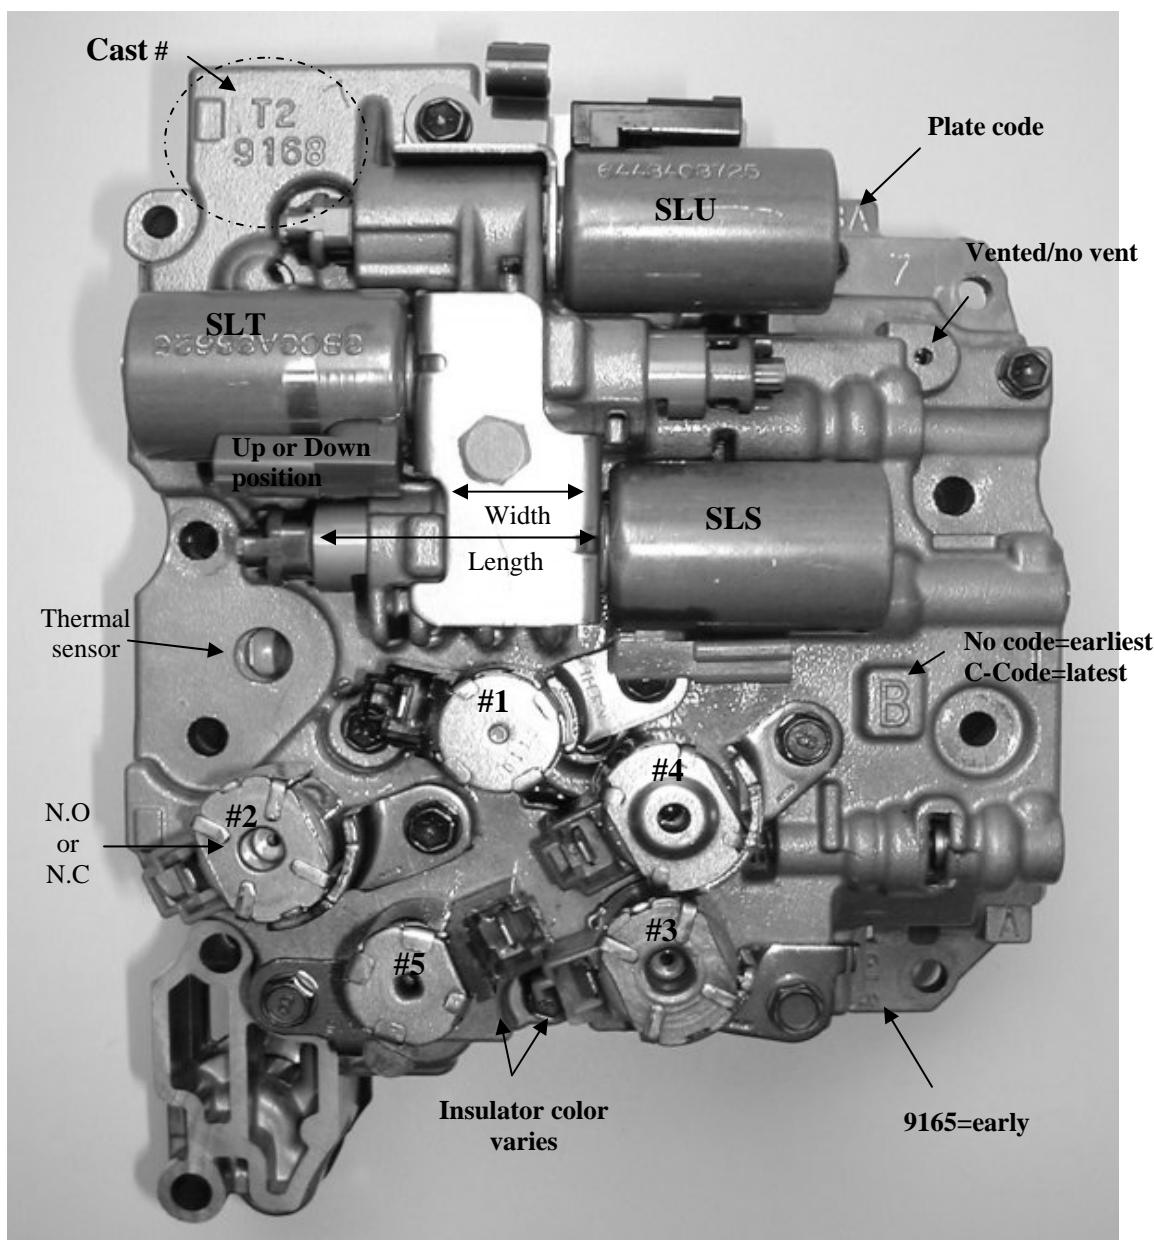
If you pressurize the SLT port with shop air (80-100 psi), air pressure will push fluid, which you see as a leak. Problematic leaks occur at the steel side cover, SLT accumulator, B-1 and C-1 control valves. A major leak or combinations, cause delayed engagement or flare up-shift and should be inspected after disassembled.

You can perform a similar air test (ill#4) with the valve body itself. When doing so, the pump line port and thermal element hole must be closed and the separator plate held as shown to eliminate cross leaks. This might sound confusing in print, but when you do it, the ports will be evident and easy to close with an opposite hand.

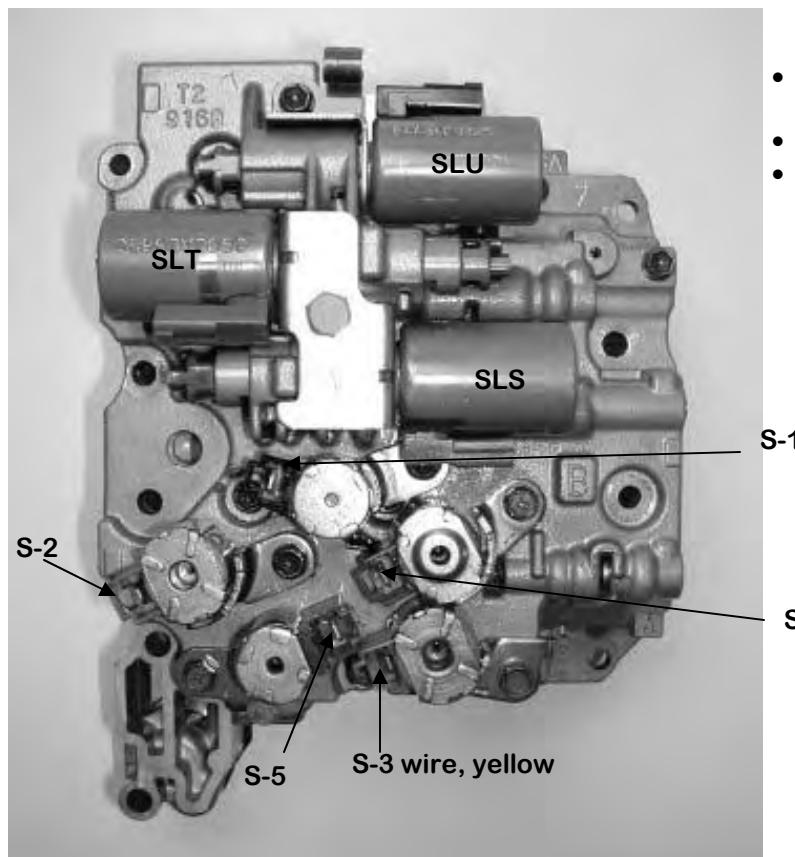
Wiring Issues (see photo left)

- Common to mix up connectors from harness
- S1- White wire, right side loom.
- S3- Yellow wire, left side loom.

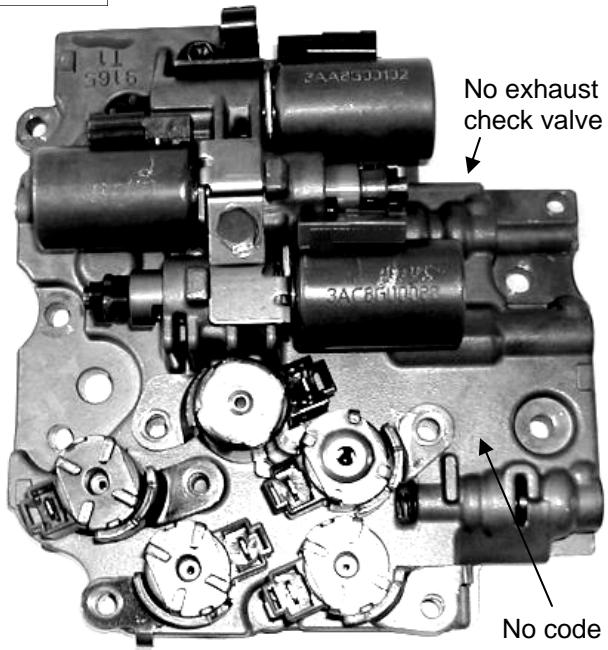
Fig. 1

This casting does not match the GM AF-23 oil circuits in Blue Technicians guide.

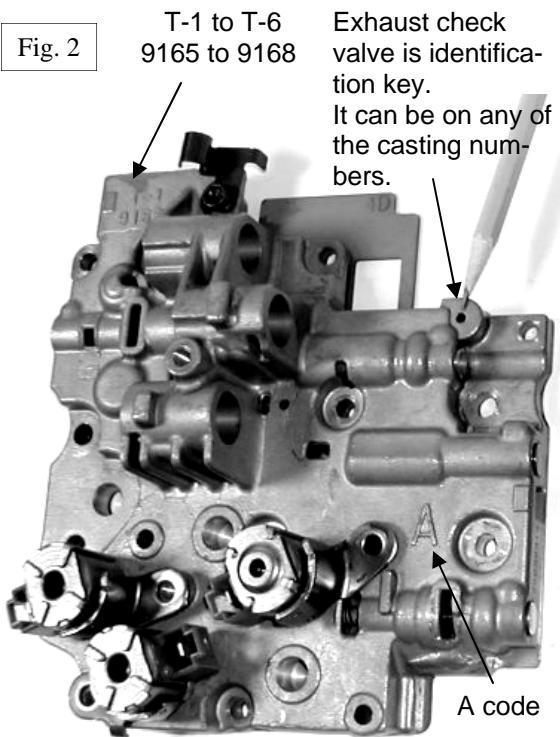
Fig. 2

Typical of the updated Volvo, C valve body

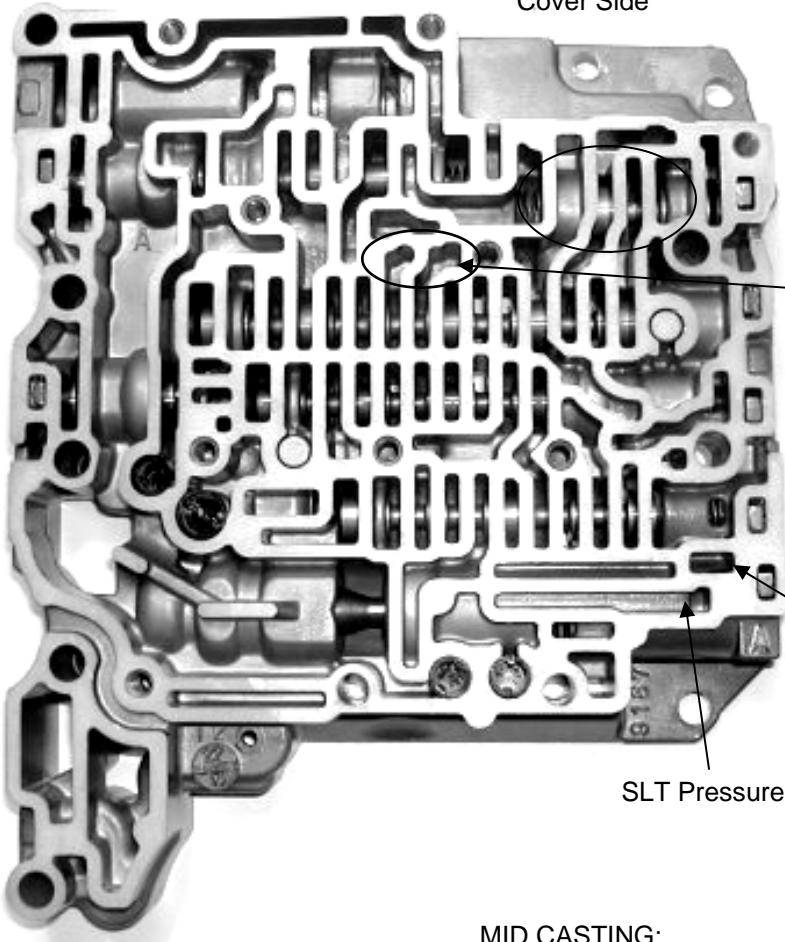
- Inspect for visible wear & scoring.
- Vacuum Test, minimum of 18" vacuum.

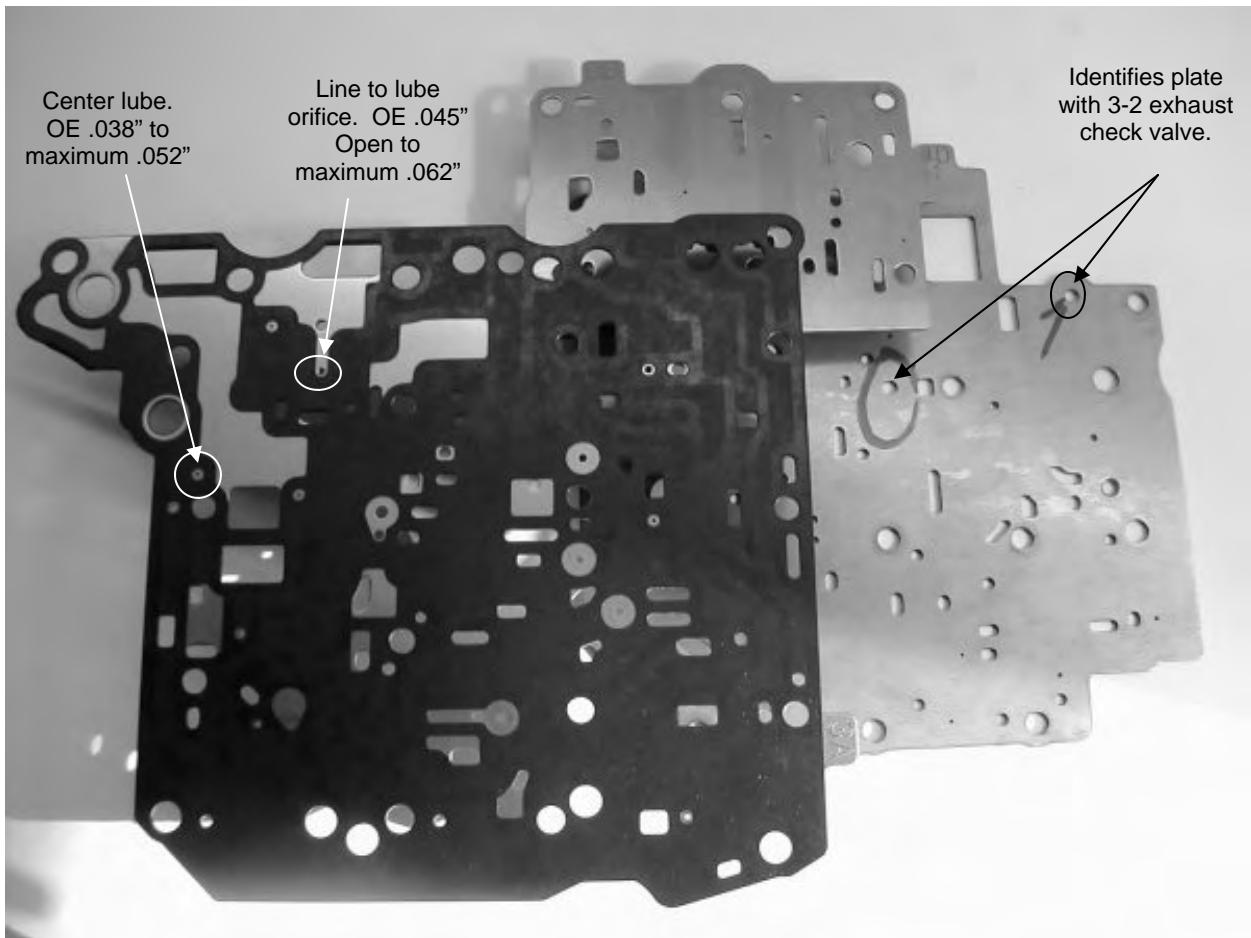
A separator plate modification can be performed, if the secondary regulator bore has minimal wear. This modification will increase lube and converter feed oil flow. Enlarging the plate feed holes is not suggested if the valve body casting has excessive wear at the secondary regulator bore, in the area of the spring to spool surface.

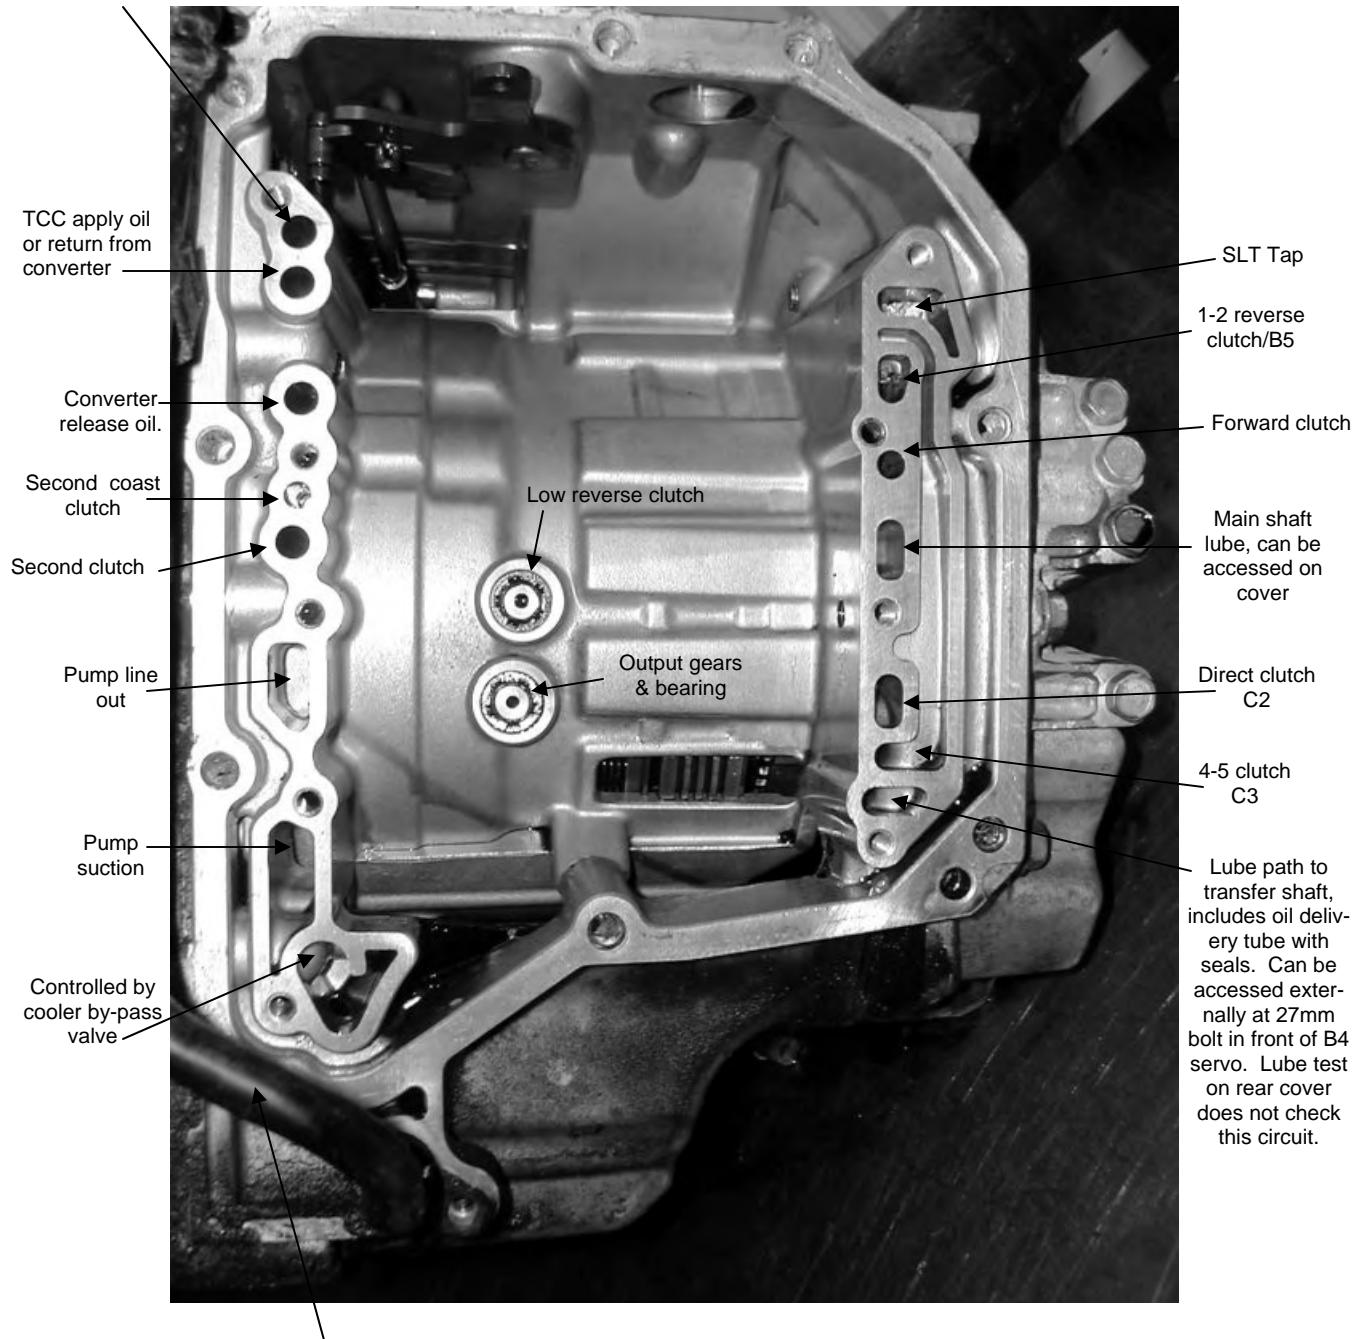
Caution:

Anytime the valve body is lifted off the case the two seals tend to fall out of place. Use assembly gel to hold in place and double check prior to assembly.
