PART NUMBER 85701-01

Servo Belleville Cushion Washer

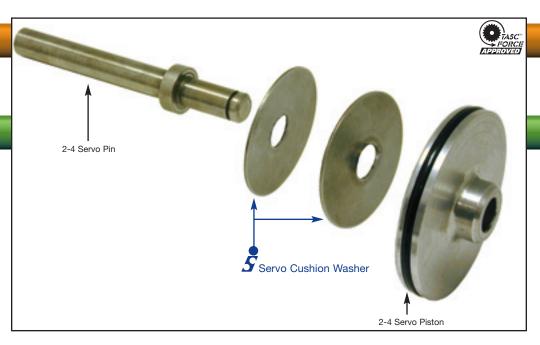
Neutralizes on 3-4 shift

A broken cushion washer that gets stuck in the overdrive servo bore will not allow band apply

Replace the broken cushion washers with these servo cushion washers which are now available separately.

This servo cushion washer is not serviced as an individual part by the OEM. In the past it was necessary to purchase an entire servo assembly. Sonnax now offers a replacement servo cushion washer 85701-01.
