TF HOME INSPECTION

TFHI RESIDENTIAL REPORT

1234 Main St. Union NJ 07083

07/21/2020 9:00AM

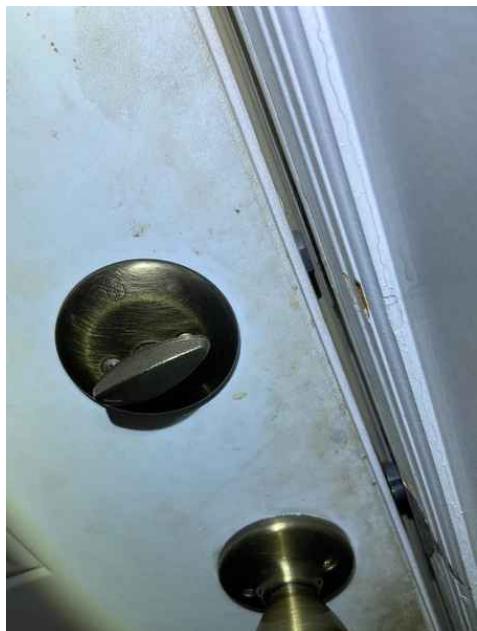
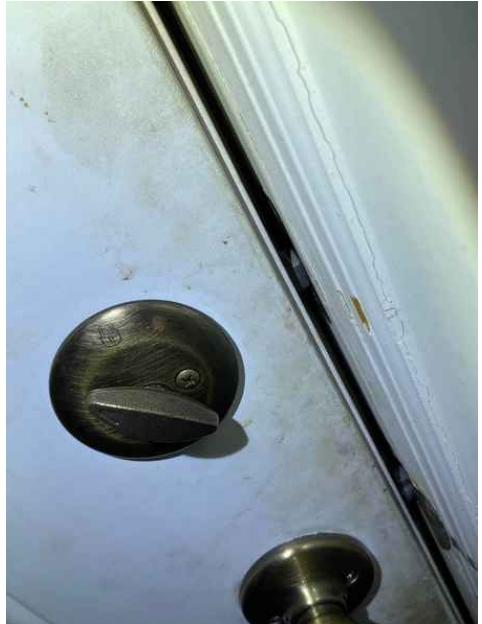
3.2.2 Exterior Doors

DOOR ALIGNMENT

REAR KITCHEN

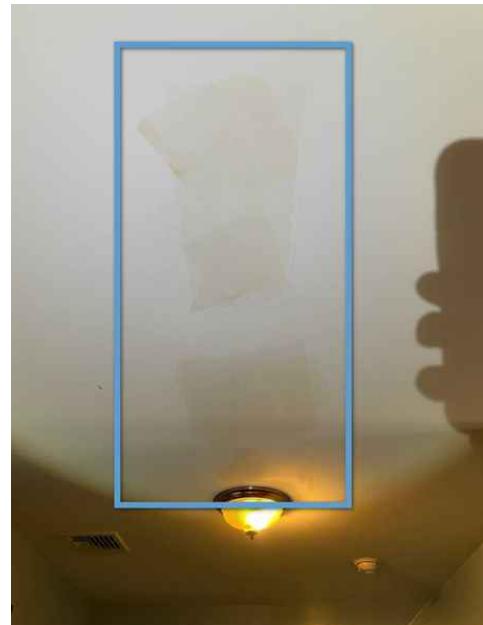
4.1.1 Ceilings

POOR PATCHING/WORKMANSHIP

The ceilings were observed to be poorly patched and are in need of painting. This is a cosmetic issue. A qualified licensed professional should repair and replace as necessary.

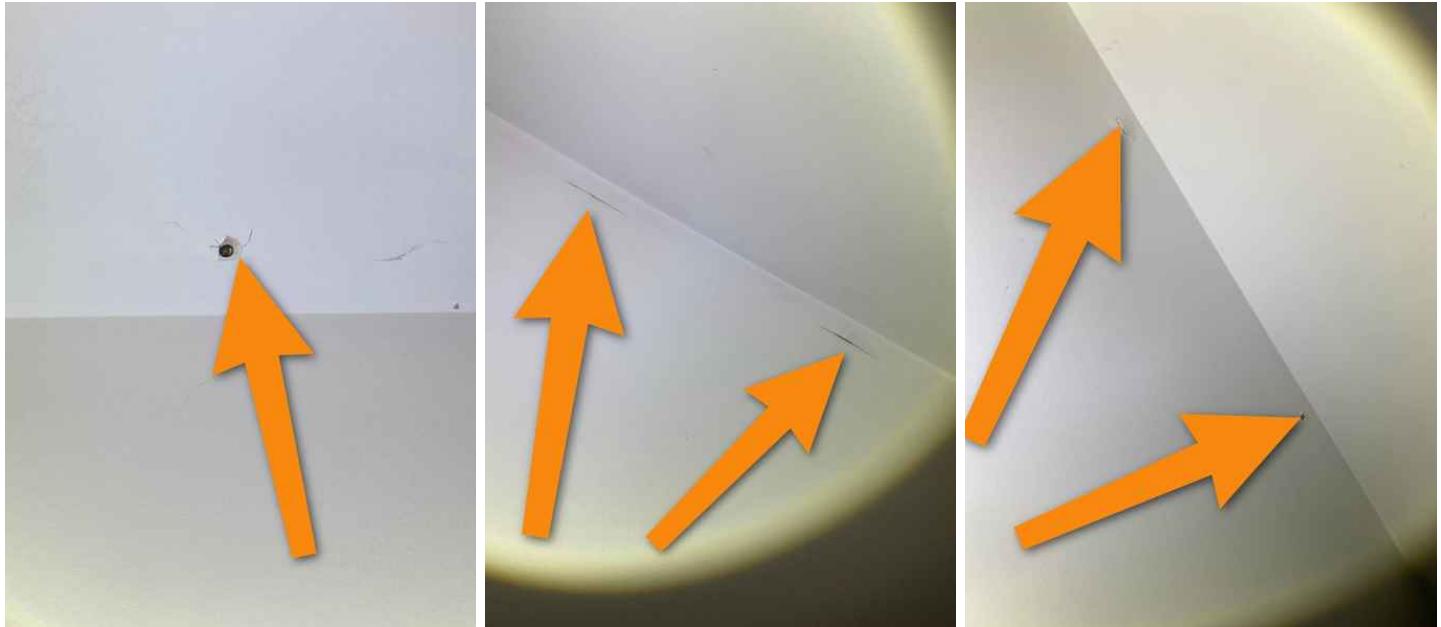
4.1.2 Ceilings

NAIL POPS/LIFTING DRYWALL TAPE

Protruding nail heads visible at the time of the inspection appeared to be the result of contact with moisture. After the source of moisture is located and corrected, protruding nails should be removed, drywall re-fastened and the drywall finished to match the existing wall surfaces. All work should be performed by a qualified licensed drywall or painting contractor.

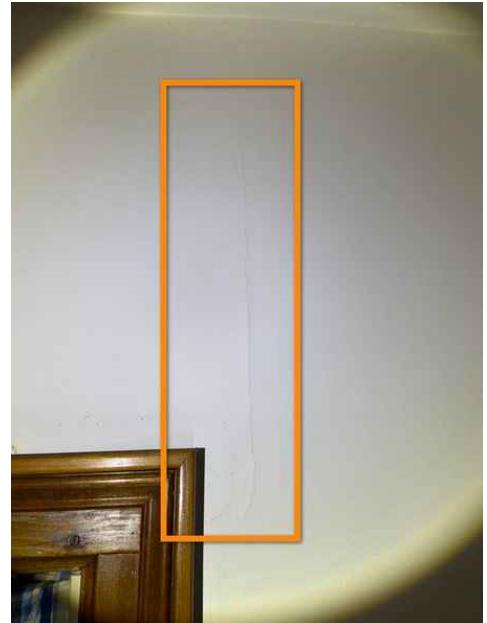
4.2.2 Walls

**MINOR CORNER CRACKS**

Minor cracks at the corners of doors and windows in walls were observed at the time of inspection. This appeared to be the result of long-term settling, which is common for a home of this age. Some settling is not unusual in a home of this age and these cracks do not appear to be a structural concern. Recommend a qualified licensed contractor evaluate and advise as necessary.

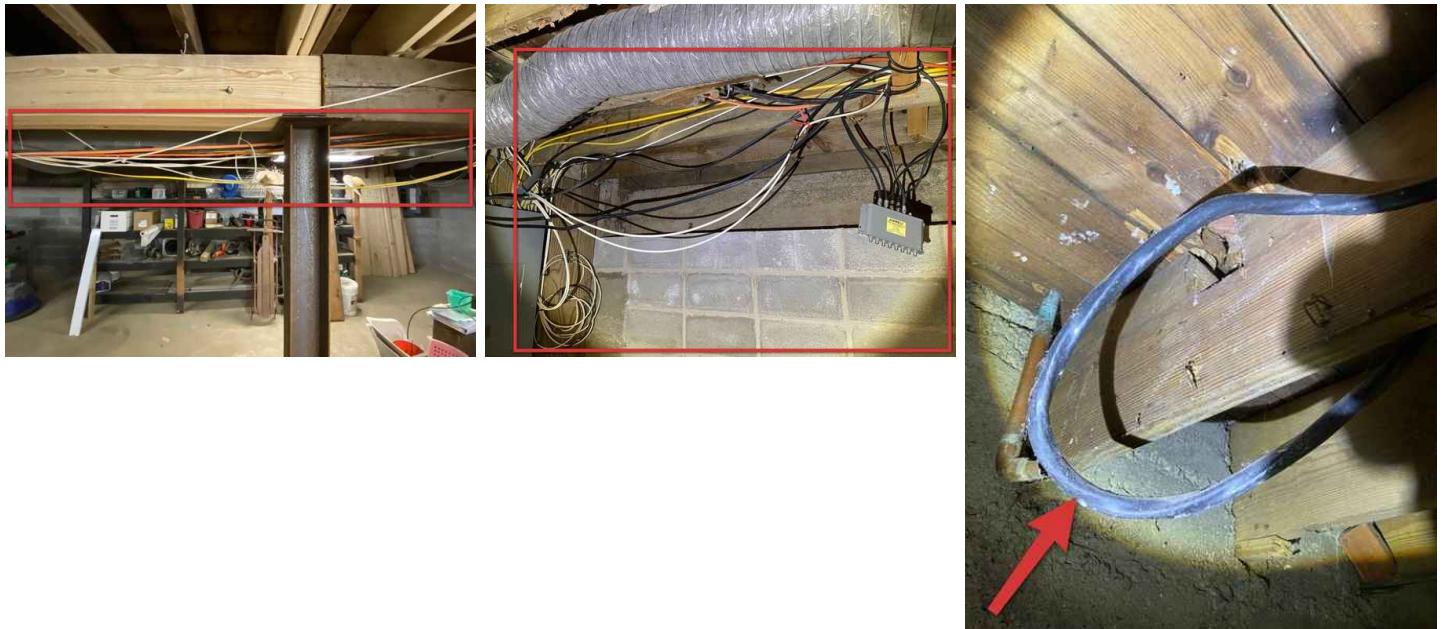
6.3.1 Branch Wiring Circuits, Breakers & Fuses

WIRING NEEDS SECURING

The wiring leaving the electric panel is not secured. This is a safety hazard. A qualified licensed professional should secure all wiring that exits the panel.

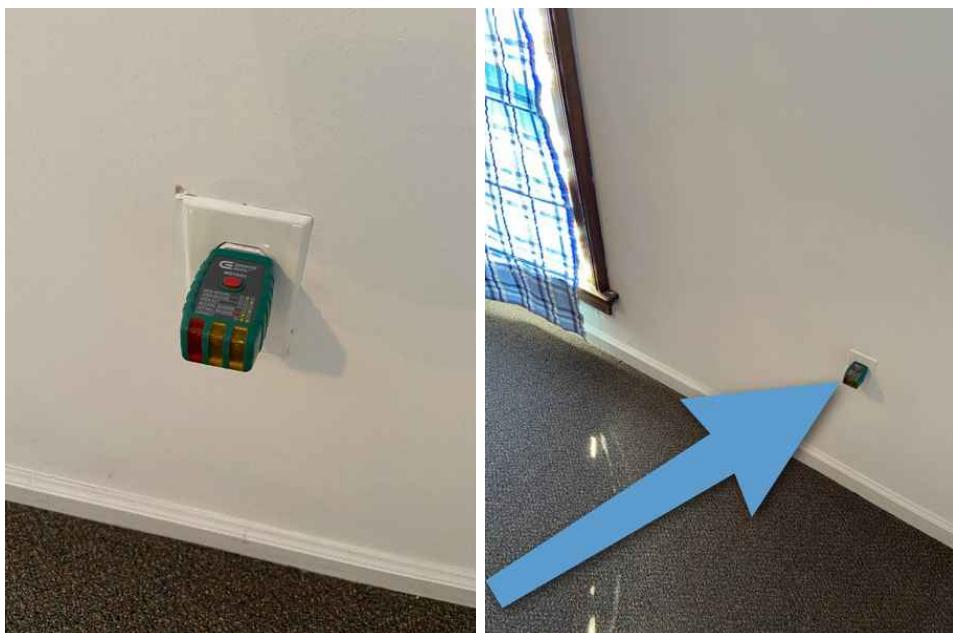
6.4.1 Lighting Fixtures, Switches, Wiring & Receptacles

NO POWER AT RECEPTACLE

2ND FLOOR

There was no power noted at the receptacle. A qualified licensed professional should repair and replace as necessary.

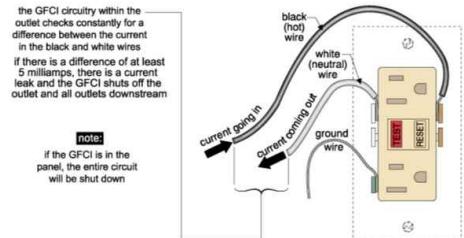
NO GFCI PROTECTION INSTALLED

BATHROOMS, LAUNDRY

No GFCI protection was present near all water supplies. This is a safety hazard. A qualified licensed electrician should upgrade by installing ground fault receptacles in all locations near water supplies.

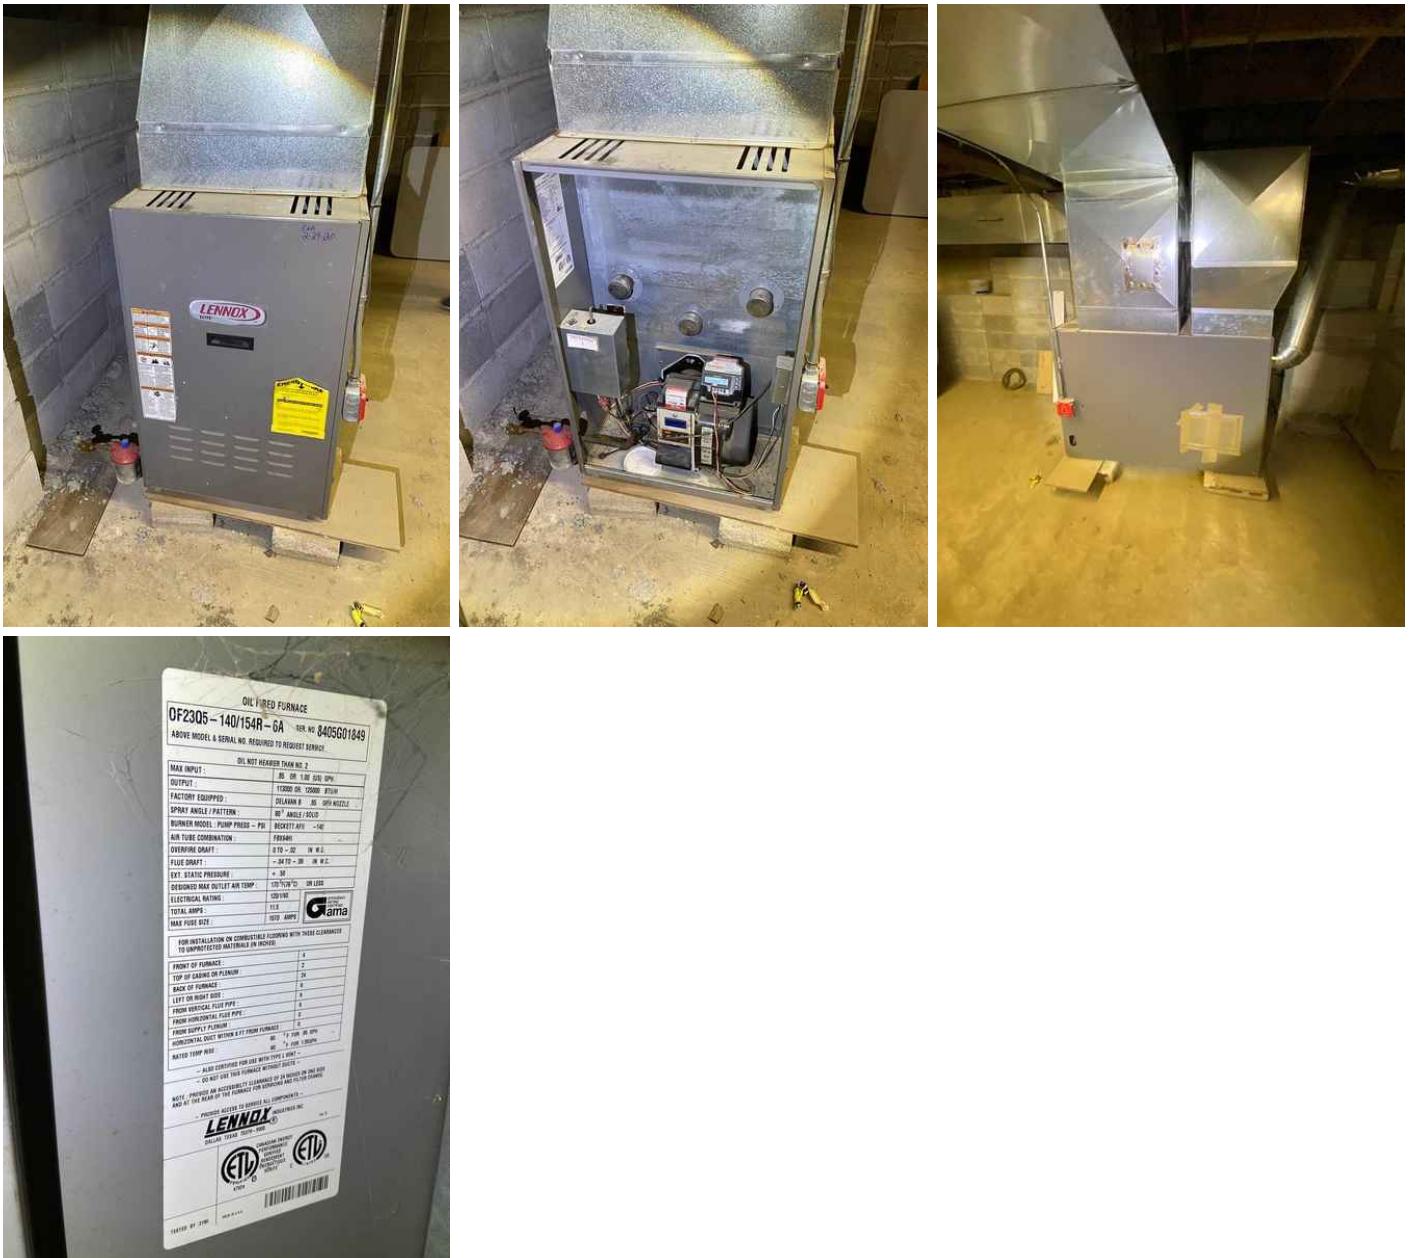
Goodman, Lennox

The a/c and heating system Lennox was manufactured in Unknown, sticker inaccessible. The serial number is (Please see image) and model number is (Please see image) and has a 15-25 year life expectancy. The condenser unit Goodman was manufactured in 2011. The serial number is (Please see image) and model number is (Please see image) and has a life expectancy of 8-15 years.

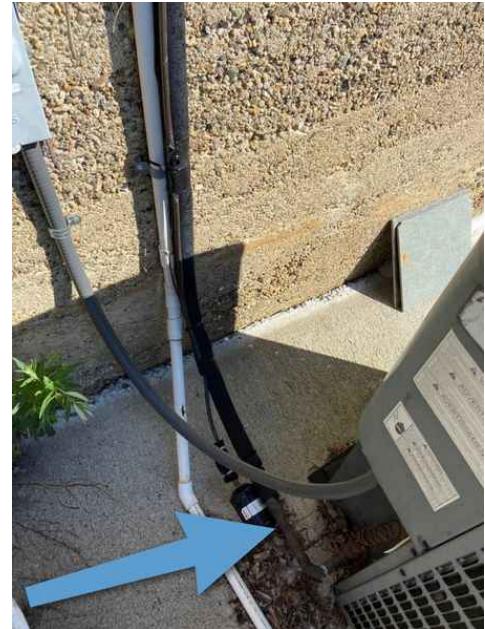
7.2.2 Equipment

**INSULATION ON CONDENSATE LINE
DAMAGED/MISSING****EXTERIOR**

Contact a qualified HVAC professional.

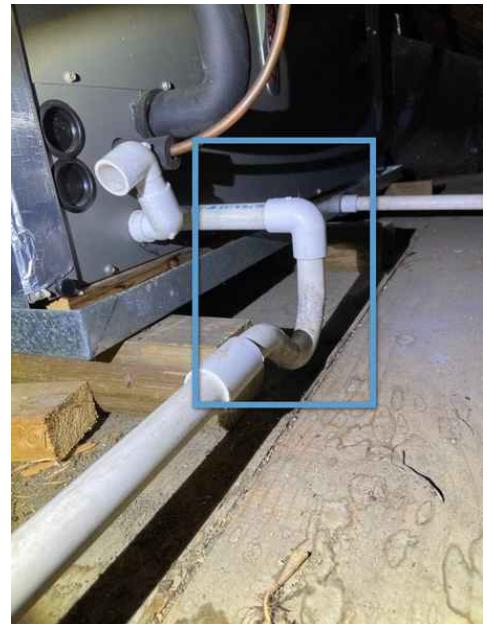
7.2.3 Equipment

P-TRAP CLEANOUT MISSING**Repair and Replace**

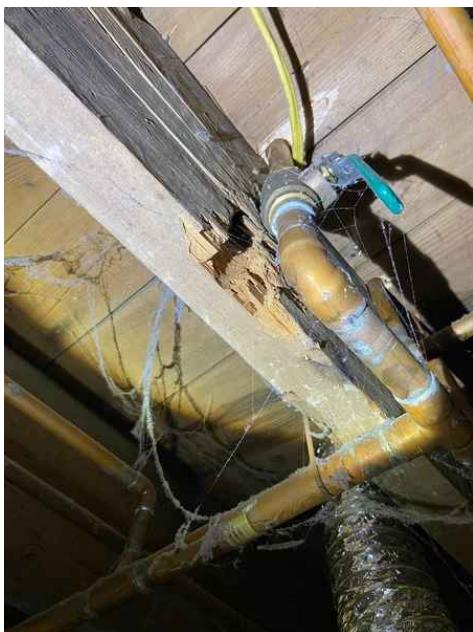
10.3.1 Floor Structure

JOISTS NEED REPAIR

Contact a qualified professional.

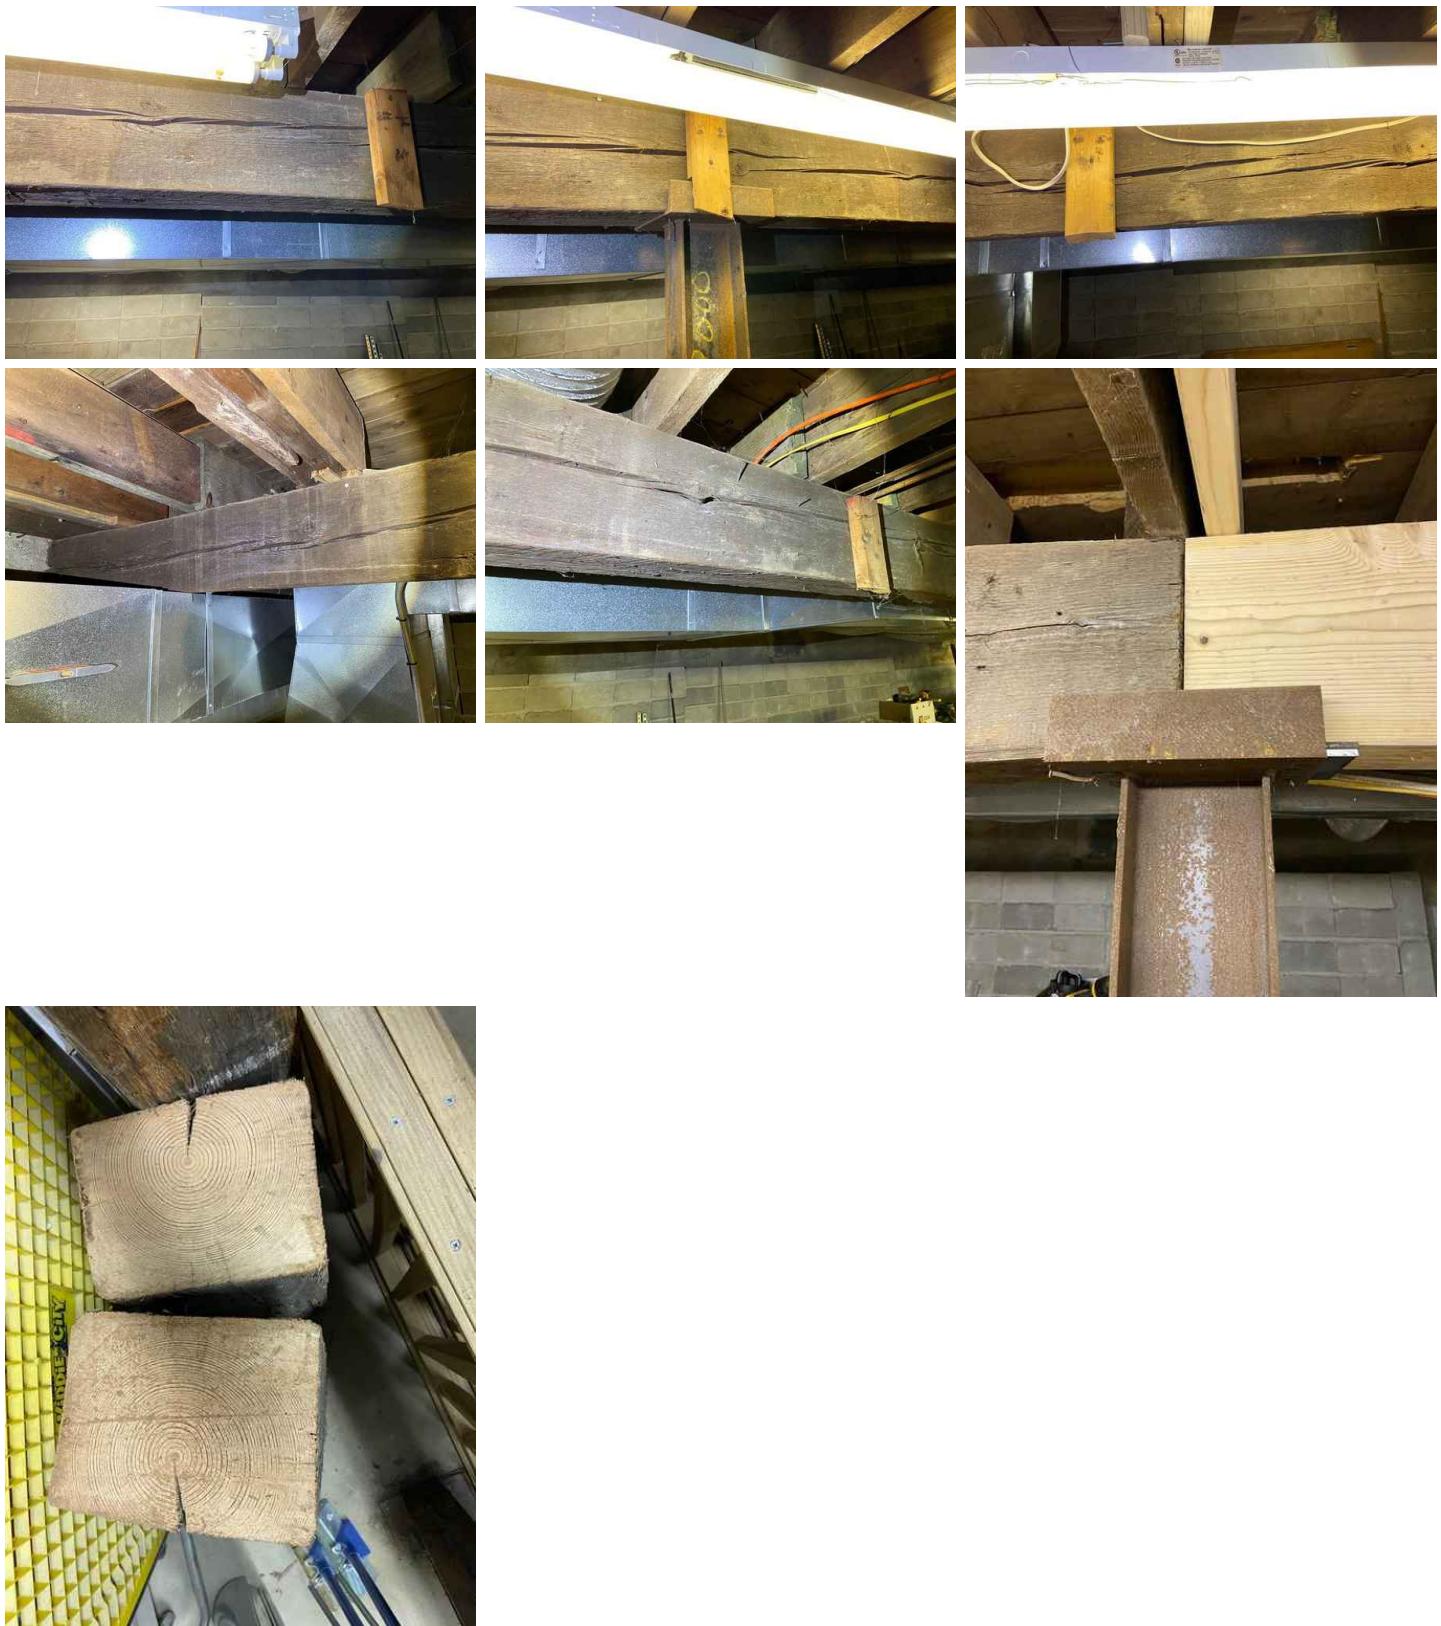
10.5.1 Ceiling Structure

BEAM CHECKING

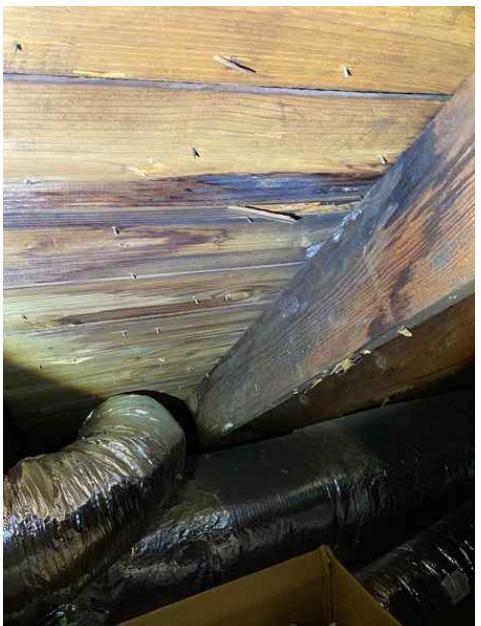
10.7.3 Roof Structure & Attic

MILDEW STAINS ON SHEATHING

Contact a qualified roofing professional.

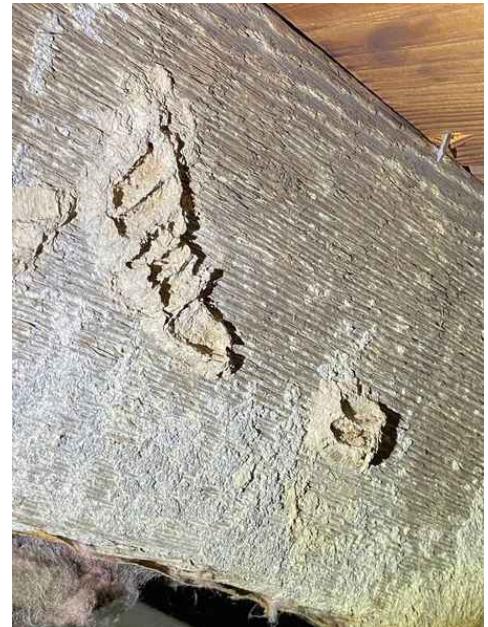
10.7.4 Roof Structure & Attic **WASP/BEES NESTS**

Wasp/bees nests were visible throughout the attic space. A qualified licensed exterminator should evaluate and recommend further action.
