TF HOME INSPECTION

TFHI RESIDENTIAL REPORT

1234 Main St. Union NJ 07083

06/24/2020 9:00AM

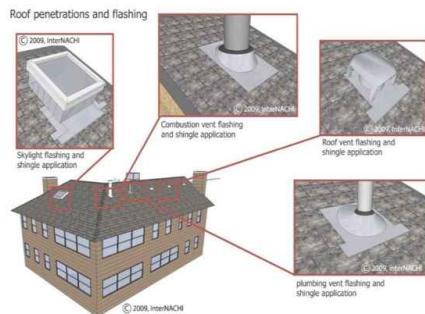
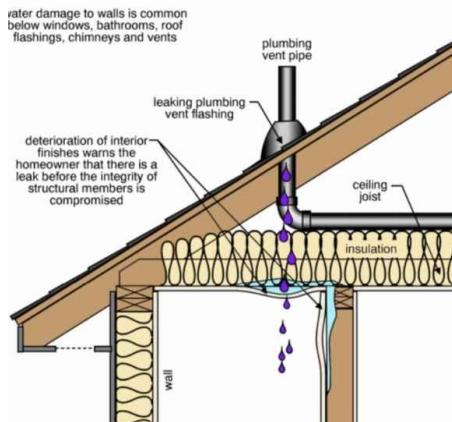
I looked at DWV (drain, waste and vent) pipes that pass through the roof covering. There should be watertight flashing (often black rubber material) installed around the vent pipes. These plumbing vent pipes should extend far enough above the roof surface.

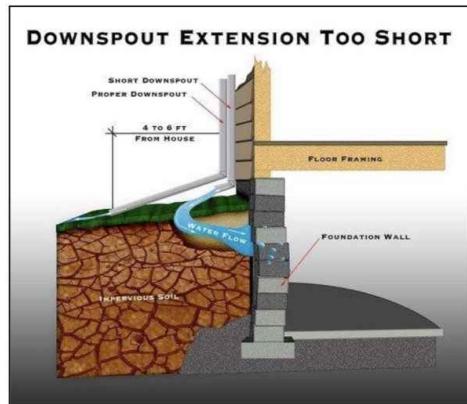
2.2.1 Roof Drainage Systems

DOWNSPOUTS DRAIN NEAR HOUSE

Some downspouts need an extension and or a buried drain line to carry water away from the home at the front, rear and sides of home. Having the downspouts terminate at such a short distance can allow for water to penetrate the basement during heavy rain. This can cause damage to the interior finishes of the basement and the foundation. I recommend a qualified licensed contractor repair or replace as needed.

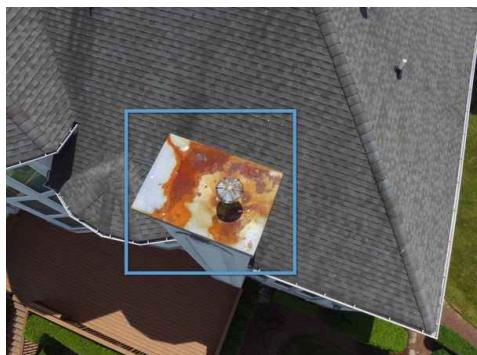
2.4.1 Skylights, Chimneys & Other Roof Penetrations

METAL CHIMNEY RUST

The metal chimneys show evidence of rust and/or rusting. A qualified licensed contractor should evaluate the chimney vents/ cap flashing which may have to be replaced at some point.

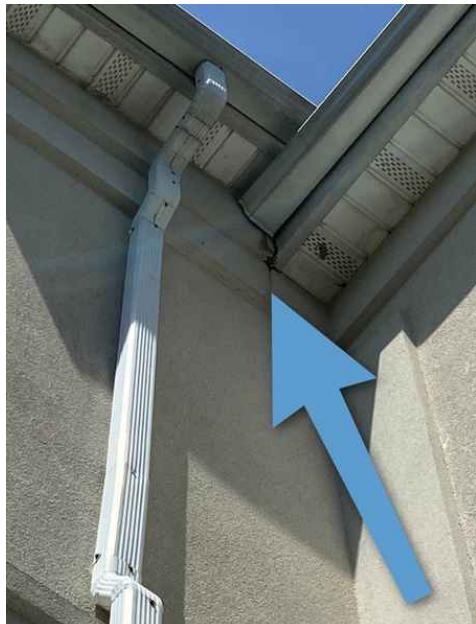
3.1.2 Wall Covering, Flashing & Trim

DISCOLORATION

Large areas of discoloration noted on the exterior stucco. This is a cosmetic issue. A qualified licensed professional should repair and replace as necessary by cleaning the EIFFS stucco after it is properly sealed in all areas.

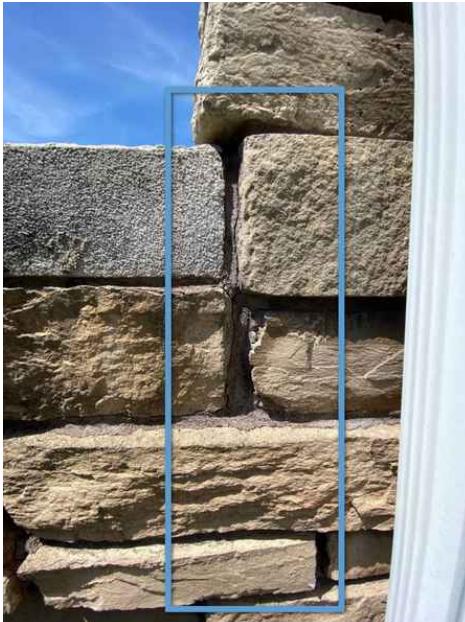
3.6.1 Decks, Balconies, Stoops, Porches, Railings & Steps

CONCRETE STEPS SETTLING

The concrete steps appear to have settled and caused settlement cracks in the stone veneer. Settlement and the weight of the material, without proper support, cause the steps to pull away from the home and damage the surrounding structure. A qualified licensed contractor should fill the cracking with epoxy, repair and replace the areas, to prevent water intrusion. The area should then be monitored for any future movement.

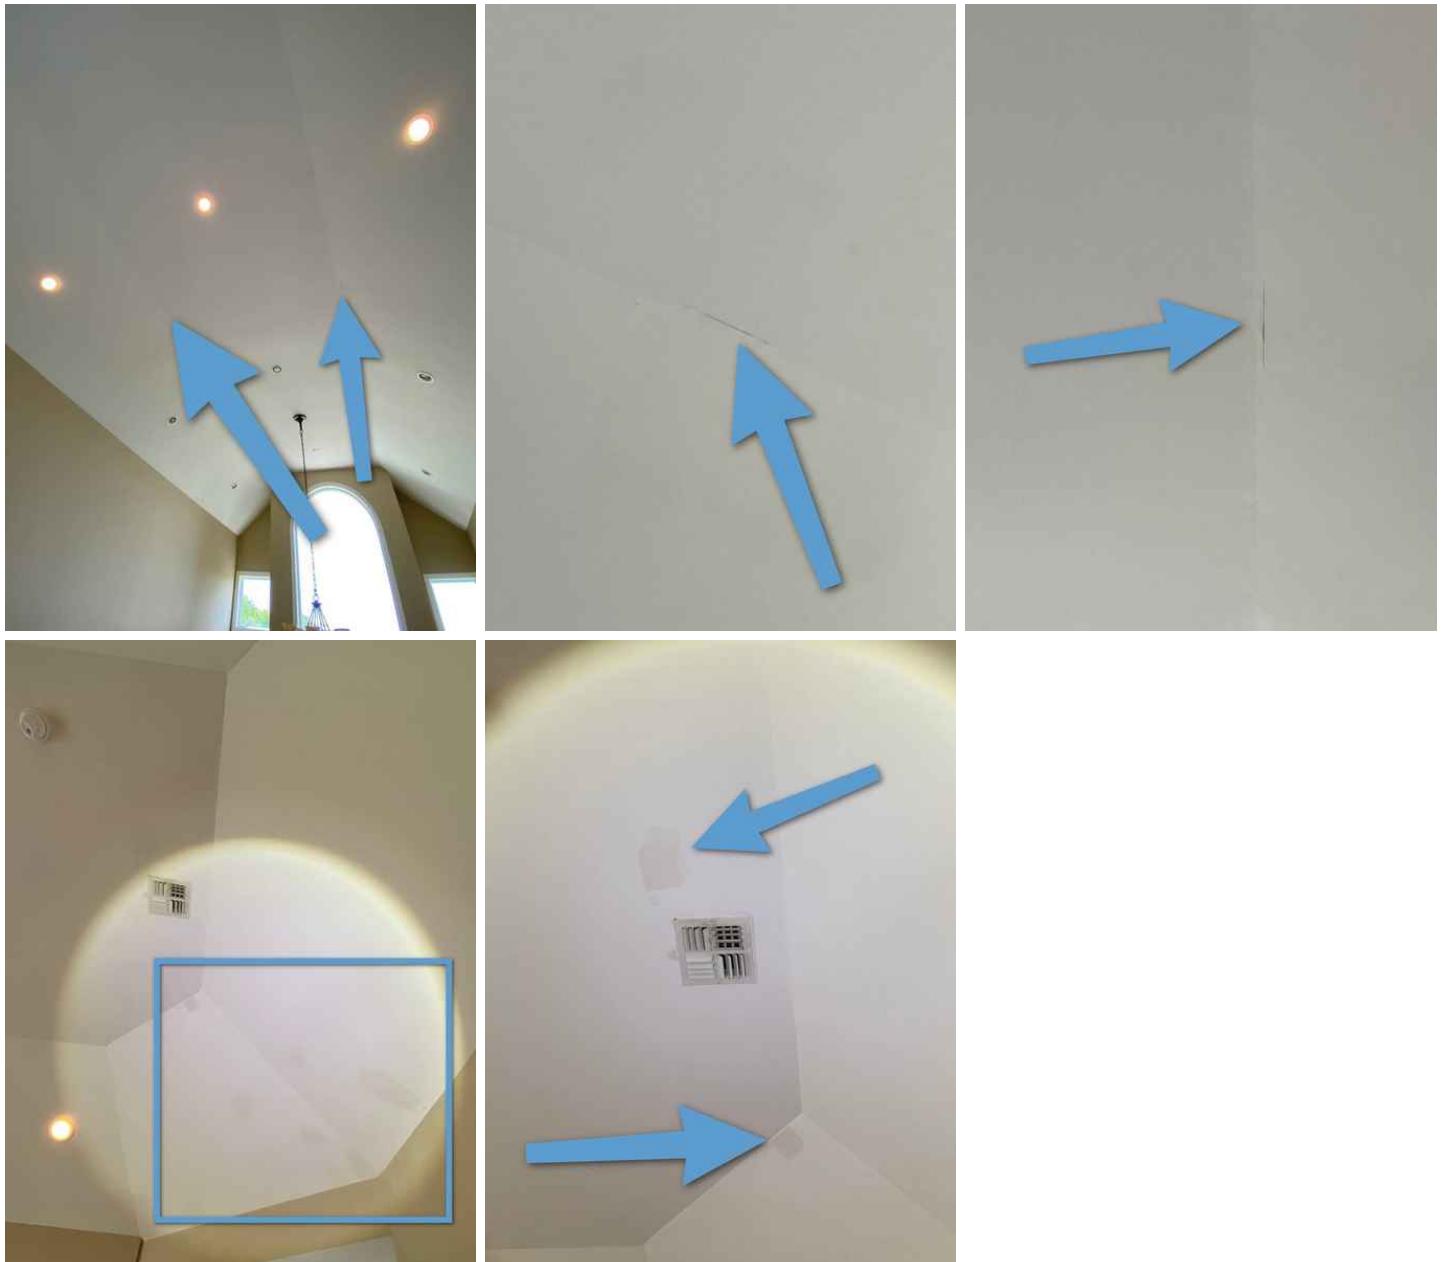
MAIN CATHEDRAL HALL, MASTER BEDROOM

PATCHING/PAINTING NEEDED

Areas of the ceilings of the home are in need of patching/painting. This is a maintenance issue. A qualified licensed professional should repair and replace as necessary.

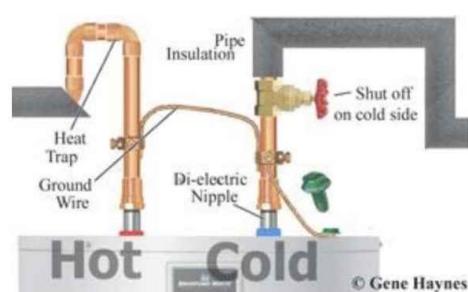
5.3.1 Hot Water Systems, Controls, Flues & Vents

BONDING BETWEEN HOT AND COLD DISTRIBUTION LINES MISSING

Missing bonding between hot and cold water supplies. This is needed for safe grounding of water distribution system. A qualified licensed contractor should evaluate, repair, and replace as necessary.

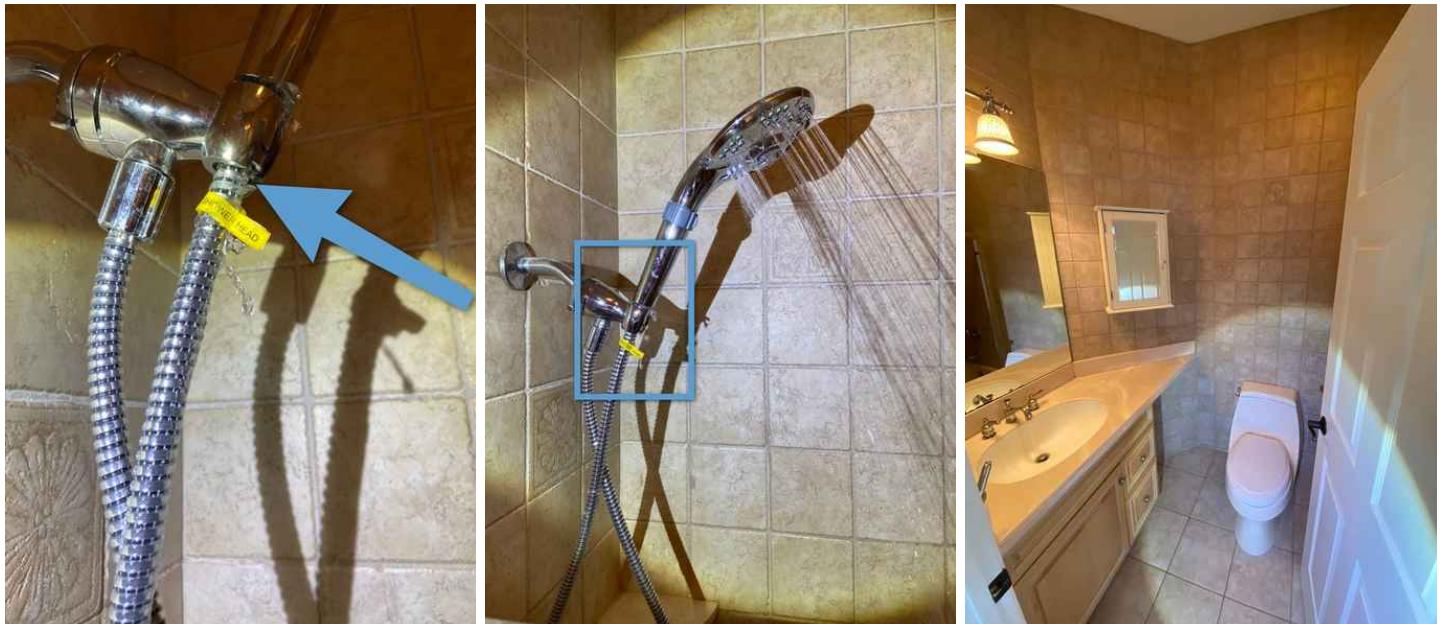
2ND FLOOR BATHROOM

ACTIVE WATER LEAK

I observed indications of an active water leak in the bathroom shower fixture. This can cause damage to the home. A qualified licensed plumber should evaluate, repair and replace as necessary.

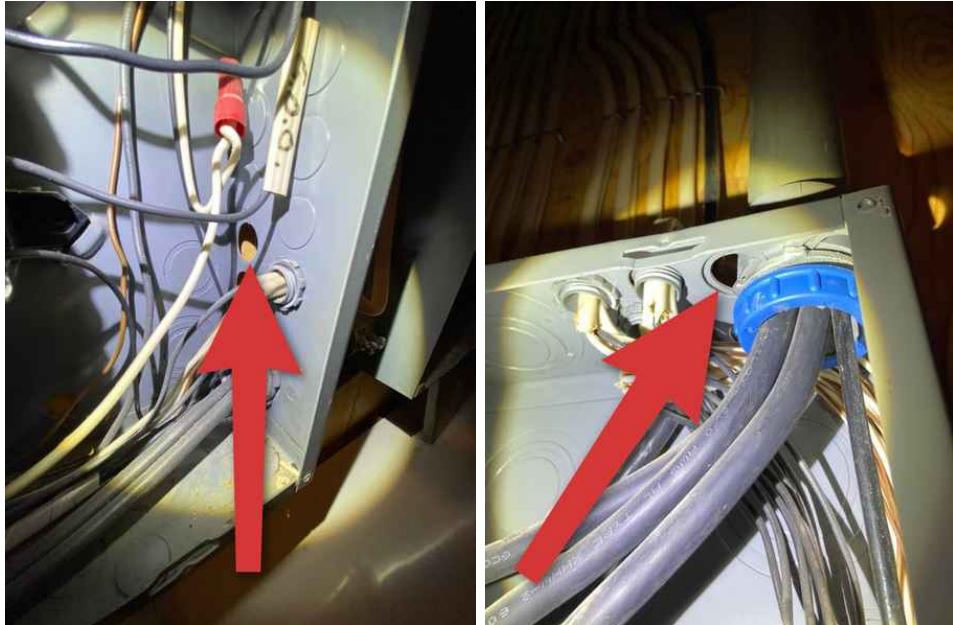
6.2.1 Main & Subpanels, Service & Grounding, Main Overcurrent Device

KNOCKOUTS MISSING

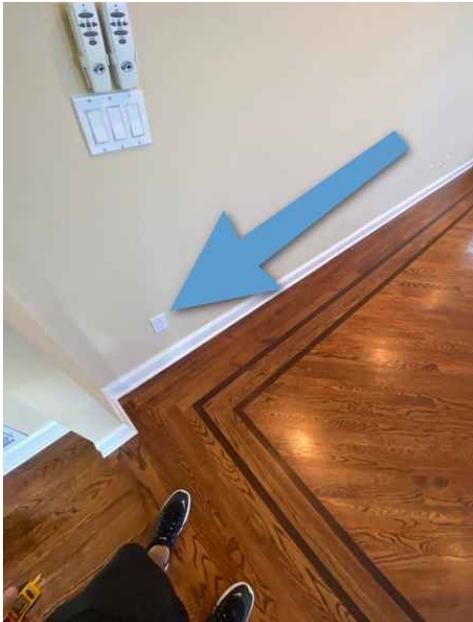
1ST FLOOR HALL, 2ND FLOOR TOP OF RIGHT STAIRS

DAMAGED RECEPTACLE

The top half of two receptacles was observed to be damaged, and the plug was unable to go into the receptacle. This is a maintenance issue. A qualified licensed electrician should repair and replace as necessary.

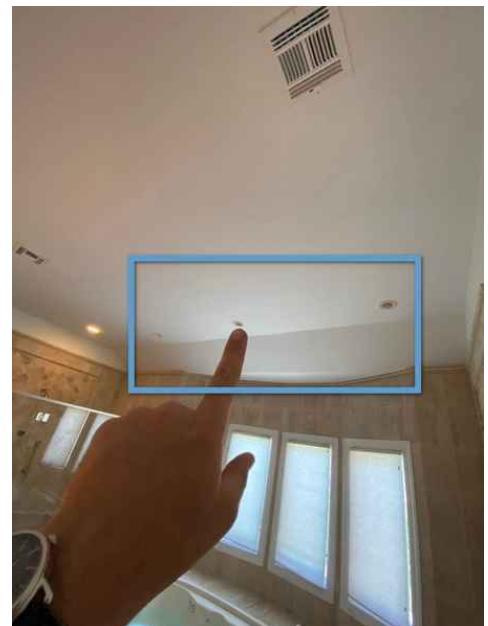
MASTER BATHROOM

LIGHT INOPERABLE

Repair and Replace

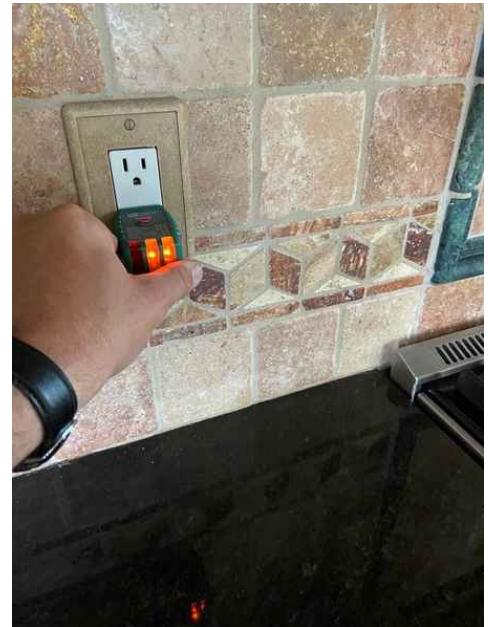
KITCHEN LEFT OF OVEN

Safety Hazard

LOOSE RECEPTACLE

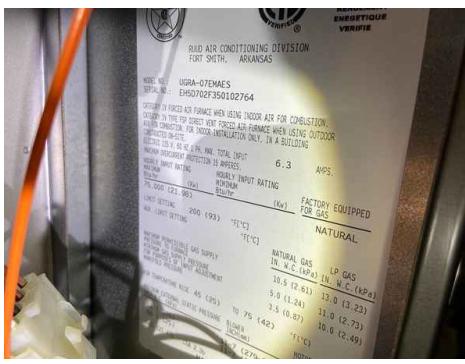
Exterior/Basement Utility Room Right Unit

The a/c and heating system (RUUD) was manufactured in 2001. The serial number is (Please see image) and model number is (Please see image) and has a 15-25 year life expectancy. The condenser unit (Goodman) was manufactured in 2016. The serial number is (Please see image) and model number is (Please see image) and has a life expectancy of 8-15 years.

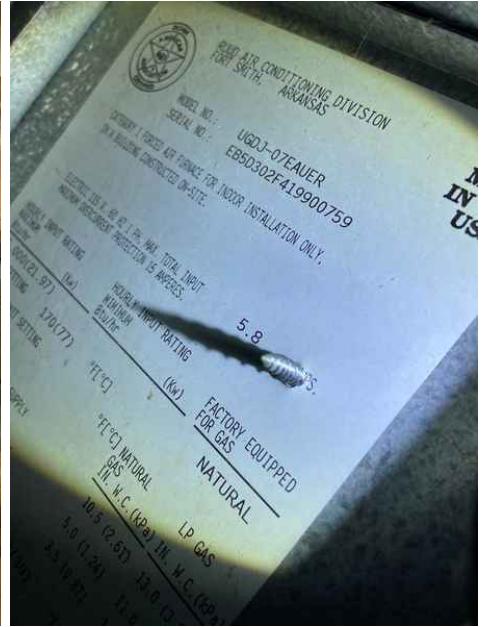
Exterior/Crawlspac

The a/c and heating system (RUUD) was manufactured in 1999. The serial number is (Please see image) and model number is (Please see image) and has a 15-25 year life expectancy. The condenser unit (Goodman) was manufactured in 2018. The serial number is (Please see image) and model number is (Please see image) and has a life expectancy of 8-15 years.

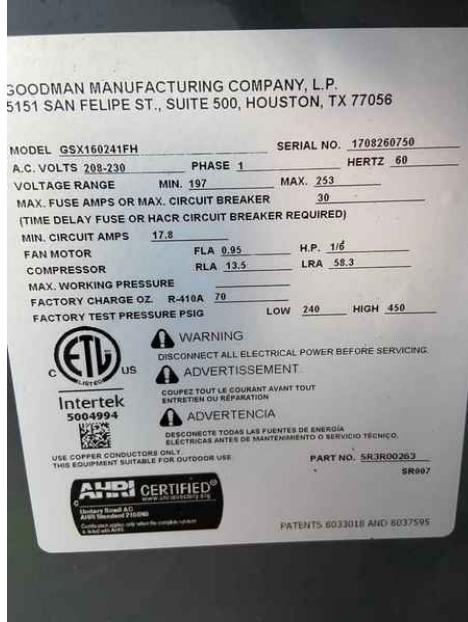
Exterior/Attic Drop down Ladder Master Bed Closet

The a/c and heating system (RUUD) was manufactured in 1999. The serial number is (Please see image) and model number is (Please see image) and has a 15-25 year life expectancy. The condenser unit (Goodman) was manufactured in 2017. The serial number is (Please see image) and model number is (Please see image) and has a life expectancy of 8-15 years.

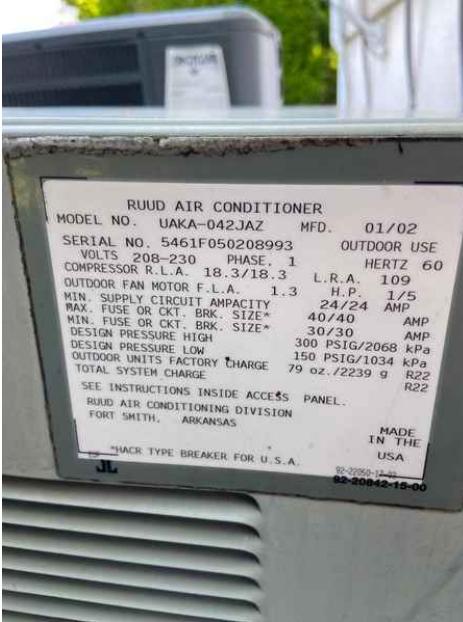
Exterior/Attic Scuttle Hole

The a/c and heating system (RUUD) was manufactured in 1999. The serial number is (Please see image) and model number is (Please see image) and has a 15-25 year life expectancy. The condenser unit (RUUD) was manufactured in 2002. The serial number is (Please see image) and model number is (Please see image) and has a life expectancy of 8-15 years.

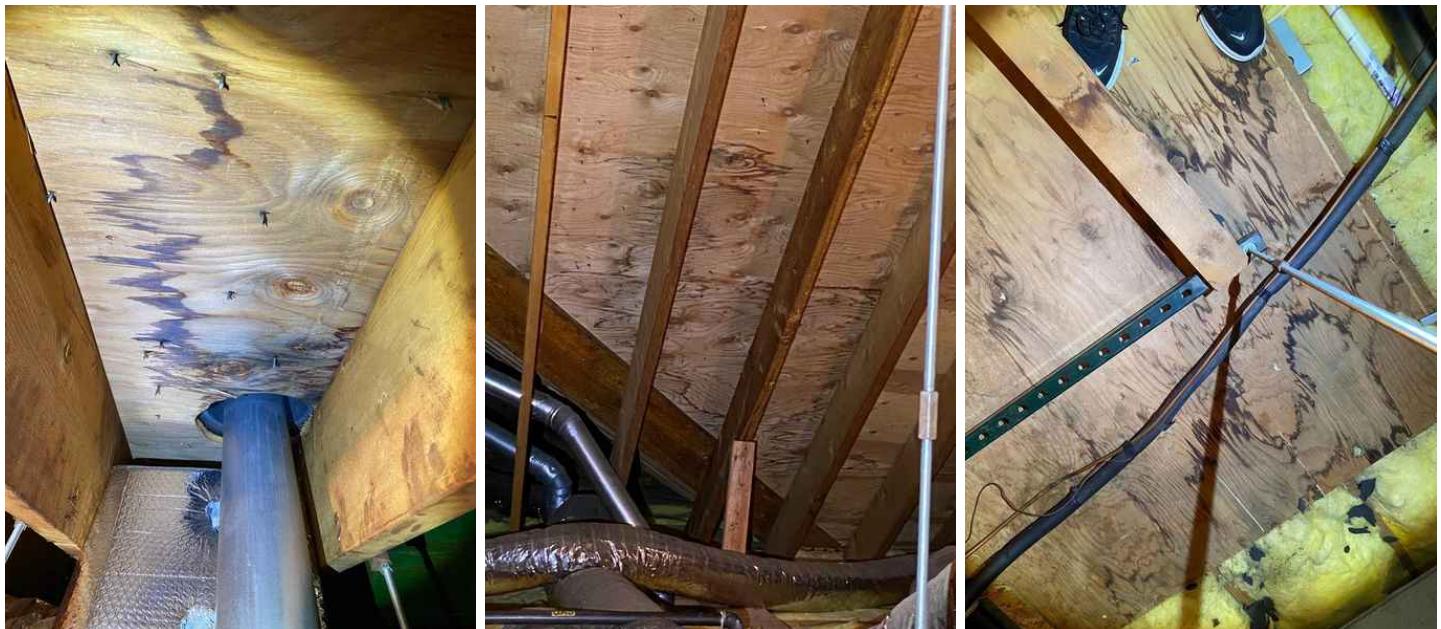
10.7.1 Roof Structure & Attic

MILDEW STAINS ON SHEATHING

Evaluate or Monitor
