Inspection Report

Property Address:
586 Mountain Fancy Drive
Big Lake NC 28715

Date: 12/15/2020	Time: 1:00 PM	Report ID: 12345-Sample
Property: 586 Mountain Fancy Drive Big Lake NC 28715	Customer: Sample Buyer	Real Estate Professional: Nath Dau-Schmidt DauSchmidt Realty

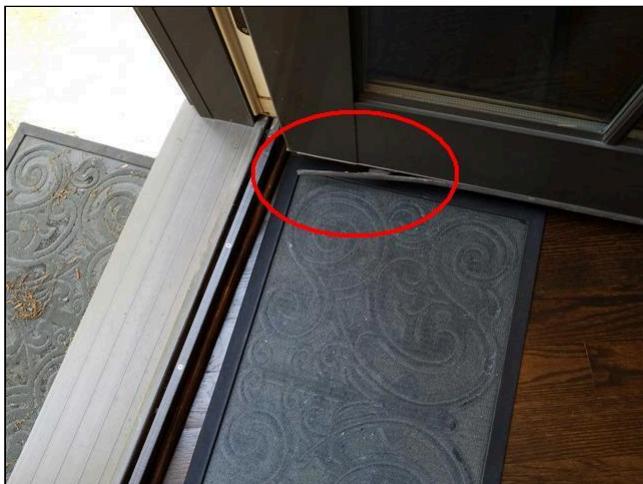
2.0 Item 2 (Picture)

(3) Some repair areas noticed

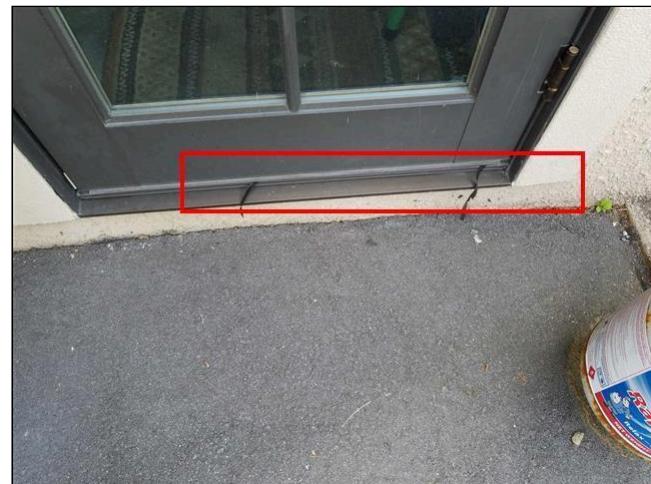
2.1 Item 1 (Picture) balcony from kitchen

(1) Weather stripping on a few exterior doors are loose, missing or damaged in areas..

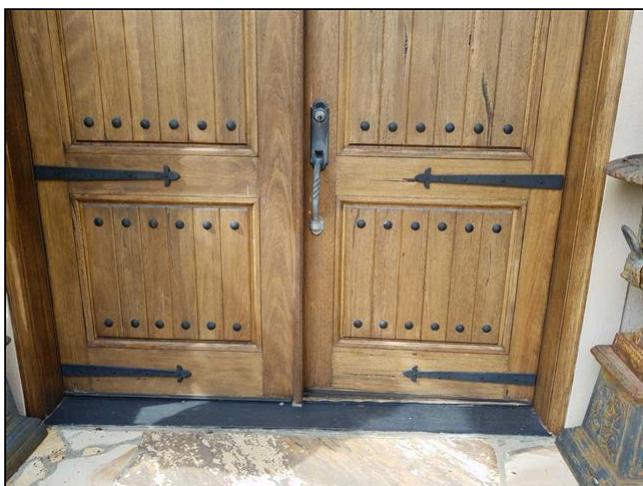
2.1 Item 3 (Picture)

(2) Stain used to protect main doors has faded or failed, and need prep and stain again.

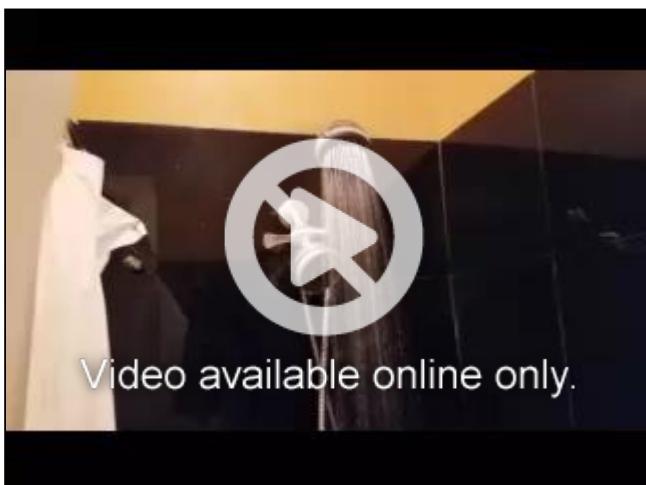
5.1 Item 1 (Video)

- (1) Shower fixture leaked in a few areas where seals may be old. Recommend repair or replace as necessary.

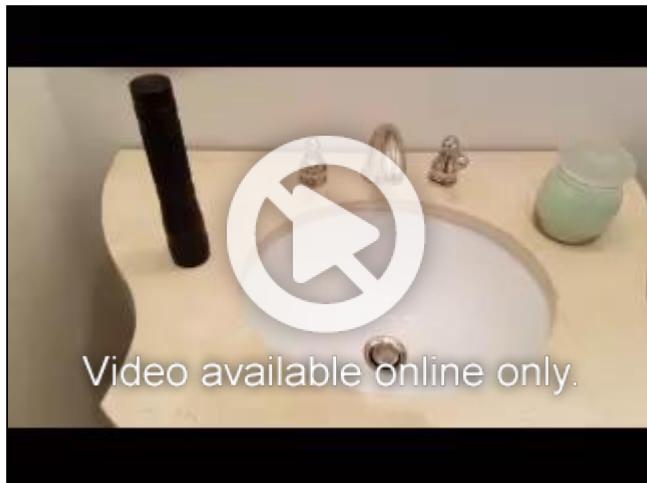
5.1 Item 2 (Video)

(2) Control knobs for guest bath sink upstairs (light blue room) appear to be installed opposite to normal direction to turn water off and on. Volume or pressure here is somewhat low compared to the other plumbing locations in the home.

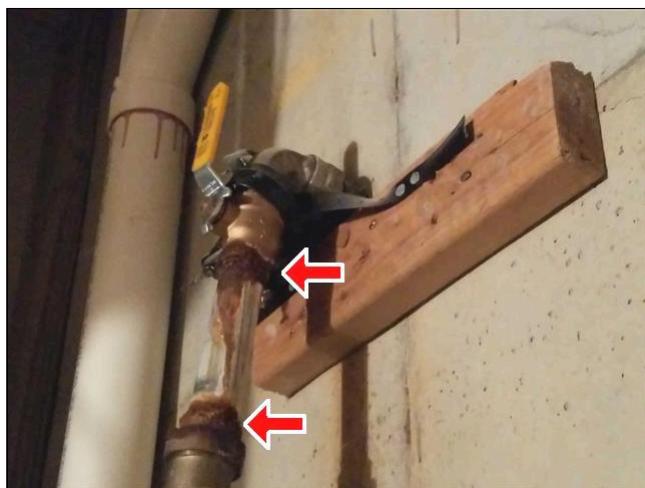
5.2 Item 1 (Picture)

Water connection to water heater leaks or has corroded and may have temporarily stopped leaking due to corrosion? A plumber should repair or replace as needed.

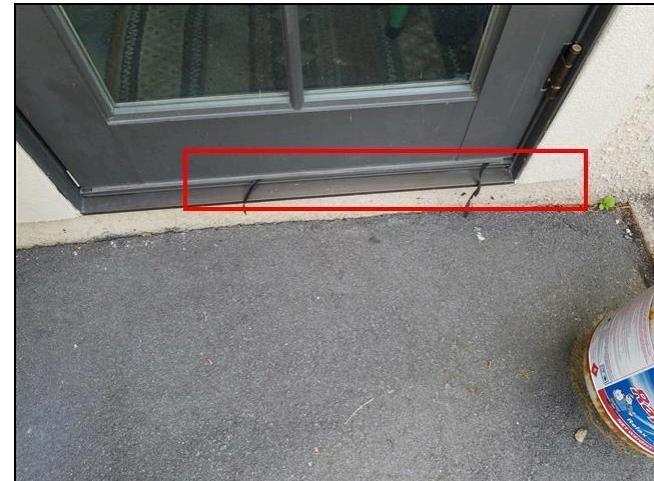
2.0 Item 2 (Picture)

(3) Some repair areas noticed

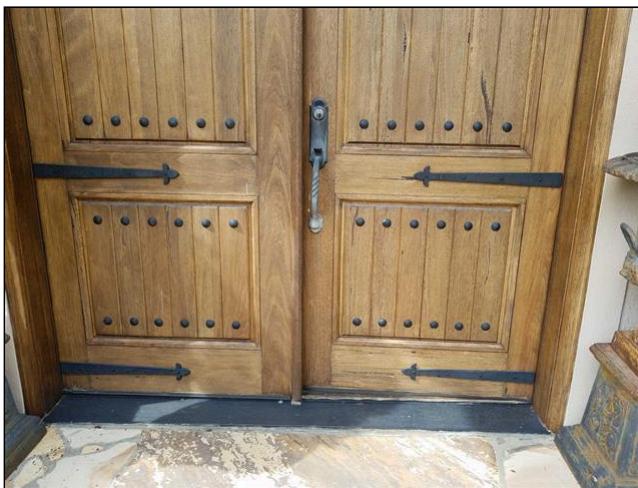
2.1 Item 3 (Picture)

(2) Stain used to protect main doors has faded or failed, and need prep and stain again.
