INSPECTION REPORT

586 Mountain Fancy Drive
Big Lake NC 28715

12/15/2020
1:00 PM

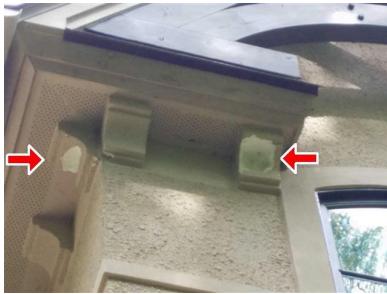
2.0 Item 1 (Picture)

- (1) The stucco siding, trim and fascia are in need of cleaning and repainting throughout. Gutters will need to be temporarily removed to paint and then re-install.
- (2) The gable wood work on at least two locations shows signs of some damage from carpenter bees etc. and need repair and prep and paint.

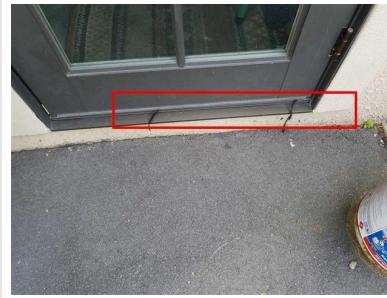
2.1 Item 1 (Picture)
balcony from kitchen2.1 Item 2 (Picture)
garage

(1) Weather stripping on a few exterior doors are loose, missing or damaged in areas..
