Defect Analysis Report — CircuitGuard AI

Report ID:	RPT-E7F7DBA7
Generated On:	2025-11-12 13:12:16
Model:	ResNet50 (custom)
Device:	cpu

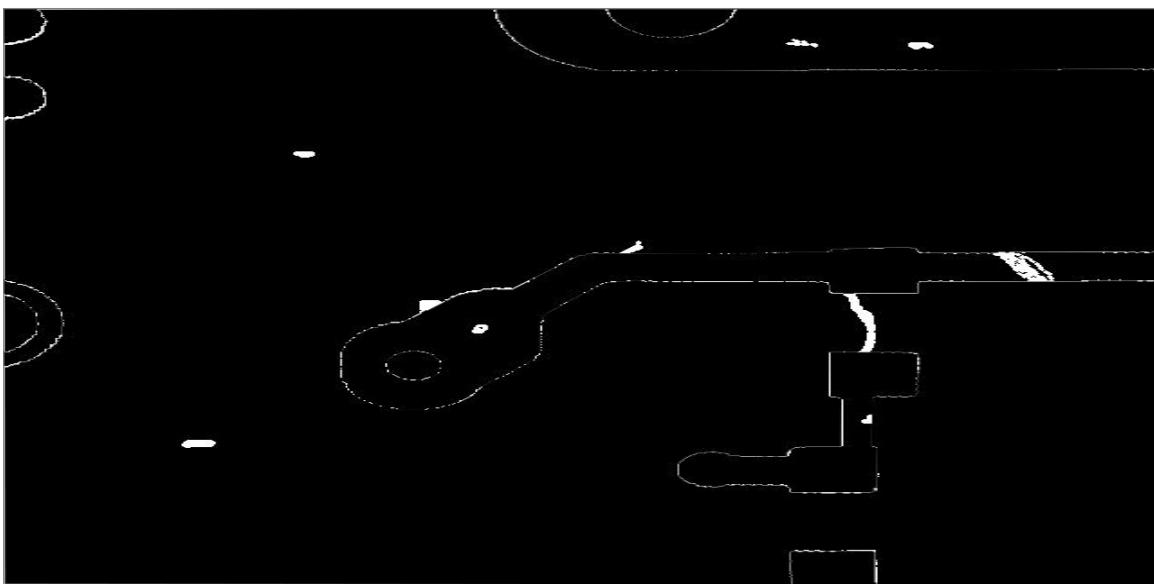
Detected 6 defect(s). High:4, Medium:2, Low:0. Avg conf: 79.62%.

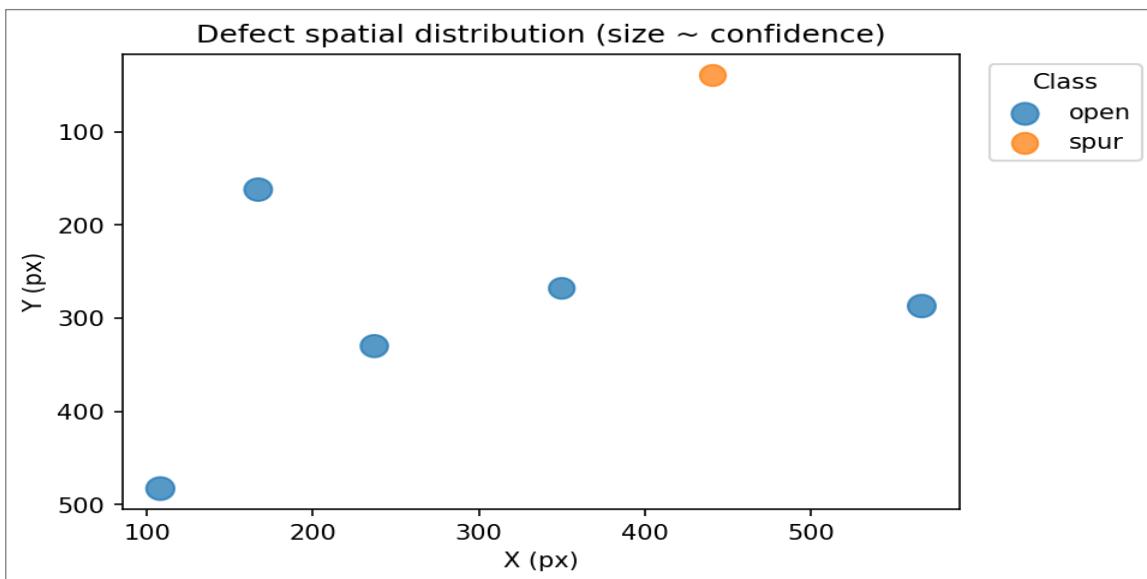
Spatial Distribution (size ~ confidence)

ID	Type	Confidence	Position (X,Y)	Size (WxH)	Area (px ²)
#1	open	86.9%	(108,483)	33x24	217
#4	open	81.3%	(237,330)	28x28	200
#6	open	84.6%	(567,287)	47x50	824
#7	open	69.7%	(350,268)	26x25	148
#8	open	84.2%	(167,162)	26x23	124
#10	spur	71.0%	(441,39)	25x22	106

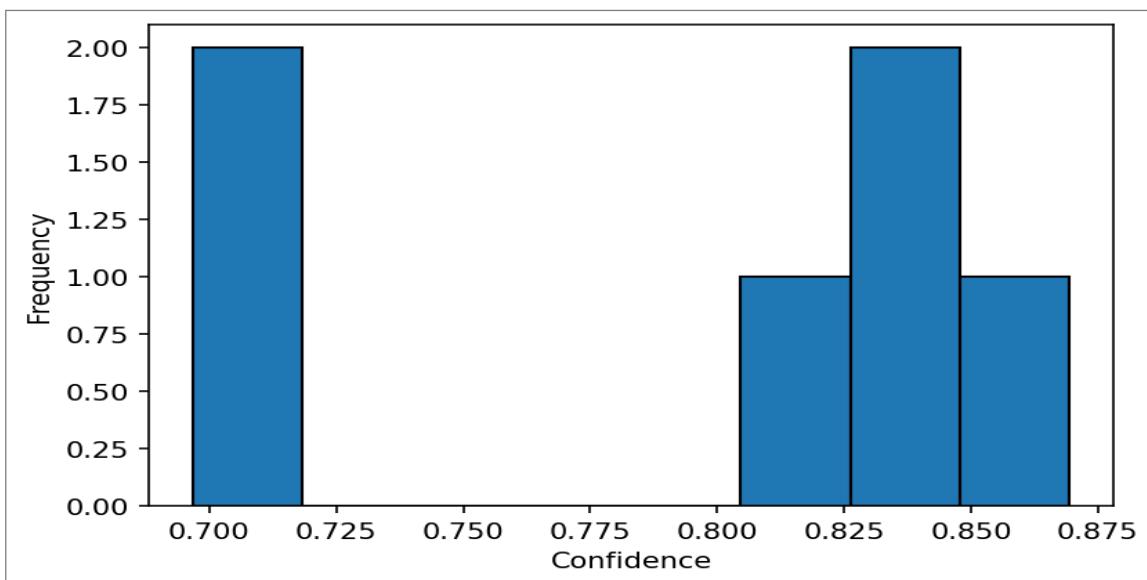
Confidence Histogram

Metric	Value
Total Defects	6
High Confidence (>=80%)	4
Medium Confidence (60-80%)	2
Low Confidence (<60%)	0
Average Confidence	79.62%
