Defect Analysis Report — CircuitGuard AI

Report ID:	RPT-0B9AF6FF
Generated On:	2025-11-12 06:46:21
Model:	ResNet50 (custom)
Device:	cpu

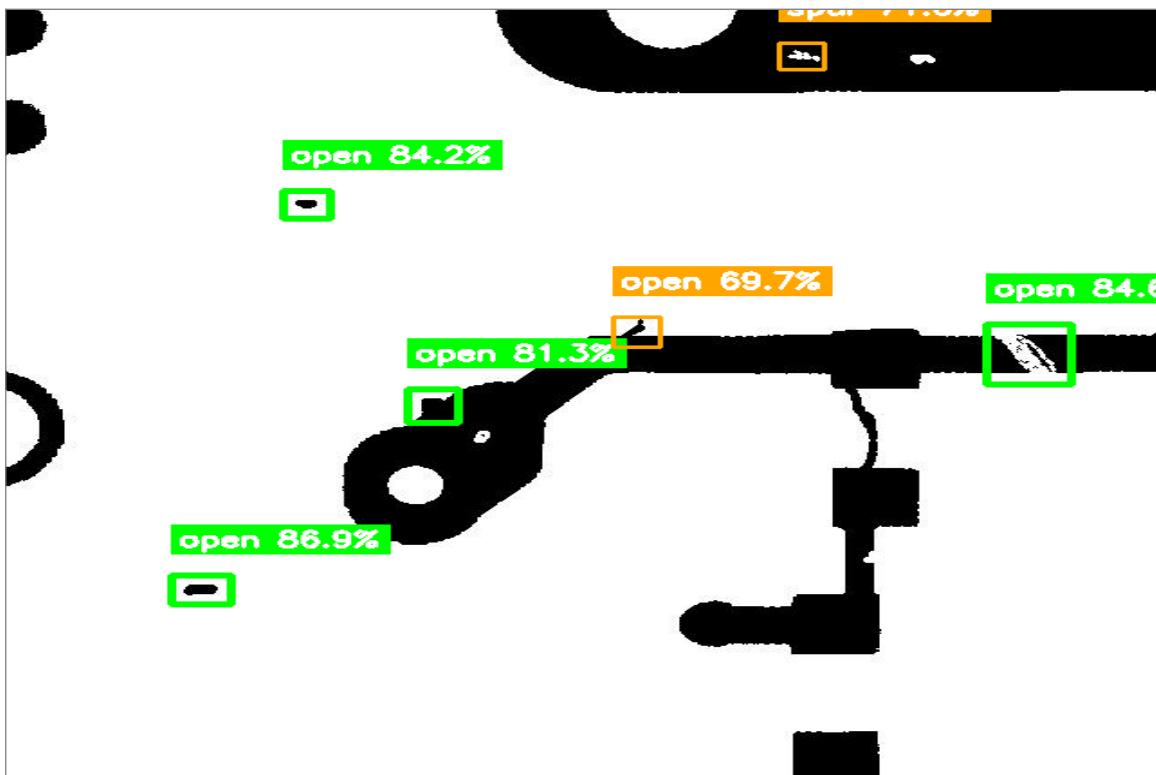
Annotated Results & Defect Details

ID	Type	Confidence	Position (X,Y)	Size (WxH)	Area (px ²)
#1	open	86.9%	(108,483)	33x24	217
#4	open	81.3%	(237,330)	28x28	200
#6	open	84.6%	(567,287)	47x50	824
#7	open	69.7%	(350,268)	26x25	148
#8	open	84.2%	(167,162)	26x23	124
#10	spur	71.0%	(441,39)	25x22	106

If no defects detected, lower diff threshold or min ROI area. Inspect high-confidence defects first.
