Defect Analysis Report — CircuitGuard AI

Report ID:	RPT-506B6FD5
Generated On:	2025-11-12 13:36:36
Model:	ResNet50 (custom)
Device:	cpu

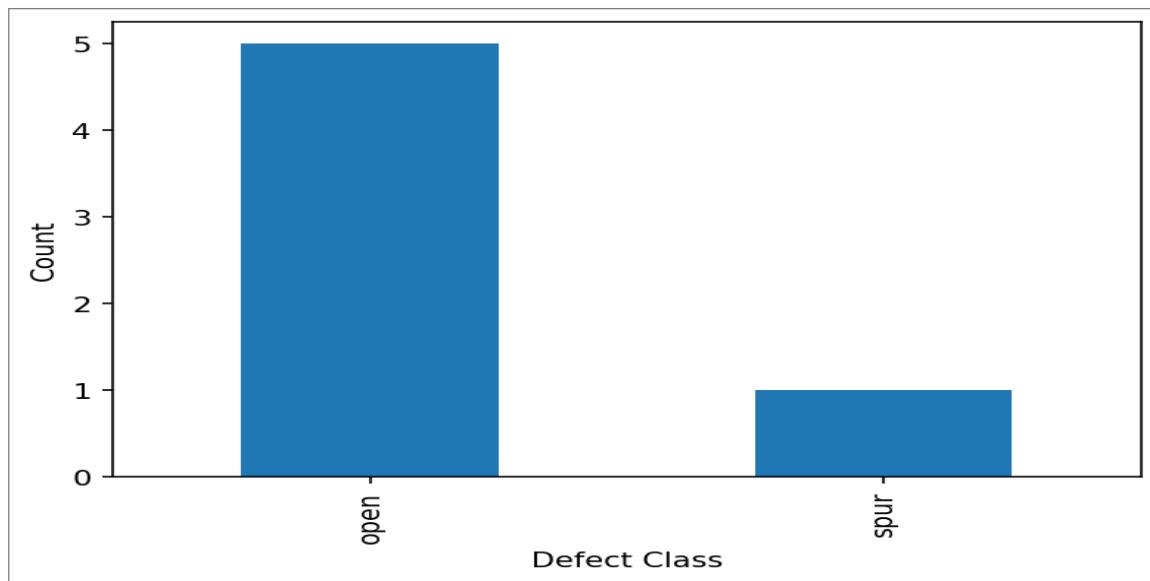
Defect Count by Class

Detected 6 defect(s). High:4, Medium:2, Low:0. Avg conf: 79.62%.

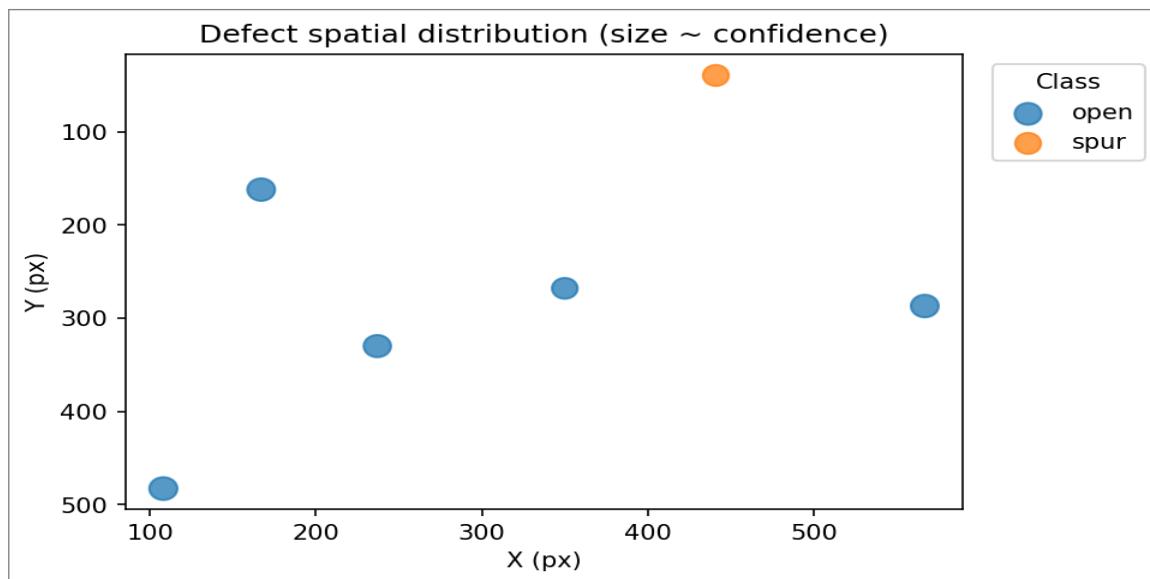
Spatial Distribution (size ~ confidence)

ID	Type	Confidence	Position (X,Y)	Size (WxH)	Area (px ²)
#1	open	86.9%	(108,483)	33x24	217
#4	open	81.3%	(237,330)	28x28	200
#6	open	84.6%	(567,287)	47x50	824
#7	open	69.7%	(350,268)	26x25	148
#8	open	84.2%	(167,162)	26x23	124
#10	spur	71.0%	(441,39)	25x22	106

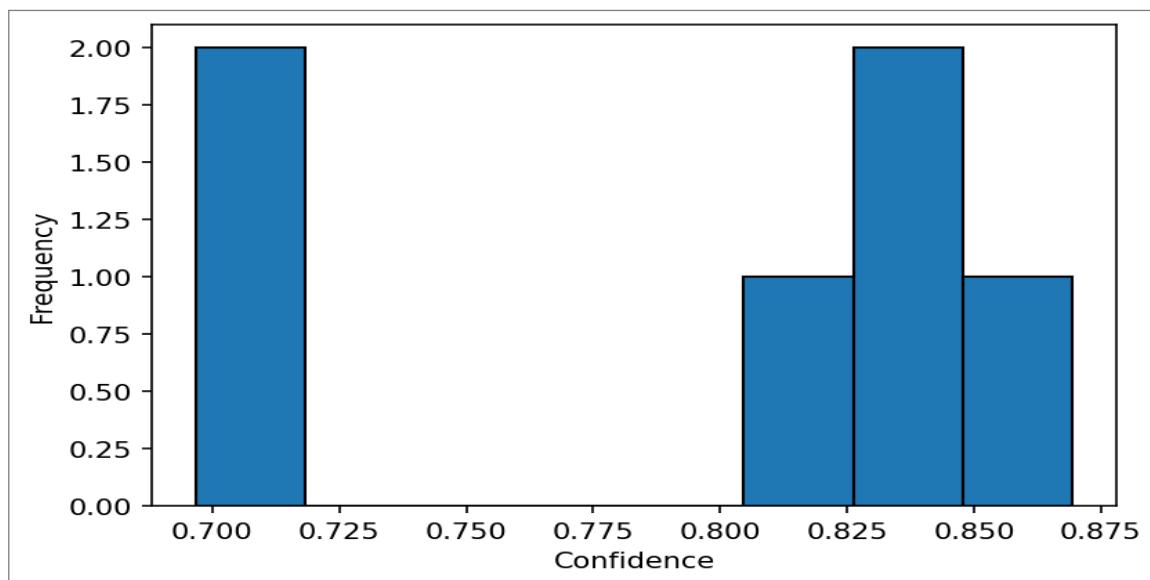
Confidence Histogram

Metric	Value
Total Defects	6
High Confidence (>=80%)	4
Medium Confidence (60-80%)	2
Low Confidence (<60%)	0
Average Confidence	79.62%
