GRAND SLAM DIESEL SERVICES
757-931-3331
GRANDSLAMDIESEL@GMAIL.COM

2026 Engine Survey Report

BOAT NAME: *Intoxication*
BOAT MANUFACTURER: *Jefferson*

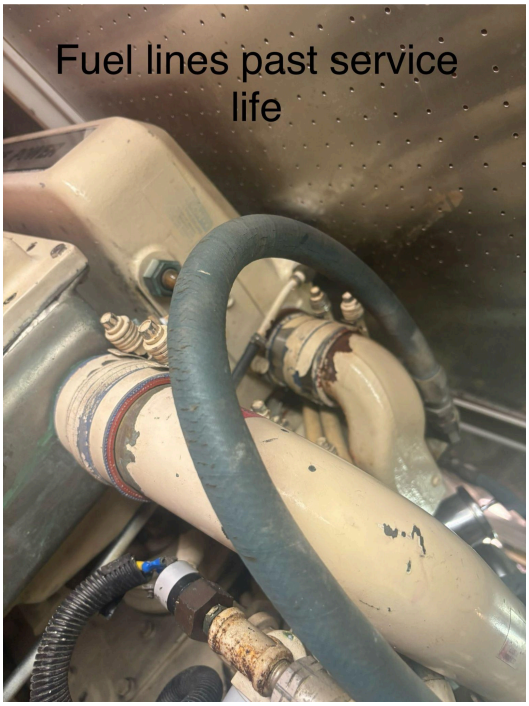
Fuel lines past service
life

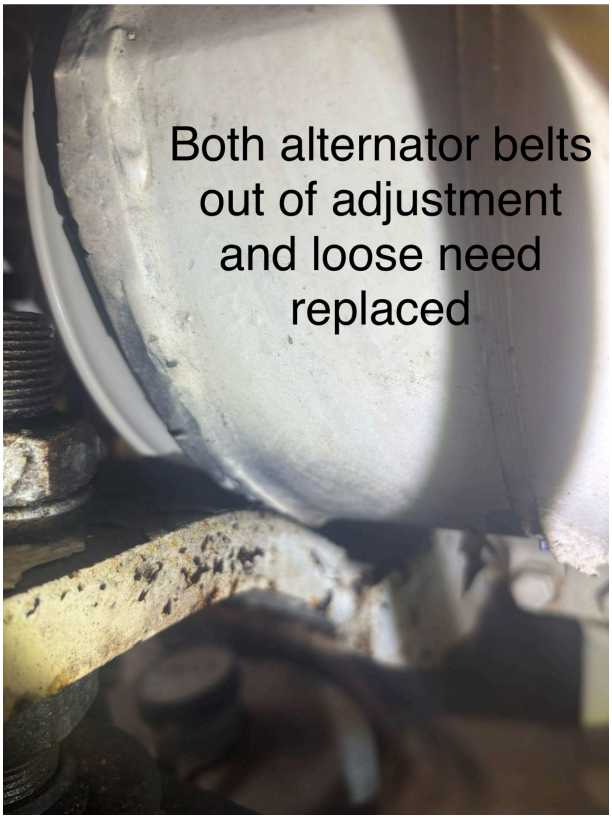
Both alternator belts
out of adjustment
and loose need
replaced

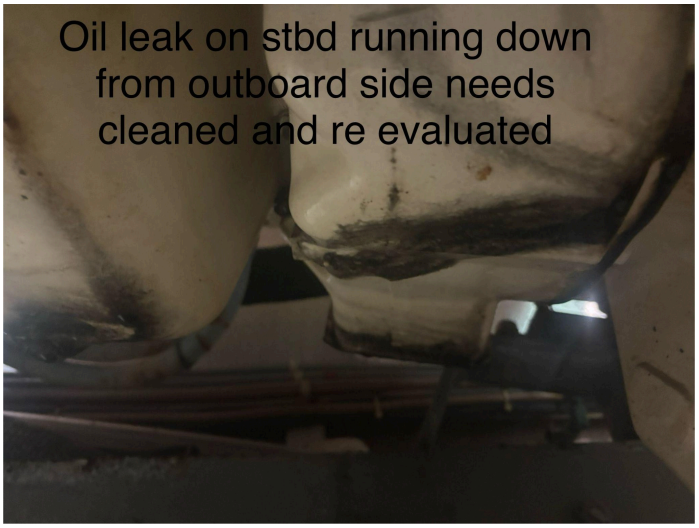
Oil leak on stbd running down
from outboard side needs
cleaned and re evaluated

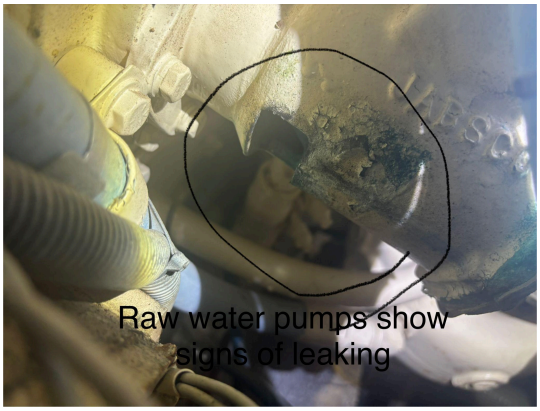
Raw water pumps show
signs of leaking

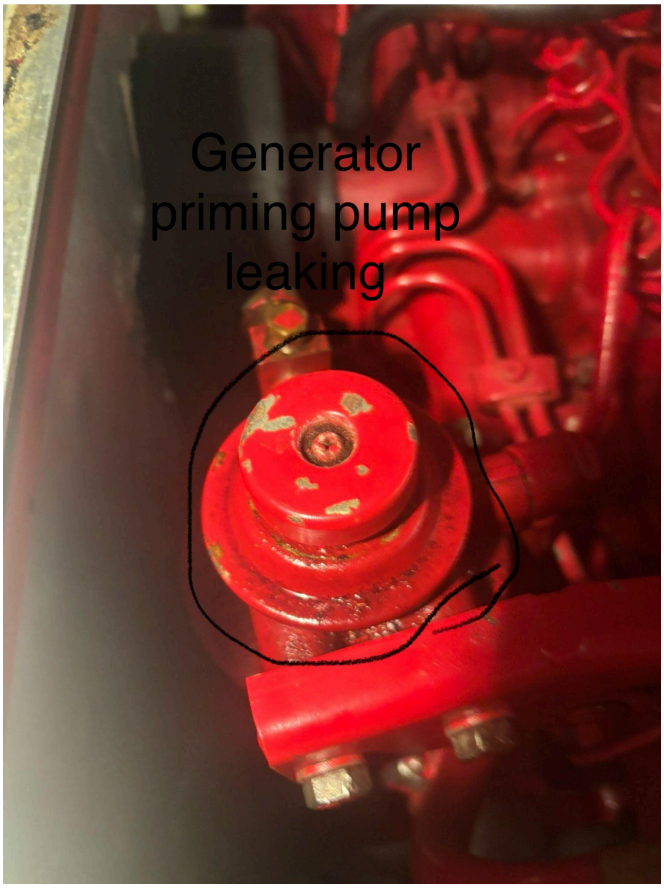
Generator
priming pump
leaking

-Coolant was low and dirty recommend flushing and filling with new coolant
- Fuel Priming pump on generator was leaking fuel recommend taking off and resealing or replacing
