## Examples of how to NOT data center!

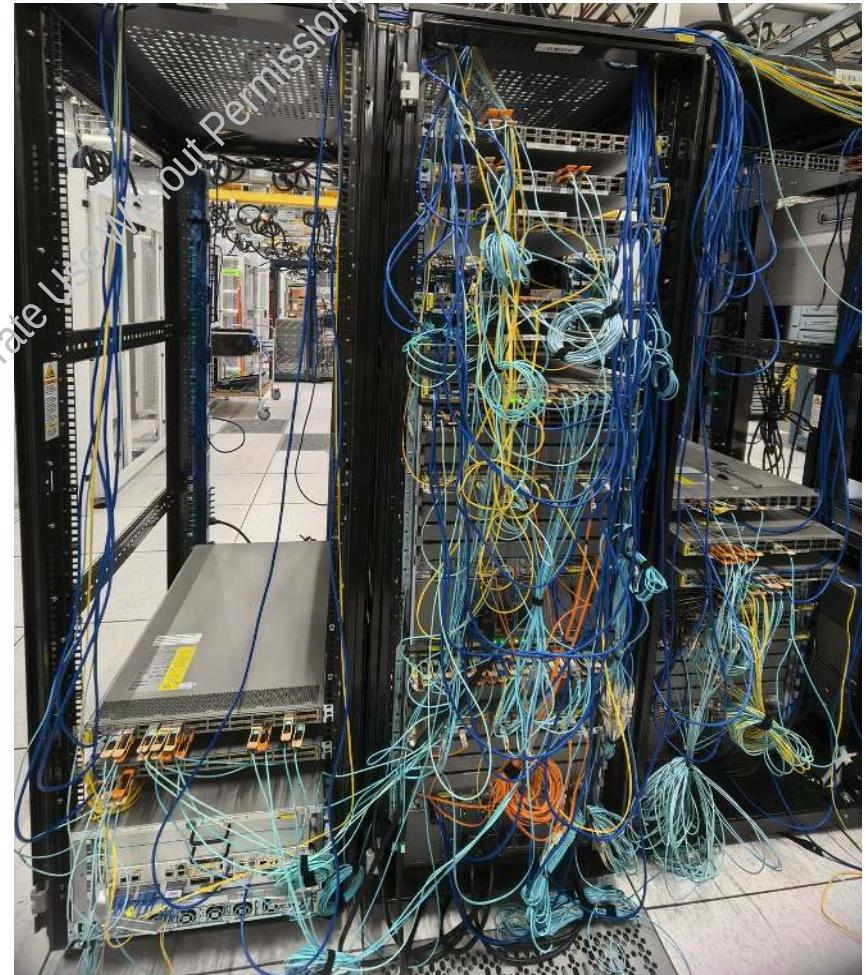
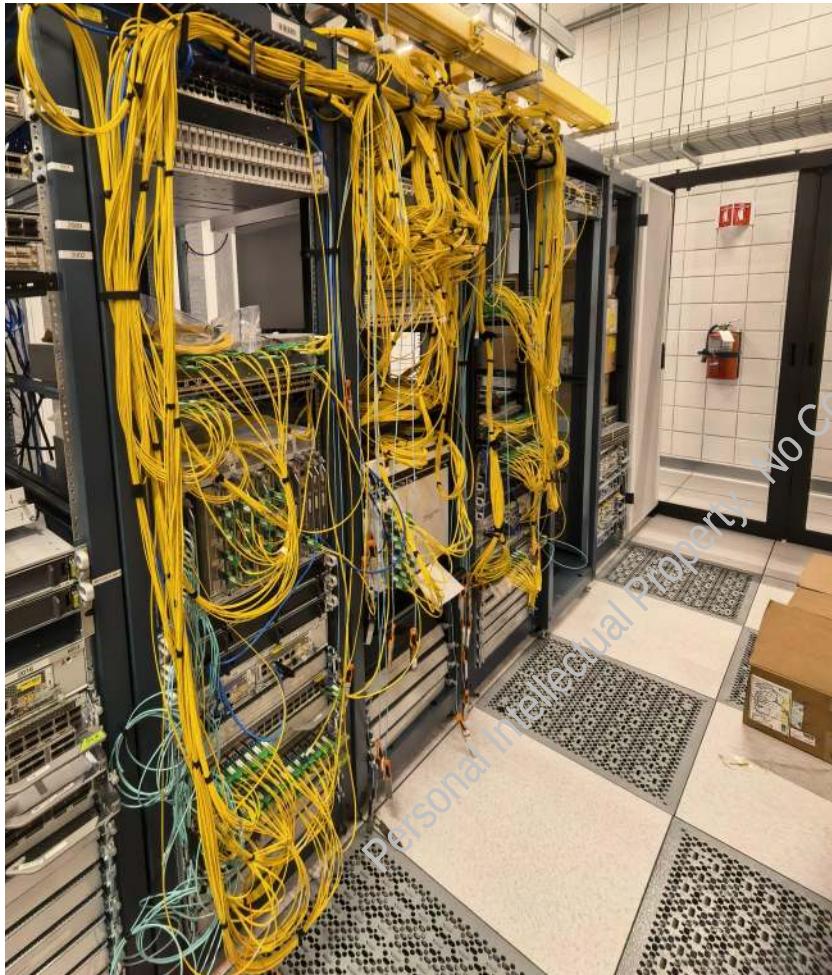
Examples of bad air flow ventilation racking

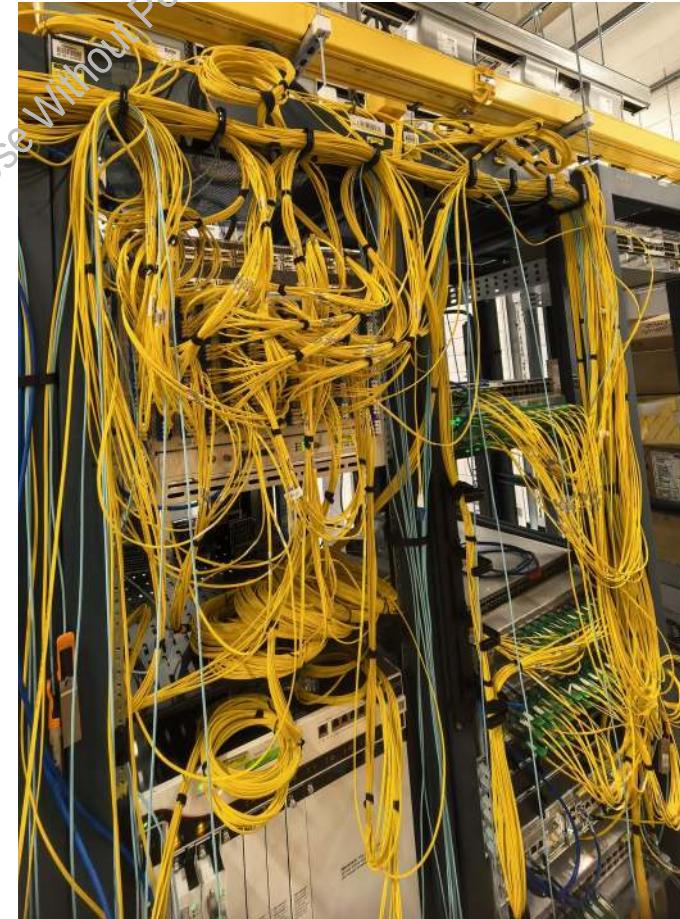
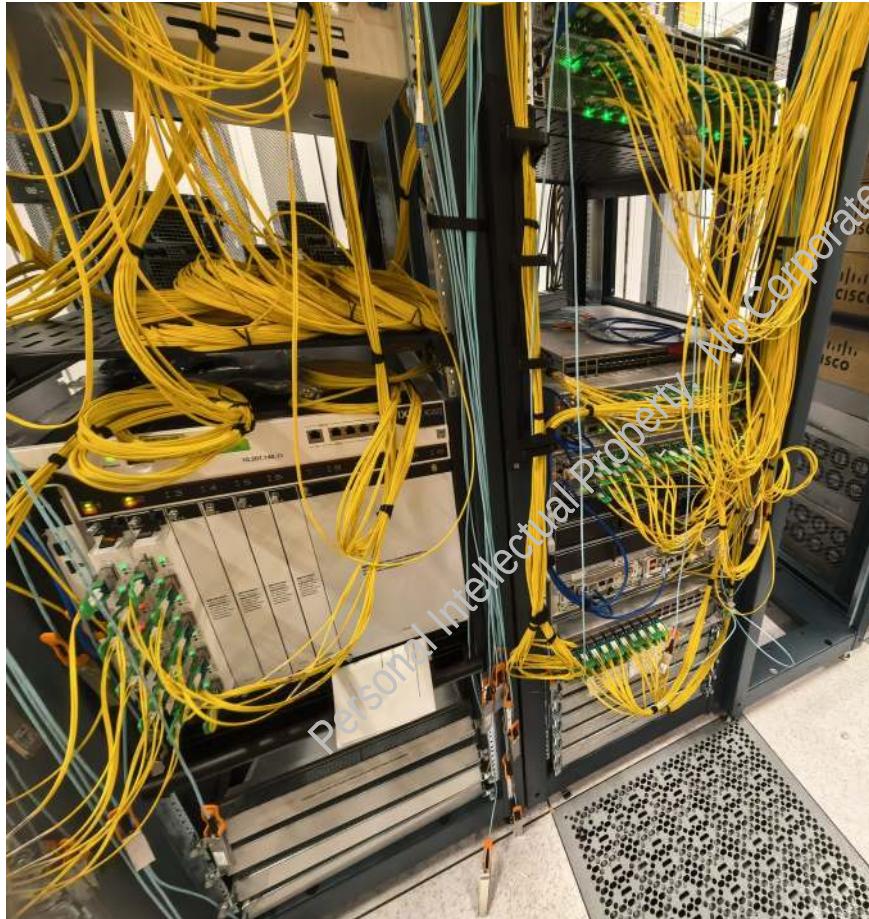
Just bad cabling management  
No Use of cable management trays  
Inappropriate cable length procurement for use

Just bad cabling management

Inappropriate cable length procurement for use

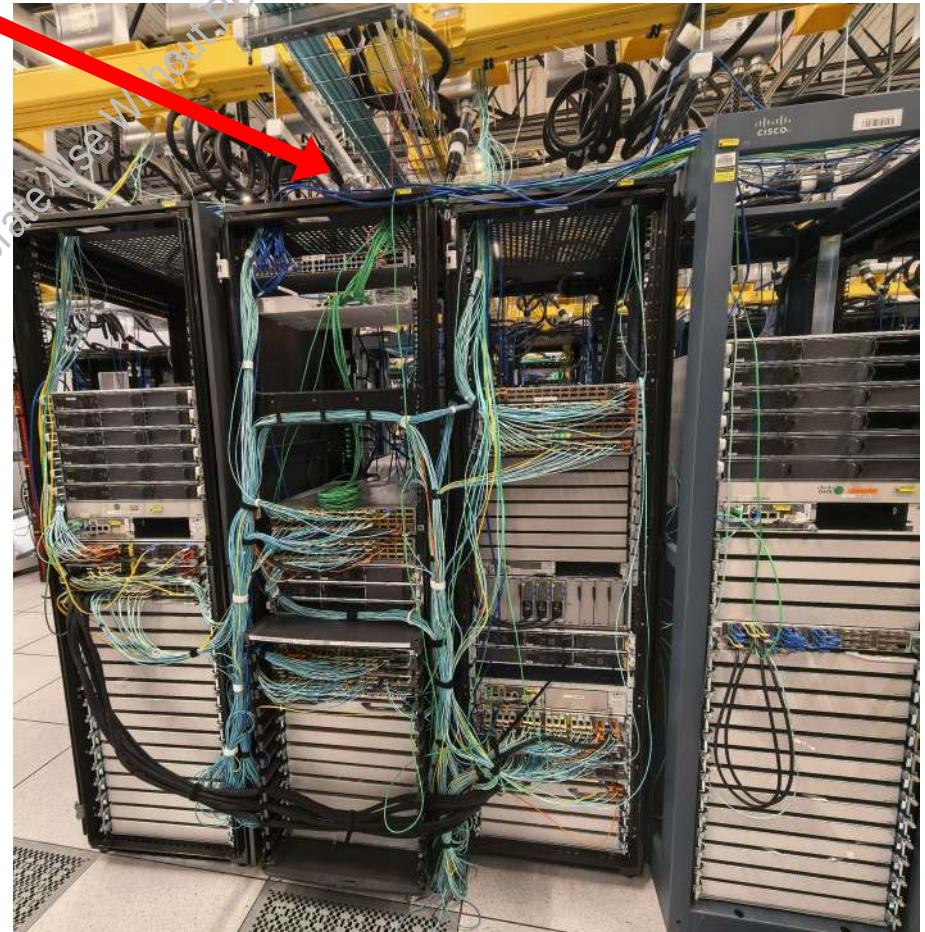
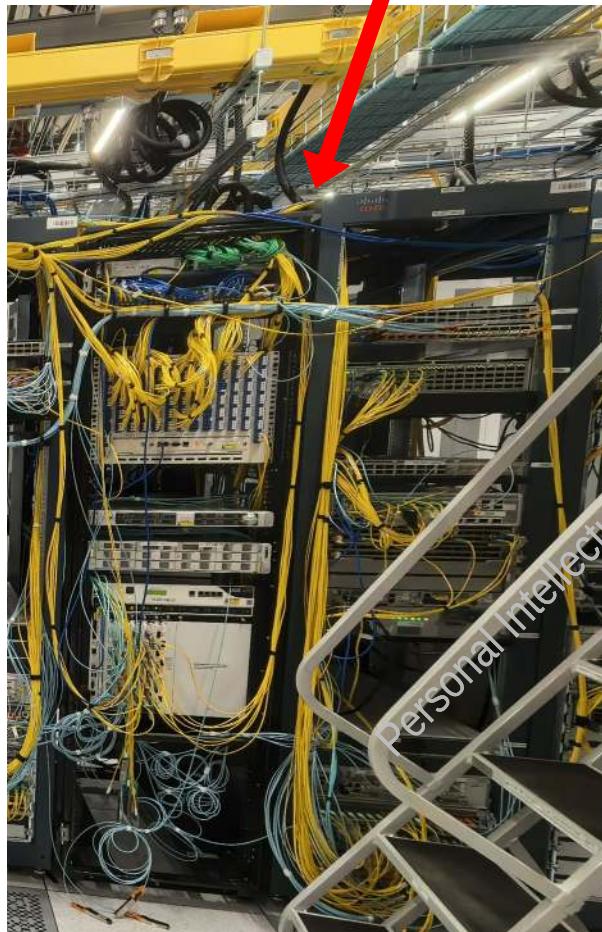
Inappropriate rack/cabinet/equipment combination/configuration, it should be flushed to the front or back or receded to allow for the cabling or utilization of management trays

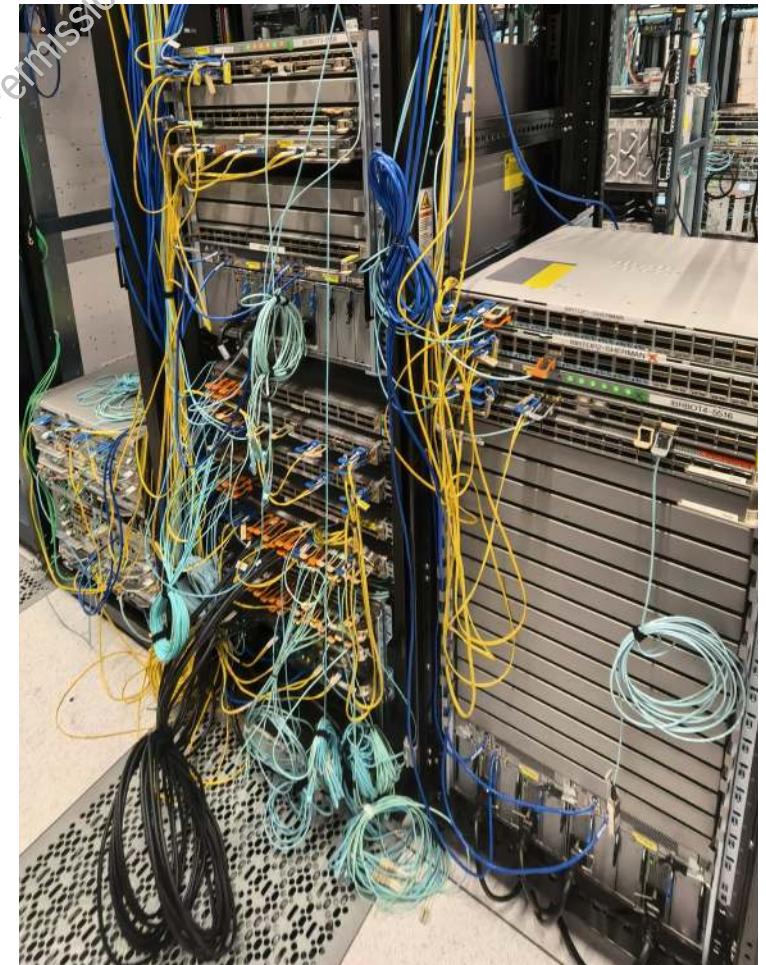
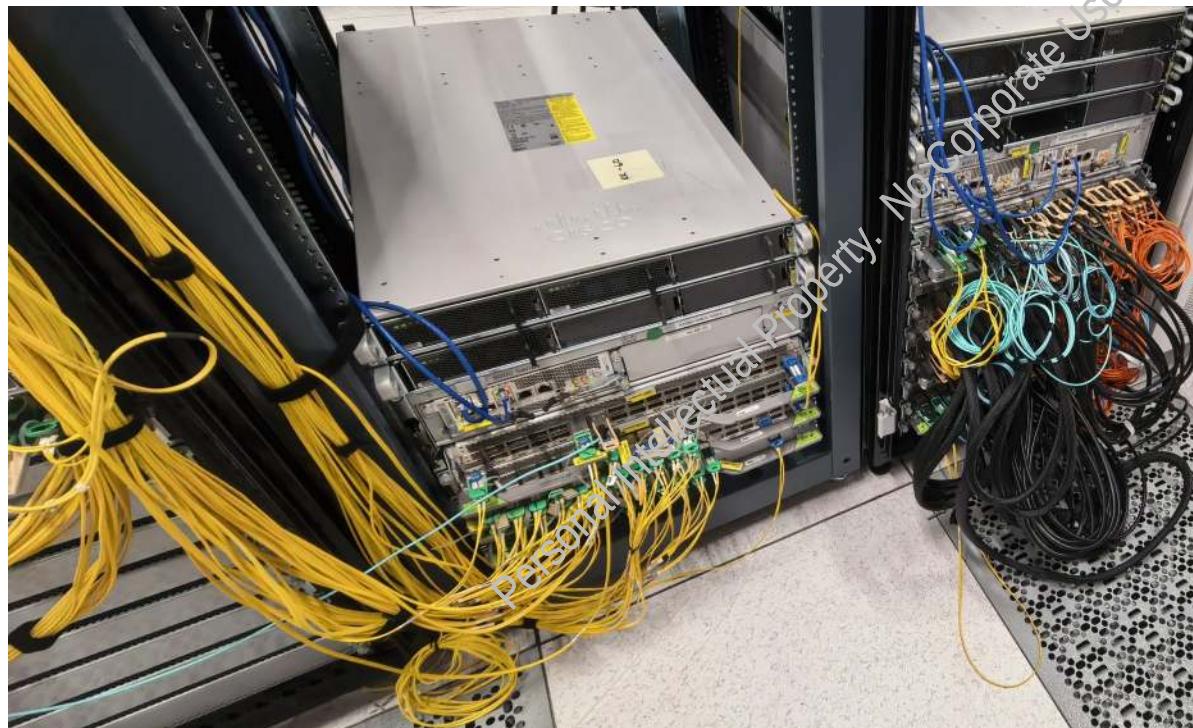
Just bad cabling management  
No Use of cable management trays  
Inappropriate cable length procurement for use  
Obstruction (cabinet) to cable tray access (NIGHTMARE for running cables)

Just bad cabling management  
No Use of cable management trays  
Inappropriate cable length procurement for use  
Obstruction of already limited – only 2 tile space, BAD design practice

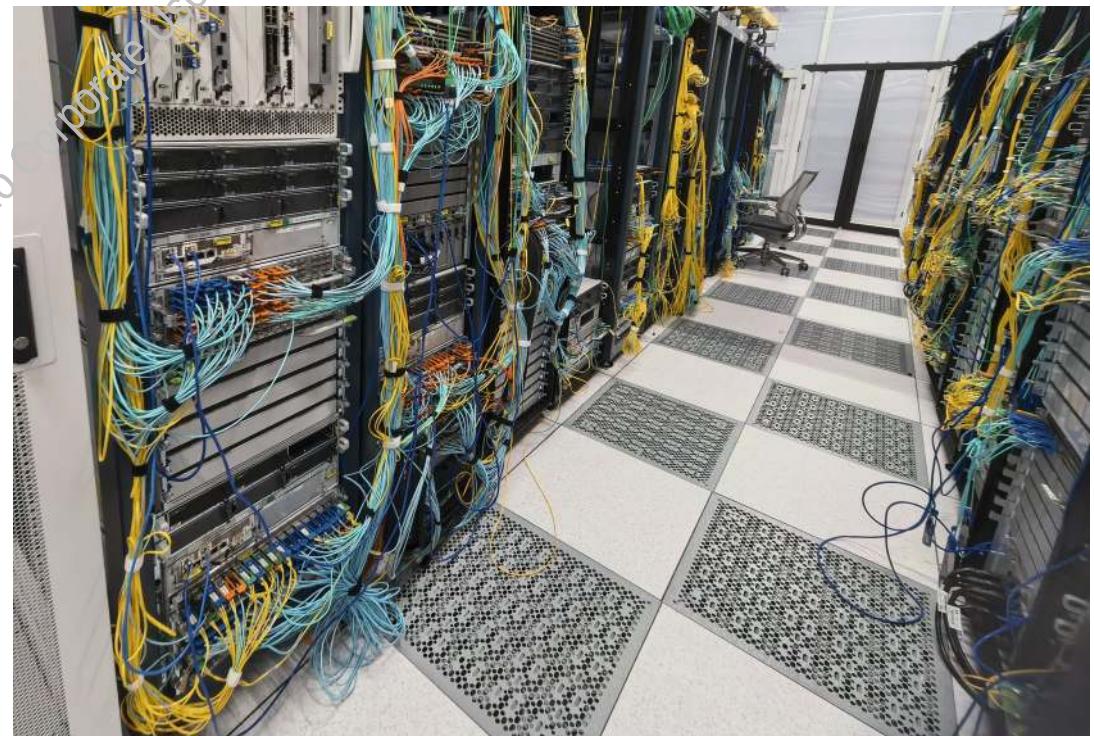
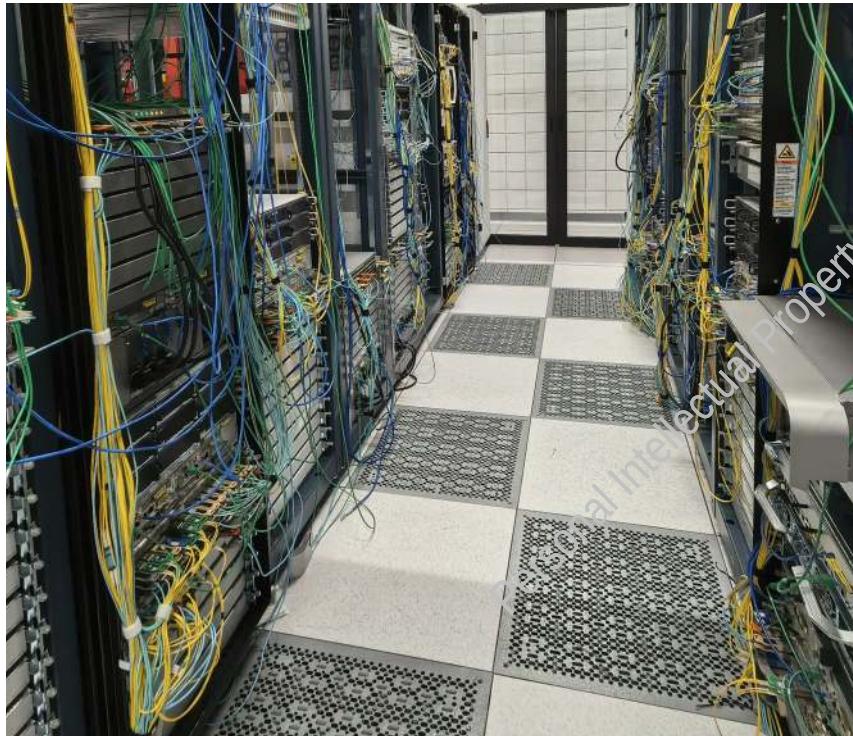
BAD design practice – only 2 tile space:

barely any room for maneuvering crash carts, equipment pallet jacks, etc...  
checkered perforated airflow tiles, budget constraints approach for equipment airflow utilization rather than full solid rows of perforated tiles for adequate airflow/cooling
