Concern Resolution Process for In-house Manufacturing

"To eliminate the concern of Back door Sagging & rattle noise in Scorpio W110 Model"

Mahindra and Mahindra Ltd, Nasik Plant, Scorpio –Xylo TCF.

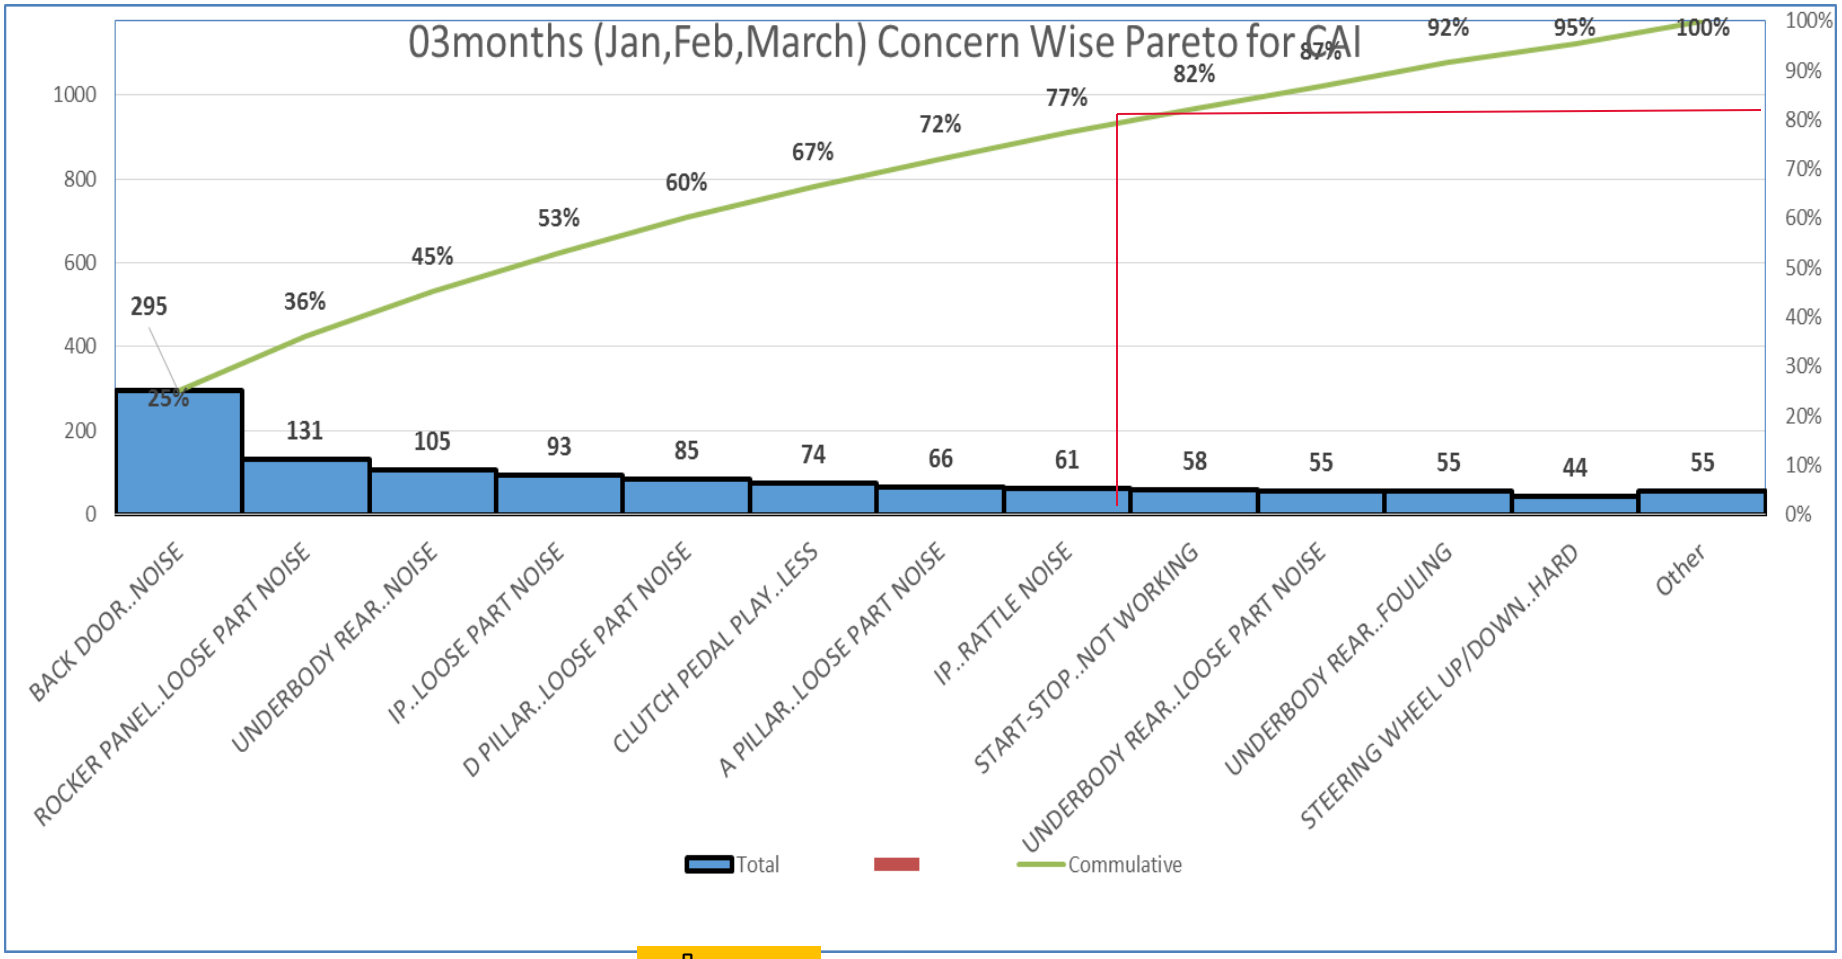
Pareto Analysis for CAI Squeak & Rattle Stage of CAI

Inference – Top defect in Incidences data taken from August -2019

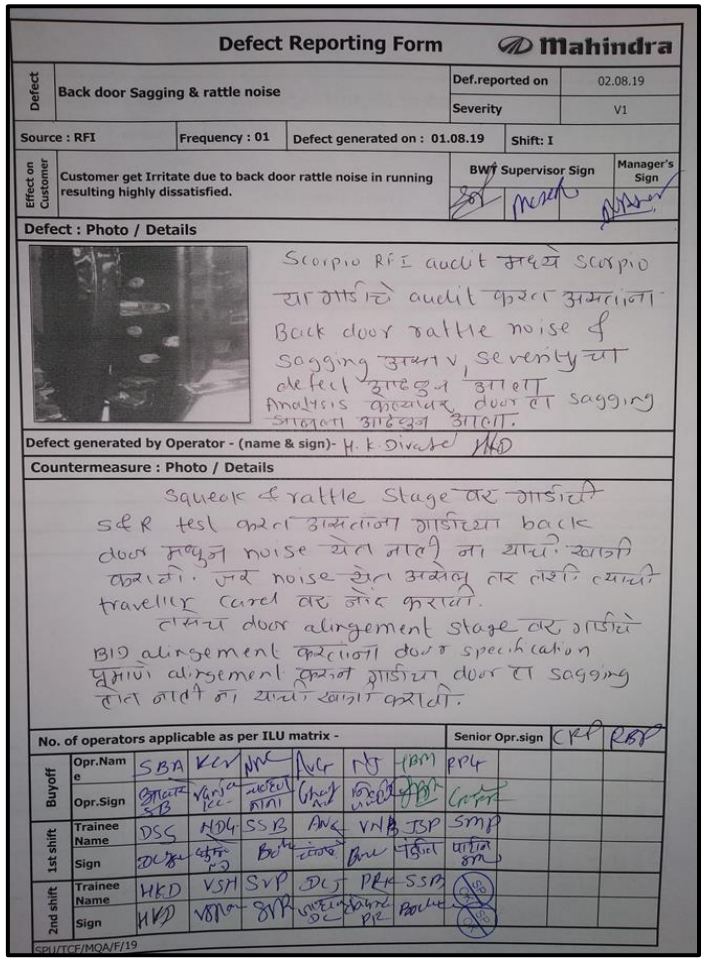
Defect	Back door Sagging & rattle noise	Def.reported on	02.08.19
		Severity	V1

Effect on Customer	Customer get Irritate due to back door rattle noise in running resulting highly dissatisfied.	BWT Supervisor Sign	Manager's Sign

Scorpio RFI audit मध्ये Scorpio या गाडीचे audit करत असताना Back door rattle noise & sagging असा V, Severity चा defect आढळून आला. Analysis करताना, door ला sagging असल्या आढळून आला.

Squeak & rattle Stage वर गाडीची S&R test करत असताना गाडीचा back door मधून noise येत नाही ना याची खात्री करावी. जर noise येत असेल तर तशी त्याची traveller card वर नोंद करावी.

तसेच door alingement stage वर गाडीचे BIO alingement करताना door specification प्रमाणे alingement करून गाडीचा door ला sagging होत नाही ना याची खात्री करावी.

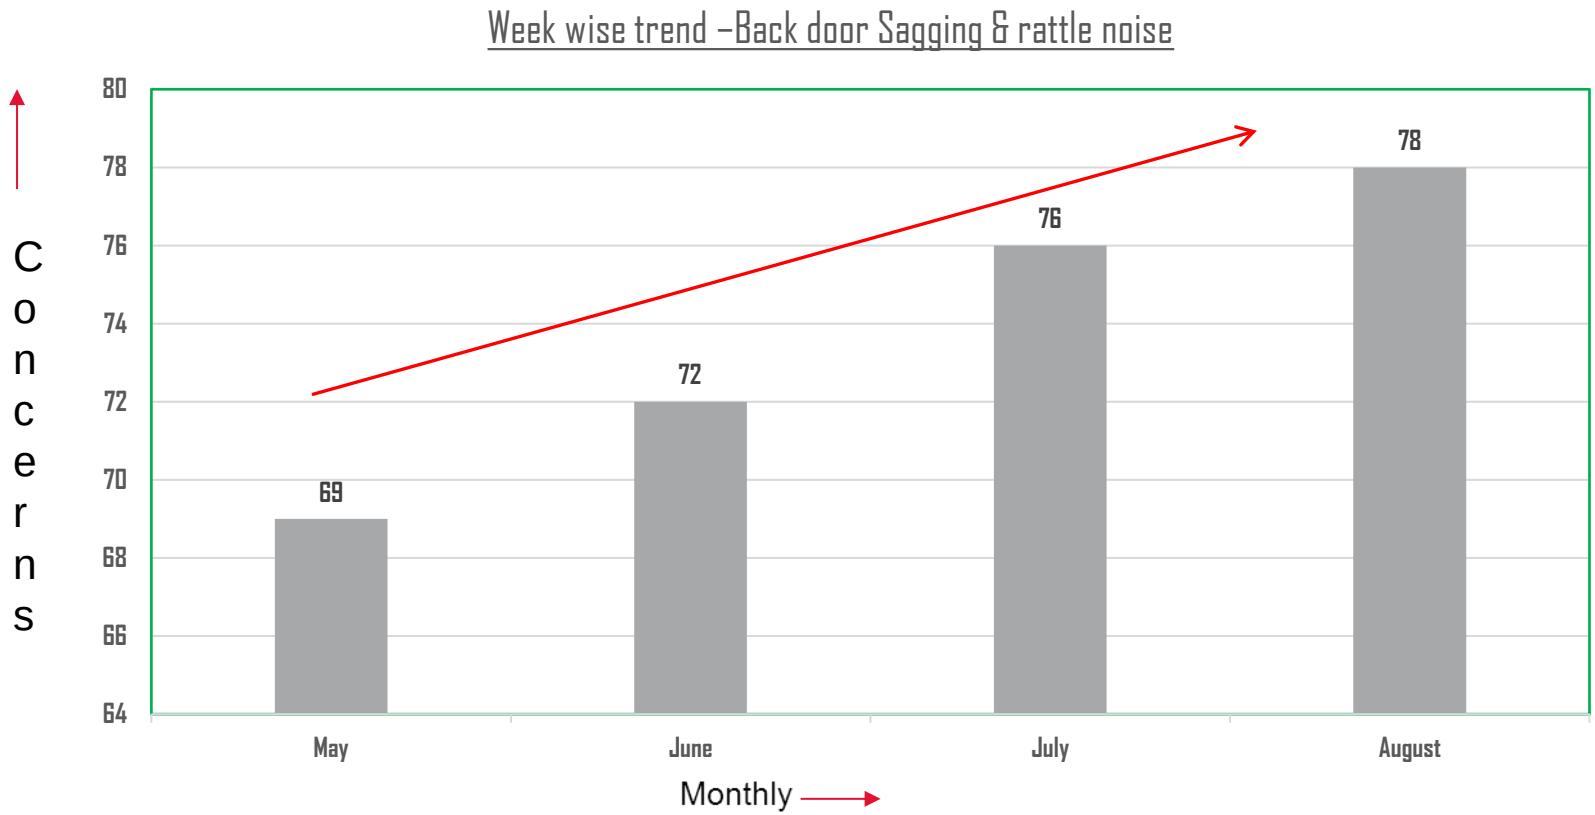
3. Understand the current situation

Inference – Defect rate increases Monthly, with Avg 74 incidence per month.

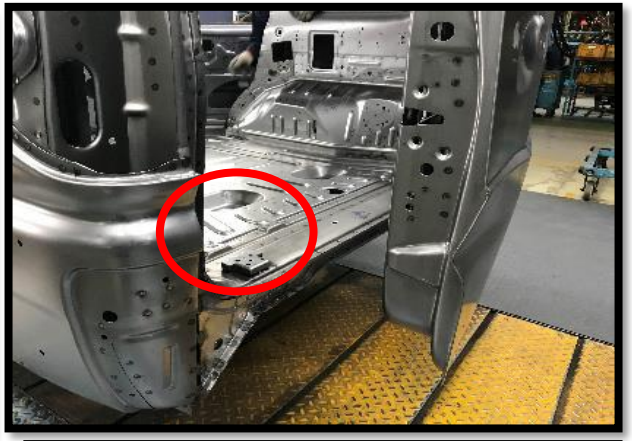
After analysing 50 BIW at TCF fitment stage found sagging of 0.8 to 1.4 mm to Lh side.

So this hypothesis is valid.

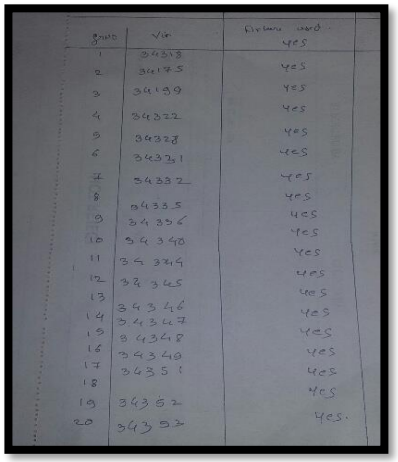
Fixture used on line for striker fitment for 100% cases .
so it is not a valid cause.

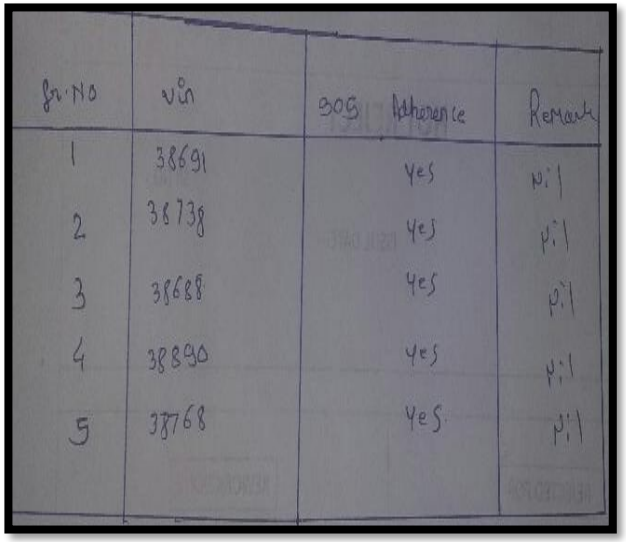
- 5 Samples of door panel checked on Gauge no Discrepancy observed.

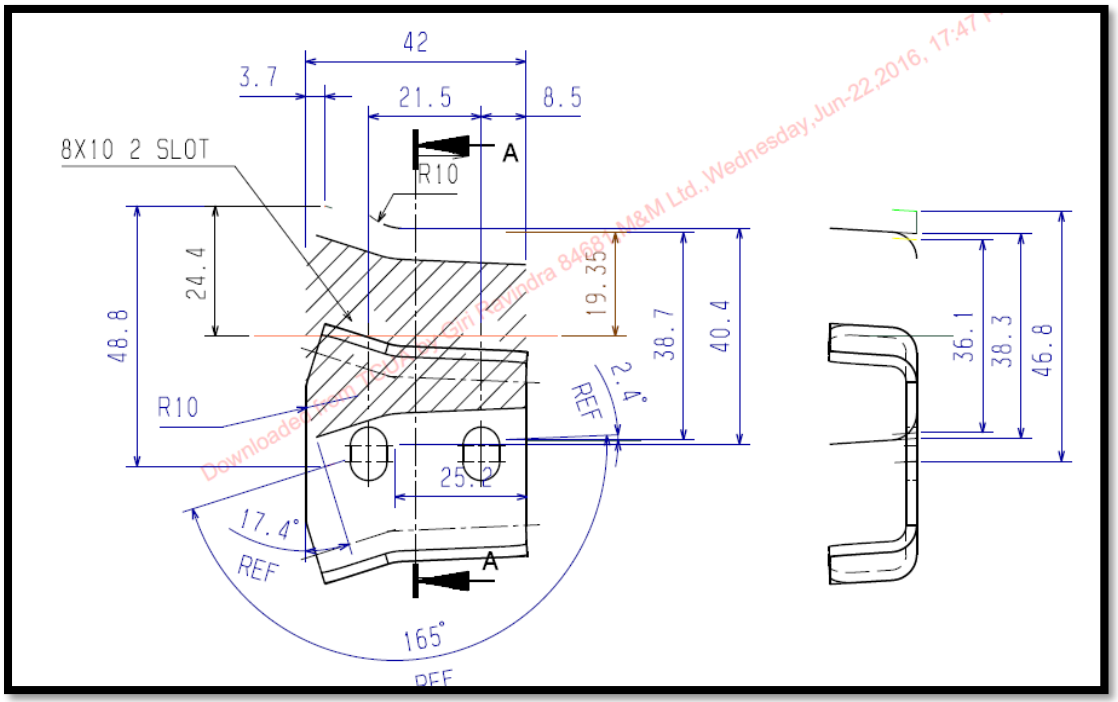
- No variation observed in Female bracket inner opening hence it is invalid cause.

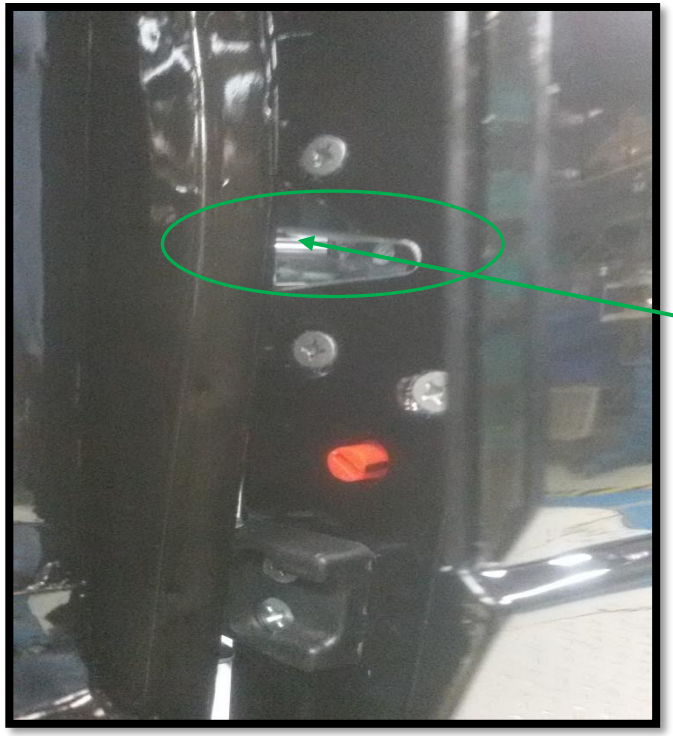
Observations :
Fixture used on line for striker fitment for 100% cases so it is not a valid.
hence this hypothesis is Invalid.

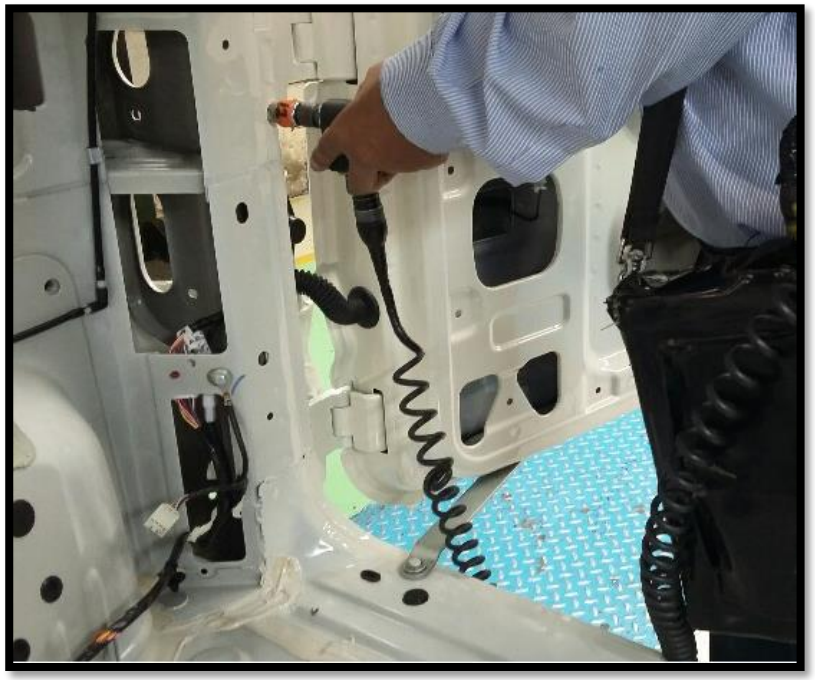
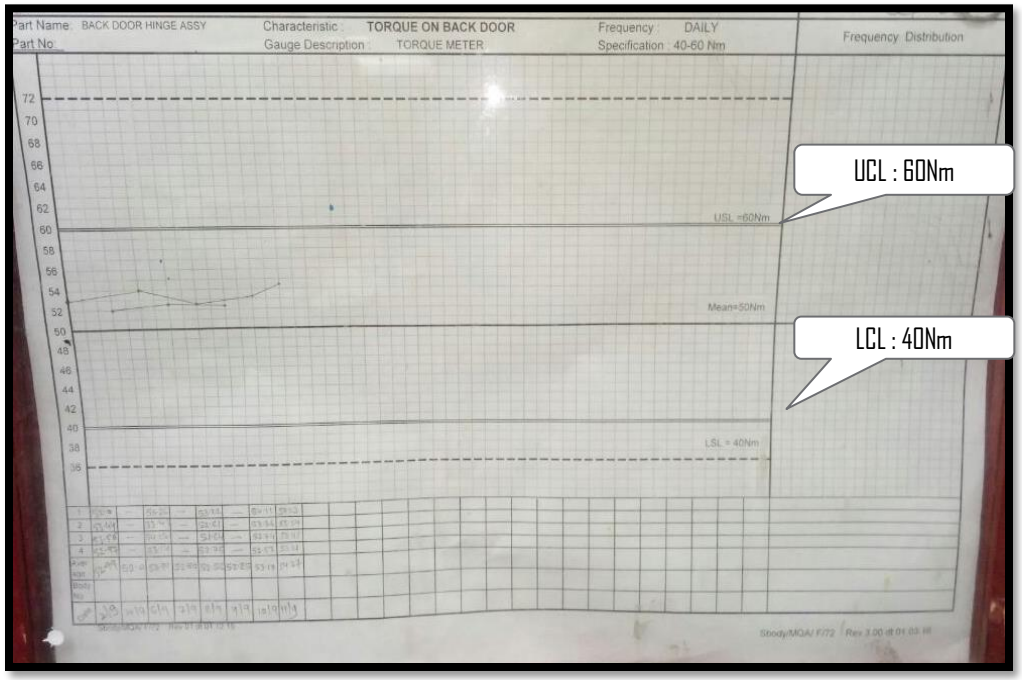
15 vehicles audited and observed no discrepancy.

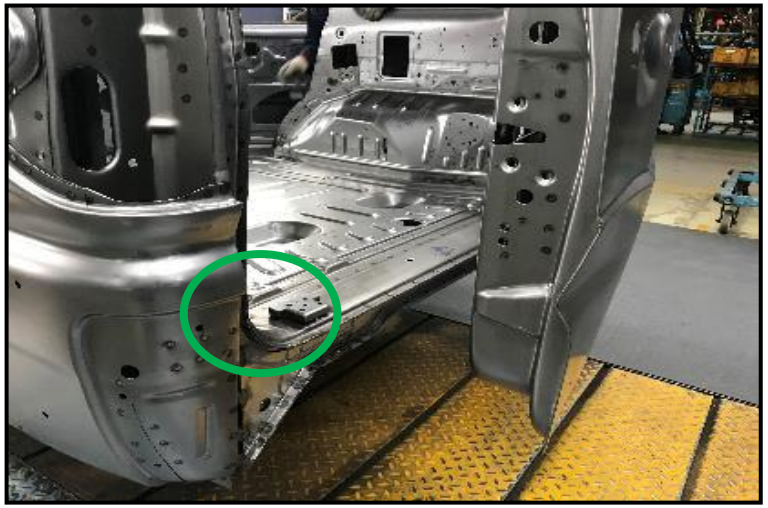
After analysing 185 BIW at TCF fitment stage found sagging of 0.8 to 1.4 mm to Lh side

Compensation of 1 mm added at seal gap and same checked by No-Go gauge at body shop

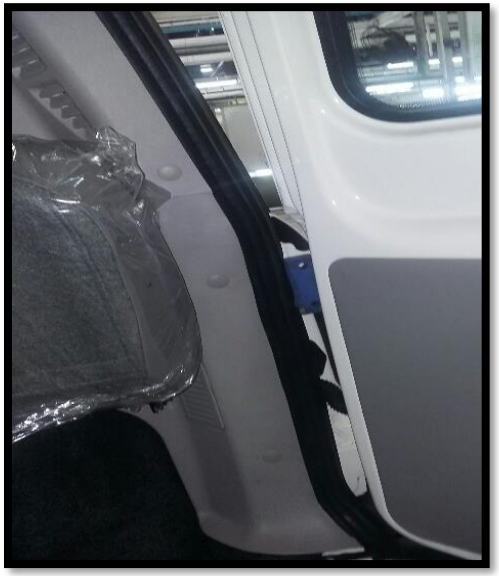
Block used in hinge for back door alignment rework

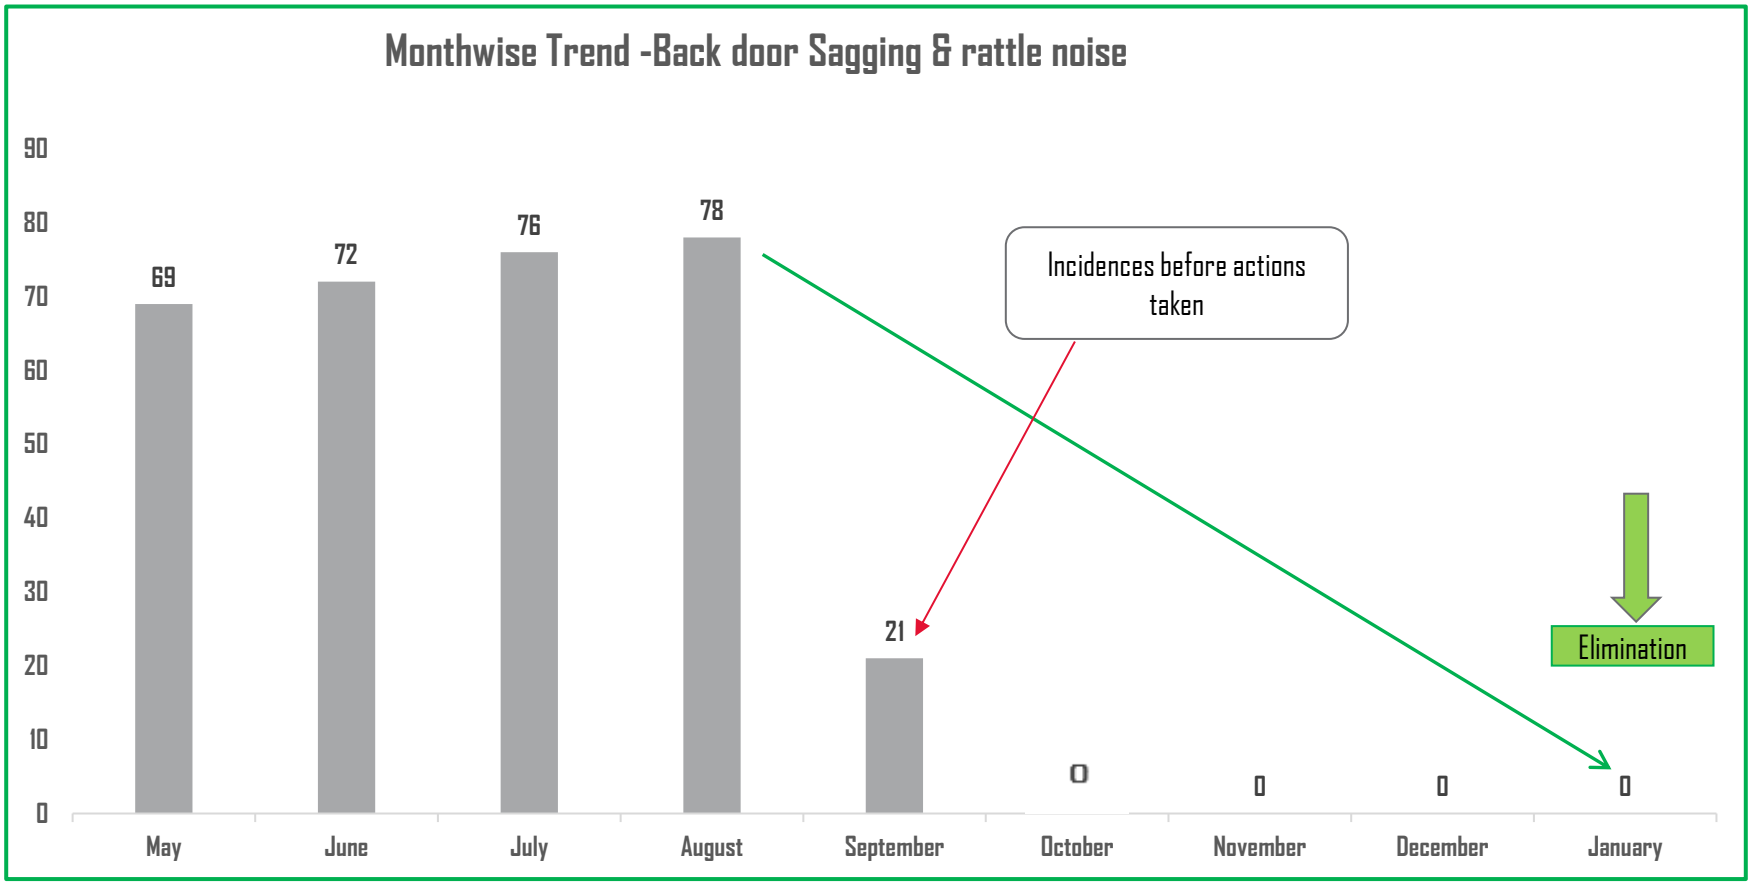
7.1 Verify Results:

03 Month data monitored after taking actions , 98 % reduction achieved & actions are effective & sustained.
