Vulnerability Title: Path traversal vulnerability in TP-Link IPC

Required Affected Versions: 1.0.8 Build 210105 Rel.65035n

Tested Platform: TL-IPC42C-4 5.0

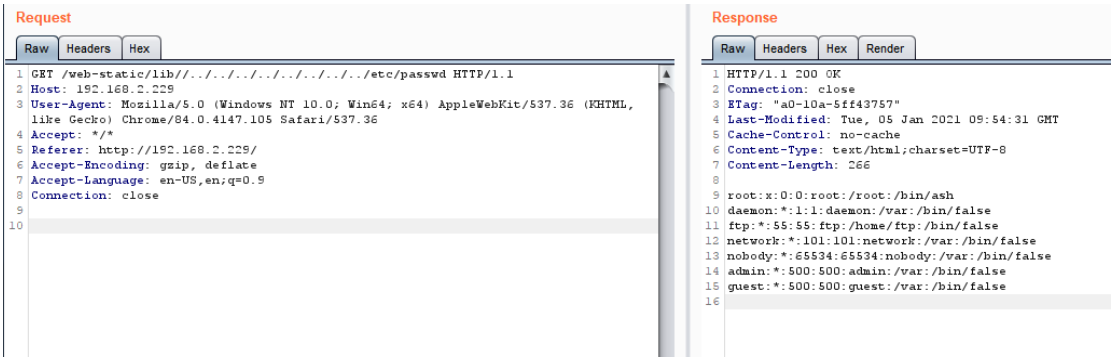
Access the etc/passwd file

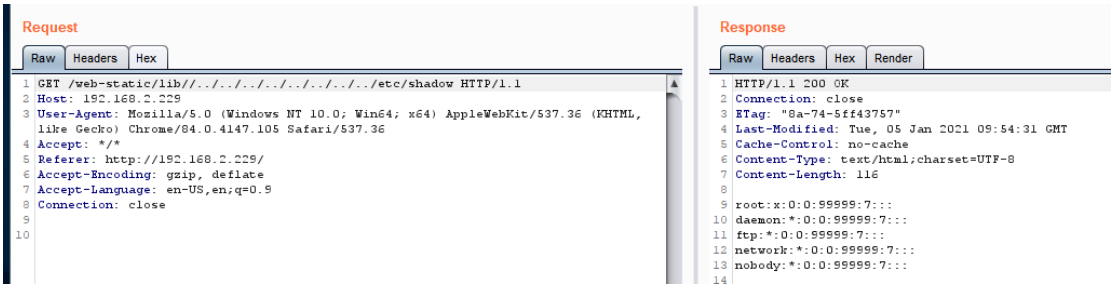
Access the etc/shadow file
