BOM CHECK (automated - verify before acting)

ECONOMISER ASSEMBLY

DRG NO : EC-13-GA-001
DRG REV : D
SCALE : NTS SIZE : A3
SAMPLE (SYNTHETIC) DRAWING

BOM CHECK SUMMARY

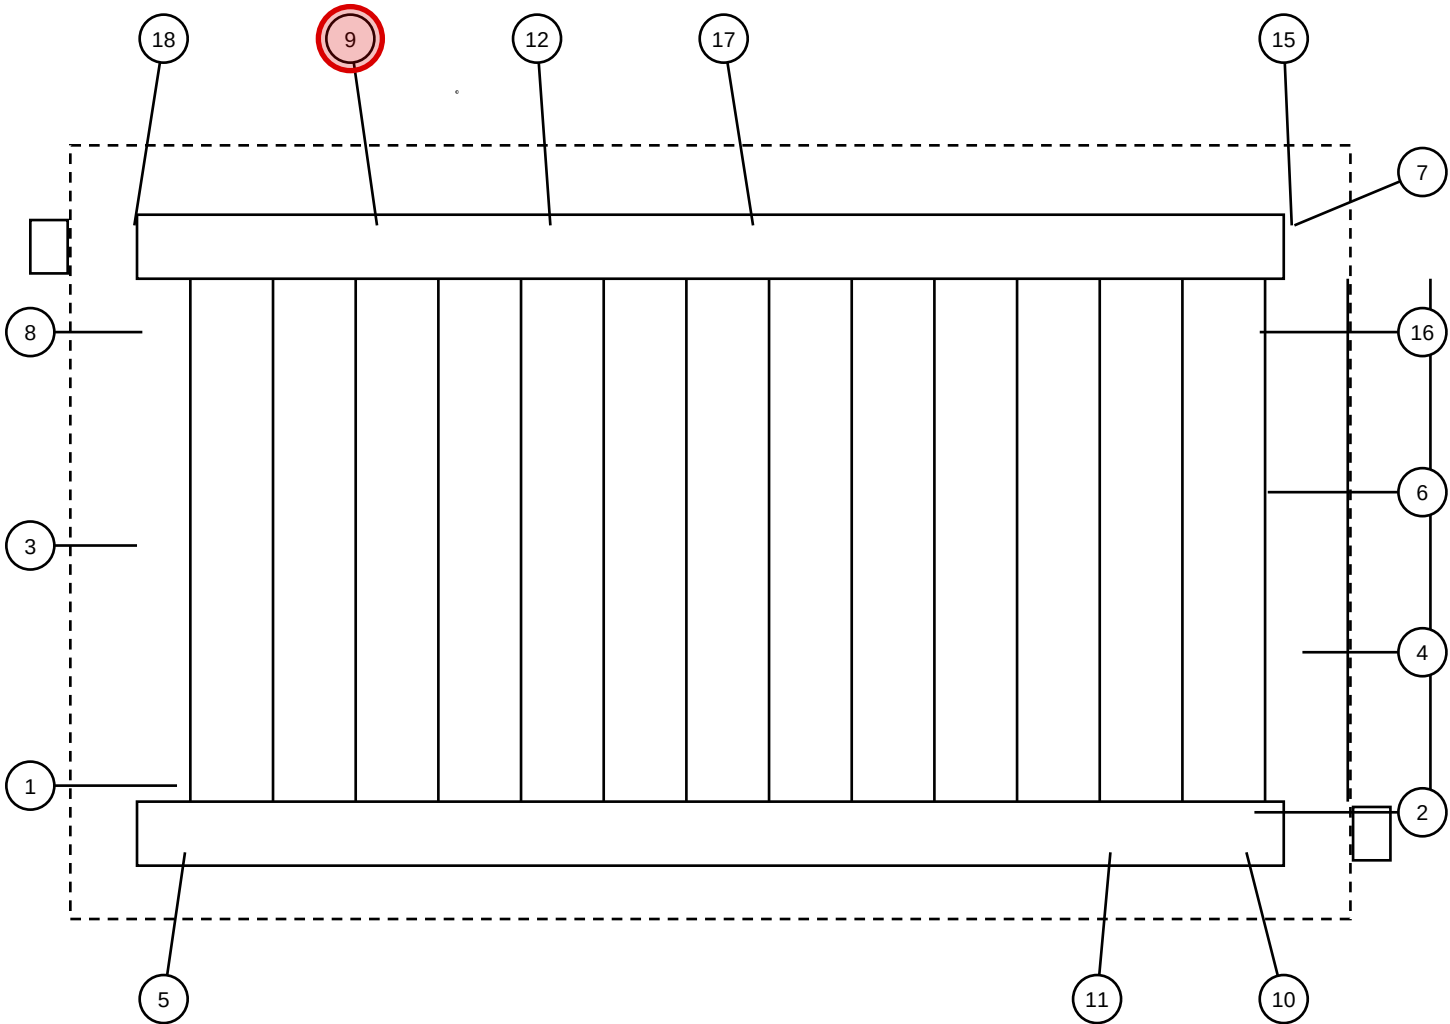
MISSING IN BOM
DUPLICATE IN BOM

QTY: dwg 1 / BOM 2

[RED] Item 9 'DRAIN VALVE 25 NB' (qty 2) is on the drawing but has no BOM line
[ORANGE] Item 16: quantity differs (drawing 1, BOM 2)
[YELLOW] BOM row 25 'Soot blower, retractable' has no matching item on the drawing (extra, or from another revision)
[YELLOW] BOM row 26 'Vent valve 15 NB' repeats item 10 (already covered by BOM row 14)
