ECONOMISER ASSEMBLY

DRG NO : EC-13-GA-001
DRG REV : D
SCALE : NTS SIZE : A3
SAMPLE (SYNTHETIC) DRAWING

BOM CHECK SUMMARY

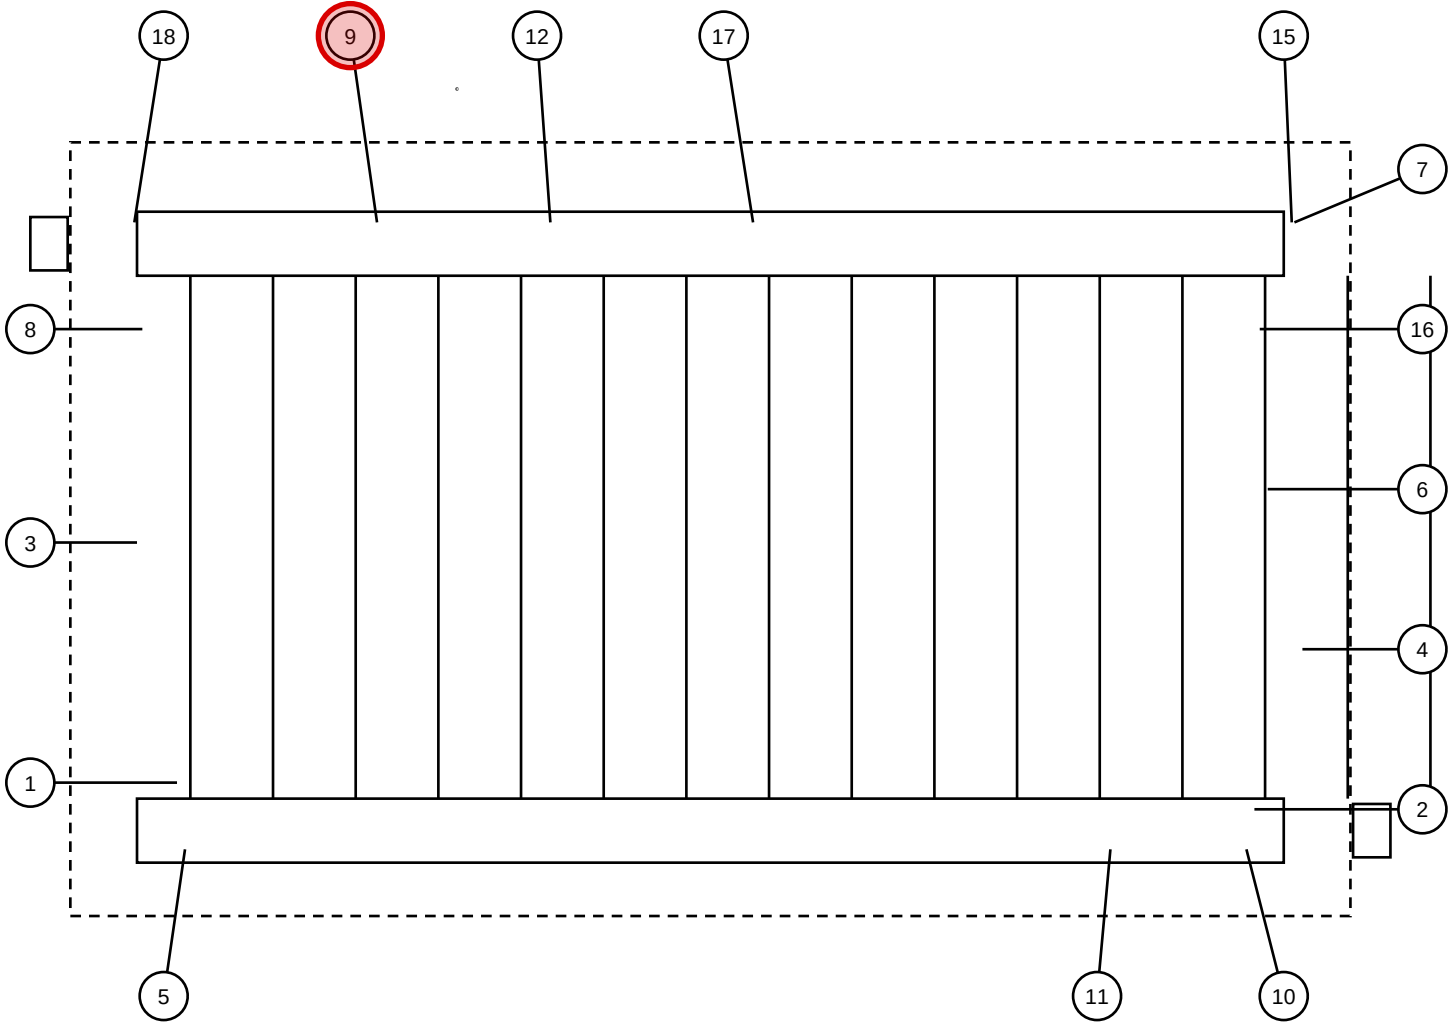
MISSING IN BOM
DUPLICATE IN BOM

QTY: dwg 1 / BOM 2

[RED] Item 9 'DRAIN VALVE 25 NB' (qty 2) is on the drawing but has no BOM line
[ORANGE] Item 16: quantity differs (drawing 1, BOM 2)
[YELLOW] BOM row 25 'Soot blower, retractable' has no matching item on the drawing (extra, or from another revision)
[YELLOW] BOM row 26 'Vent valve 15 NB' repeats item 10 (already covered by BOM row 14)
