INSPECTION REPORT

INS-2026-00008 · Motor vehicle claim

CLAIM NUMBER
CLM-383573

VEHICLE
2015 Toyota Corolla Cross 1.8 · ND 420-191

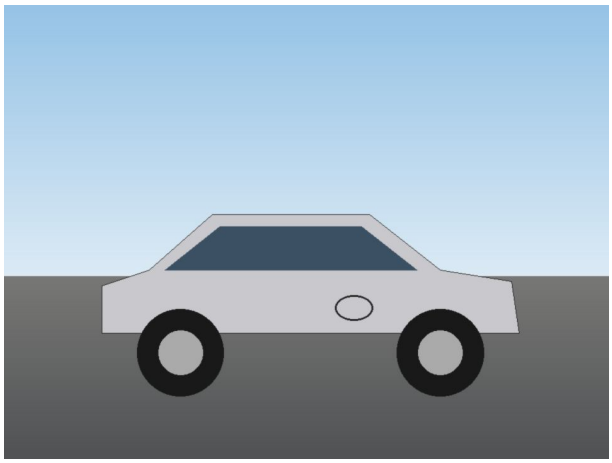
1. MODERATE - Dent, left rear door
2. MINOR - Scuff on right front wing

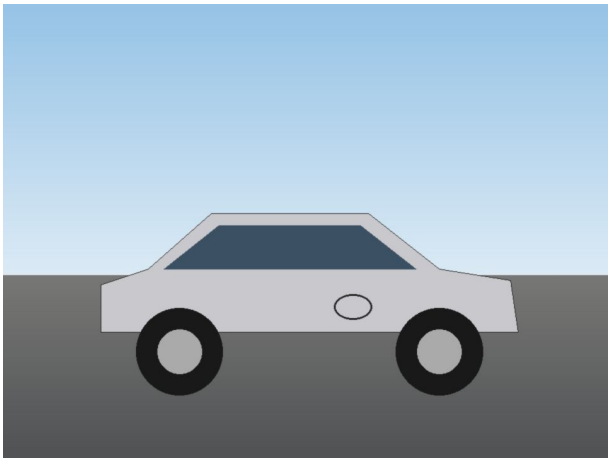
Bodywork free of undeclared damage	**Fail** Left rear door dented, paint scratched over 30 cm.
Windscreen condition	**Intact**
Head and tail lights working	**Pass**
