INSPECTION REPORT

INS-2026-00023 · Motor vehicle claim

VEHICLE
2017 Mercedes-Benz C200 · ND 748-530

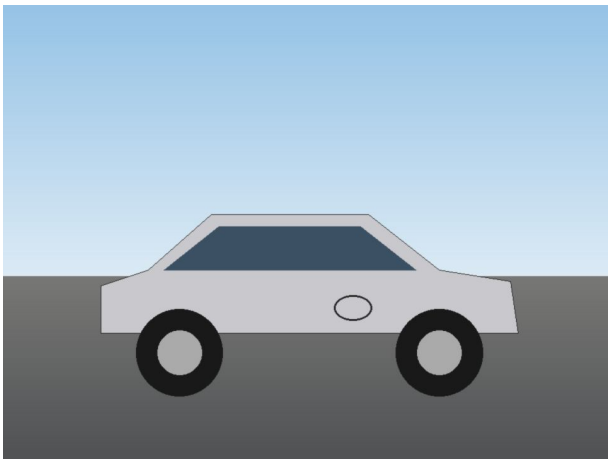
Bodywork free of undeclared damage	**Fail** Left rear door dented, paint scratched over 30 cm.
Windscreen condition	**Intact**
Head and tail lights working	**Pass**
