RIVERTON POLICE DEPARTMENT

Form RPD-TC-1 (rev. 07/2024)
Report No. RPD-26-018842

TRAFFIC CRASH REPORT

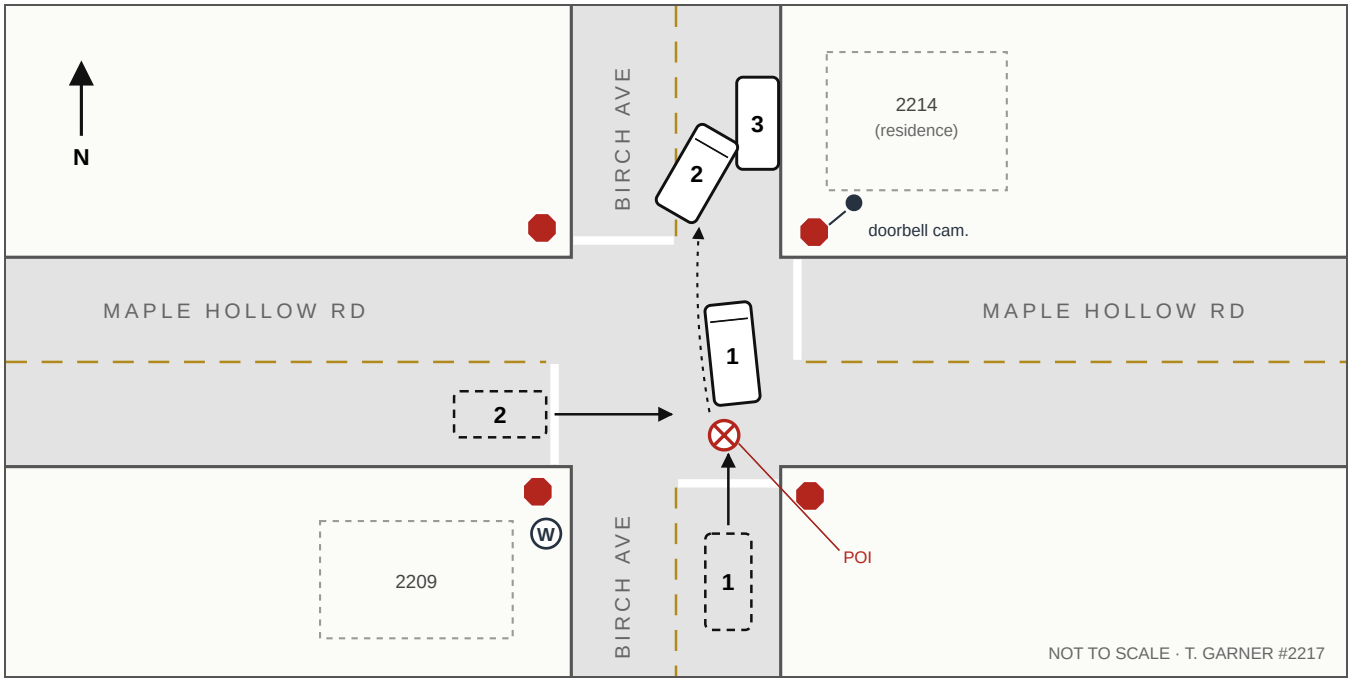
Collision diagram

Unit 1 failed to stop at the stop sign for northbound traffic and struck Unit 2's front passenger door in the SE quadrant of the intersection. The impact pushed Unit 2 north into Unit 3 (Honda Civic, unoccupied), legally parked at the east curb of Birch Ave. No skid marks from Unit 1 located before the POI. Debris field in the NE quadrant.
