NETWORK ASSESSMENT PROPOSAL AND PRELIMINARY FINDINGS

Aranda environment | CEO review draft

Prepared for	Executive / CEO review
Assessment status	Preliminary - missing Meraki MS core/aggregation review

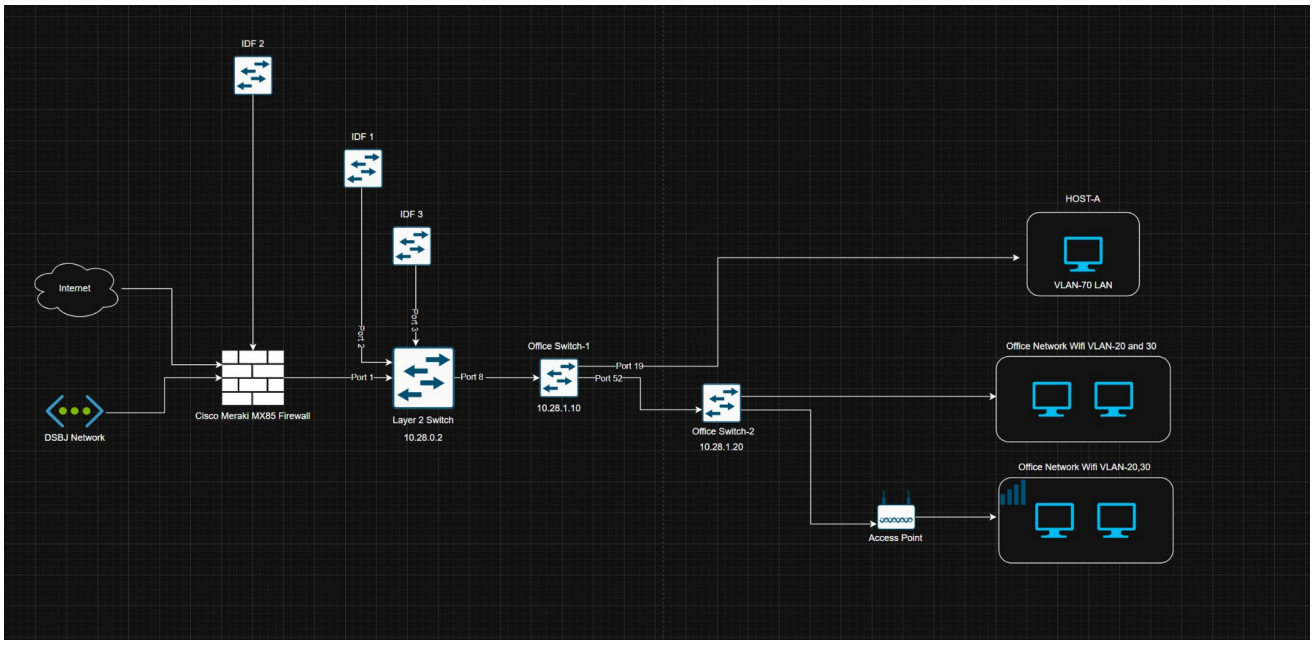
Provided topology diagram reviewed during the assessment.

Based on the diagram and the matching management IPs in the text exports, arandaswitch01 (10.28.1.10) and arandaswitch02 (10.28.1.20) align with Office Switch-1 and Office Switch-2. The central switch in the diagram is labeled 10.28.0.2 and does not appear in the supplied non-Meraki text configs, which increases the likelihood that at least part of the omitted Meraki MS set sits at the aggregation/core layer.
