Stage 1 (Feasibility) Road Safety Audit Report

Parcels R1/R2, South Marston
Section 38 Highway Works
(Designer and Auditor Responses)

Project Name: Parcels R1/R2, South Marston.

Report Title: Stage 1 Road Safety Audit

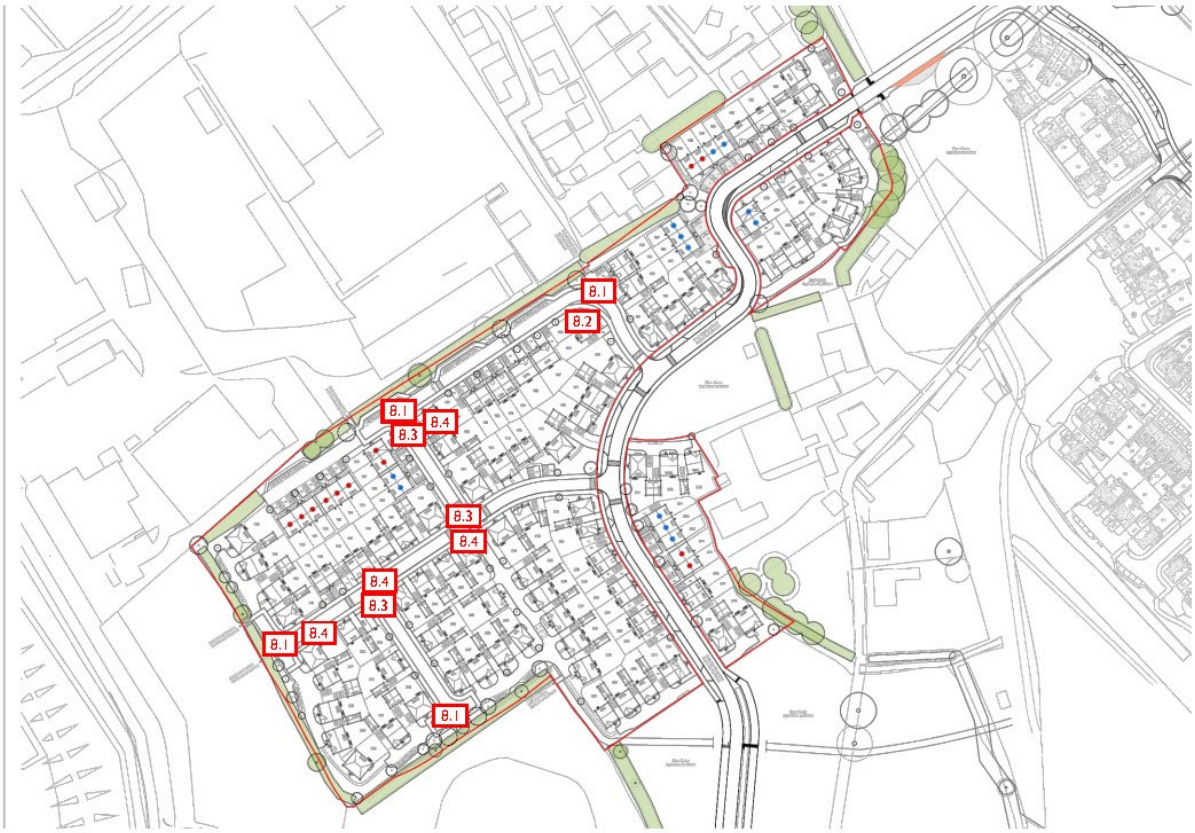
13. Appendix B - Identified Road Safety Audit Matters Location Plans

8.1*Problem* (Item A1.12)	
Location:	General
Summary:	Larger vehicles may have difficult negotiating the site
There are a number of locations throughout the proposals where larger vehicles such as refuse vehicles may have difficulty manoeuvring; junction, turning heads and sharp horizontal alignment changes. This may result in kerb strike / loss of control or vehicles having to perform onerous reversing manoeuvres. Carry out swept path analysis of all likely large vehicles that will travel through the site. Amend the design where necessary.	
TYPE OF CONFLICT/COLLISION	
Risk of collisions.	
RECOMMENDATION	
Carry out swept path analysis of all likely large vehicles that will travel through the site. Amend the design where necessary.

8.2*Problem* (Item A3.1)	
Location:	Carriageway alignment at Plots 168/169
Summary:	No forward visibility splays detailed at sharp bend in road alignment
There is a sharp bend detailed adjacent to Plots 168/169. Forward visibility has not been detailed at this bend. A lack of forward visibility may result in head-on collisions at the bend. Check forward visibility splays around bends, ensure they fall over land to be offered for adoption where visibility can be maintained and meet current criteria. Amend design where required.	
TYPE OF CONFLICT/COLLISION	
Risk of head-on collisions due to reduced visibility.	
RECOMMENDATION	
Check forward visibility splays around bends, ensure they fall over land to be offered for adoption where visibility can be maintained and meet current criteria. Amend design where required.

8.3*Problem* (Item A3.2)	
Location:	Proposed junctions
Summary:	No visibility splays detailed
There are a number of junctions to be provided within the parcels. Visibility splays have not been detailed at these junctions. A lack of suitable visibility may result in vehicles emerging from side roads into the path of oncoming vehicles, resulting in collisions. Appropriate junction visibility splays need to be detailed at all junctions to ensure that they are provided free of obstructions and within land to be offered for adoption.	
TYPE OF CONFLICT/COLLISION	
Risk of collisions due to reduced visibility at junctions.	
RECOMMENDATION	
Appropriate junction visibility splays need to be detailed at all junctions to ensure that they are provided free of obstructions and within land to be offered for adoption.

8.4*Problem* (Item A4.2)	
Location:	Proposed pedestrian crossing points
Summary:	No visibility splays detailed at the new pedestrian crossing points
There are a number of pedestrian crossing points detailed throughout the site. There are no visibility splays detailed at these crossing points. Pedestrians need to see and be seen by approaching drivers before crossing the road. Appropriate pedestrian visibility splays need to be detailed at all pedestrian crossing points to ensure that they are provided free of obstructions and within land to be offered for adoption.	
TYPE OF CONFLICT/COLLISION	
Risk of collisions due to reduced visibility at crossing point.	
RECOMMENDATION	
Appropriate pedestrian visibility splays need to be detailed at all pedestrian crossing points to ensure that they are provided free of obstructions and within land to be offered for adoption.

8.1	Larger vehicles may have difficult negotiating the site	Refuse swept path analysis is demonstrated on drawing: SW192-EN-401A which demonstrates the refuse vehicle can manoeuvre around the development without conflict

8.2	Forward visibility not detailed	Forward visibility splays are demonstrated on drawing SW192-EN-401A – Engineering Layout, all visibility splats are contained within the proposed adoptable extents.

8.3	Visibility splays not detailed	Junction visibility splays are demonstrated on drawings SW192-EN-401A – Engineering Layout, all visibility splays are contained within the proposed adoptable extents.

8.4	Pedestrian visibility splays not detailed	Pedestrian crossing points are location at the Junction tangent point in order to reduce the distance at which a pedestrian needs to be on the carriageway, the exact location of the tactile crossings will be determined at the detailed design stage.

8.1 Noted . Local Authority to agree that these meet their standard requirement
8.2 Agreed
8.3 Agreed
8.4 Agreed. Ensure all ped vis splays detailed are over adopted land
