STAGE 2 ROAD SAFETY AUDIT

Proposed Roundabout Access, Thornhill Road, South Marston, Wiltshire on Behalf of Brookbanks Ltd

Date: August 2023
Issue No. 2

Project: **Proposed Roundabout Access, Thornhill Road, South Marston, Swindon, Wiltshire**

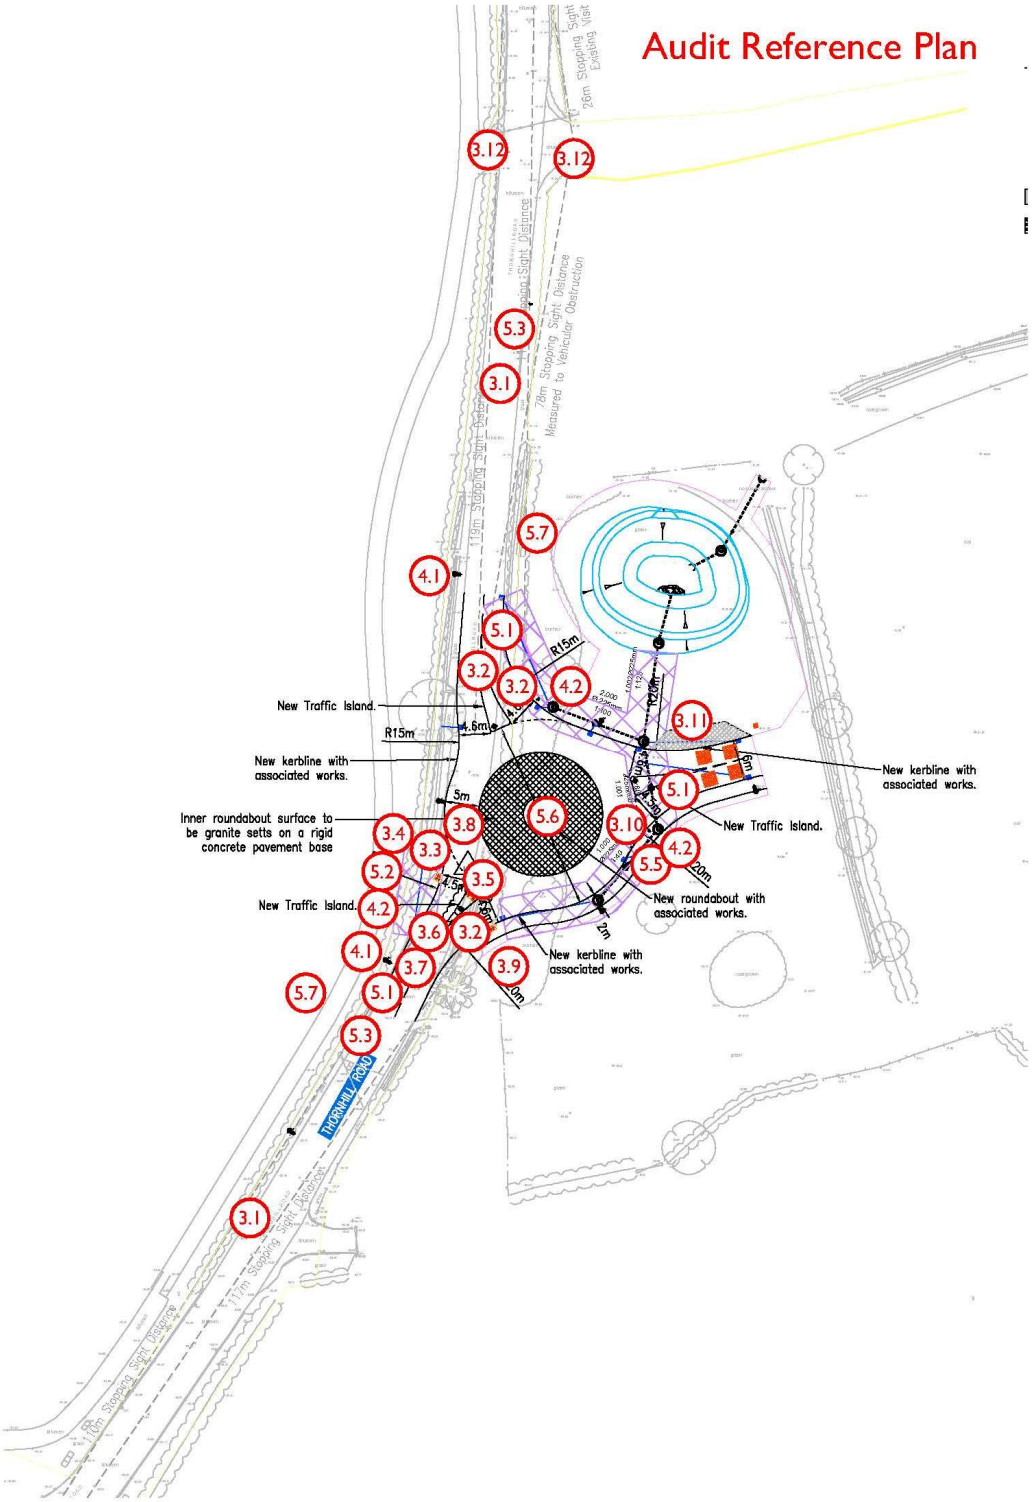
Appendix 1

Audit Reference Plan
New Traffic Island.
New kerbline with associated works.
Inner roundabout surface to be granite setts on a rigid concrete pavement base
New Traffic Island.
New roundabout with associated works.
New kerbline with associated works.
New kerbline with associated works.
New Traffic Island.
THORNHILL ROAD
3.12
3.12
5.3
3.1
5.7
4.1
5.1
3.2
3.2
4.2
3.11
5.1
5.6
3.10
4.2
5.5
3.4
3.8
3.3
5.2
3.5
4.2
3.6
3.2
4.1
3.7
5.1
3.9
5.7
5.3
3.1
R15m
R20m
R15m
4.6m
5m
1.5m
2m
20m
10m
