Ensuite bathroom maintenance

Refer to this document when the sinks start to drain slowly.

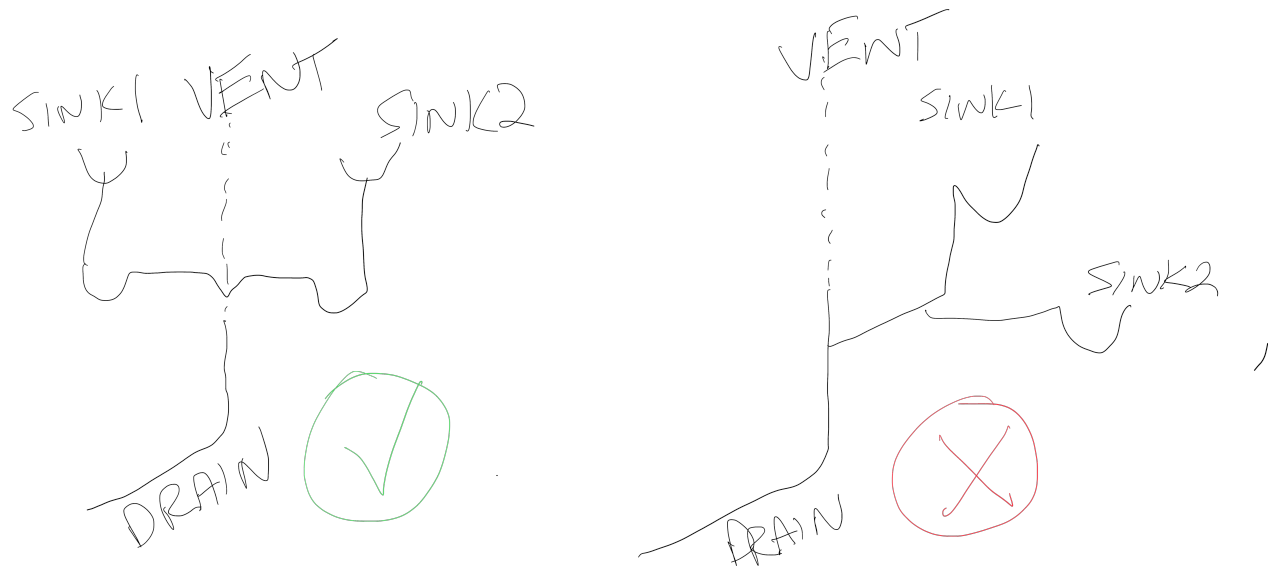
Figure 1: Plumbing diagram

The sink plumbing in our ensuite bathroom was not properly set up and as such, the right hand sink uses the drain in the left hand sink for some of its venting. Figure 1 illustrates the issue.

The plumbing illustrated on the left shows the correct way to connect two sinks, the drawing on the right show how it was actually installed. This means that once the sinks start to get clogged with hair etc. Then draining on the right sink will get markedly worse when the left sink is in use at the same time.
